The removal of Saeltzer Dam on Clear
Creek : an update

Mike Ferry and Peter Miller
June 2, 2003

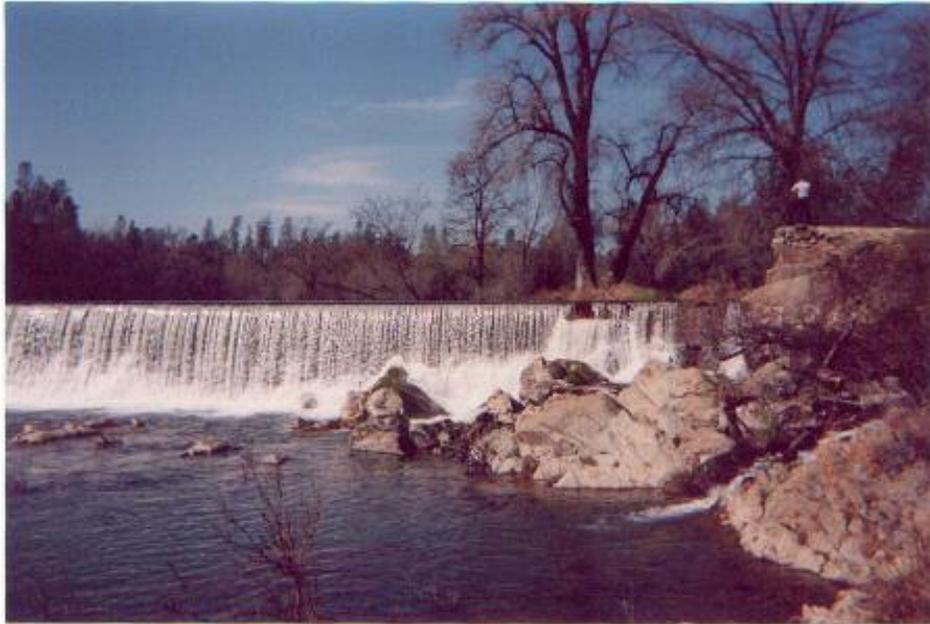
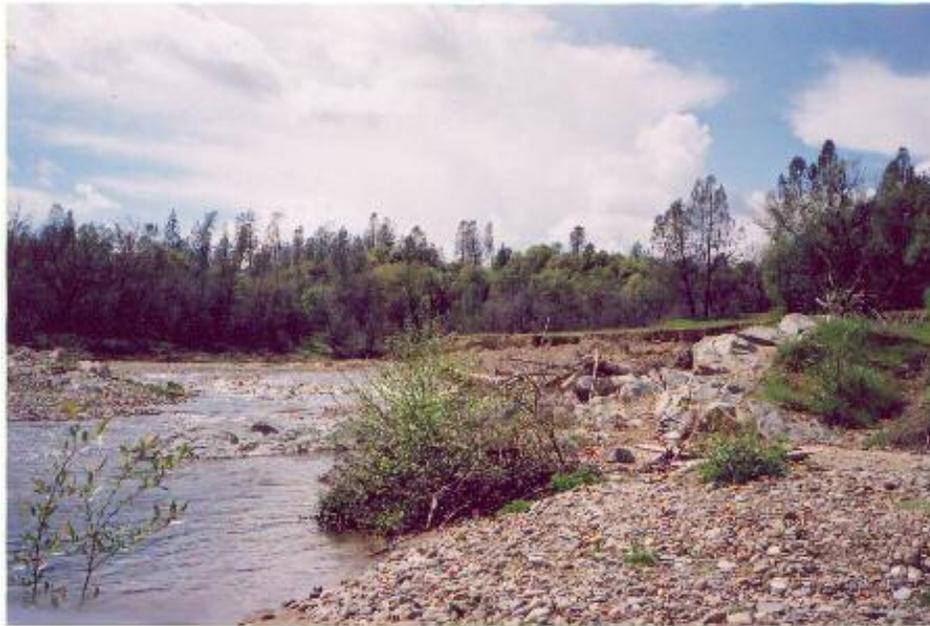
Figure 4: Saeltzer Dam, Before and After Removal, View Upstream

Three pairs of pre- and post-dam removal photographs are presented in Figures 4, 5, and 6. The “pre” photographs were collected as part of the environmental assessment of dam removal and were given to us by Mike Urkov of CH2M Hill (see Table 1). The post-dam photographs were taken by us on April 4, 2003. In each case we attempted to duplicate pre-existing photographs of Saeltzer Dam.
