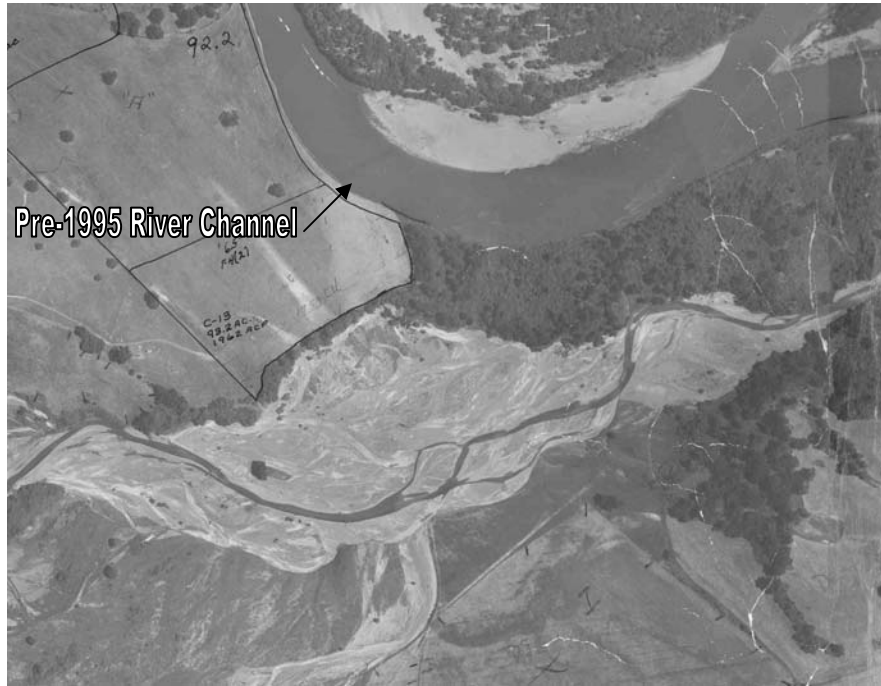
Image Comparison 4a. Thomes Creek confluence with the Sacramento River (delta) in 1952 (top) and 2004 (bottom). Note that Thomes Creek's mouth may be migrating further to the north, eliminating riparian forest along the Sacramento River and cutting off the 1952 river channel. In the late 1990s a new river channel formed by cutting through the large point bar and it is possible that the island created will become attached to the western land mass.

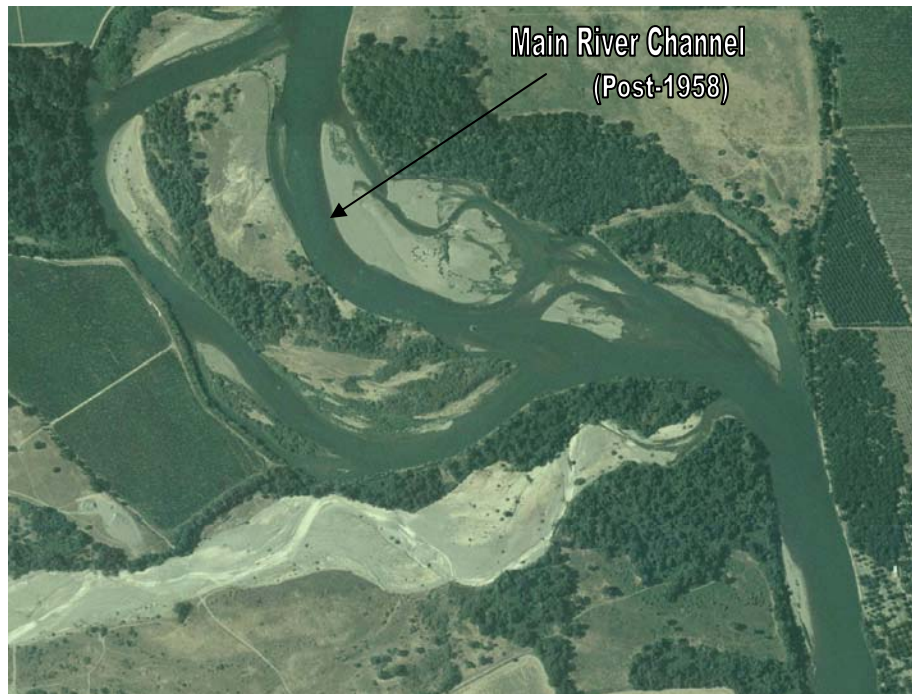
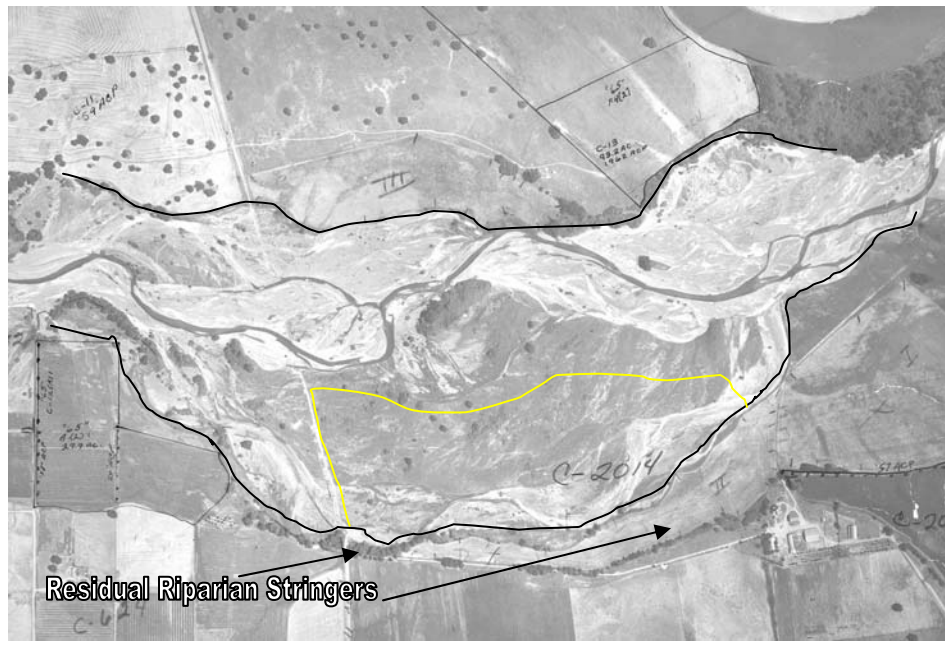
- Thomes Creek is wide and has a highly braided character through the entire assessment area. Total stream channel width was often in excess of 1,000 feet, while at both the Hall Creek low-water crossing (see Image Comparison 4b) and Interstate 5 crossing site (see Image Comparison 4c) total stream width was about 3,000 feet.

- Streamside vegetation is very sparse and only exists as small "islands" of short-statured growth within the channel boundaries and as stringers of moderate to large canopied trees along the external edges of the stream channel. Frequently these stringers of hardwood trees are associated with cut bank features (see Image Comparison 4b).

- Thomes Creek continues to be highly braided throughout its reach; however, in many locations its 1952 width has been constricted. Examples include: the Hall Creek crossing (see Image Comparison 4b); levees constructed to protect the Tehama-Colusa Canal; and the Interstate 5 crossing (see Image Comparison 4c). In the latter case the original width was narrowed from 0.6 miles to less than 0.3 miles.

Image Comparison 4b. Thomes Creek at the Hall Road crossing in 1952 (top) and 1994 (bottom). Note the extent of the stream's overflow patterns in 1952 (black lines) and the rows of riparian trees along the outer stream banks. By 1994 significant portions of the overflow channels have been converted to agricultural land (area encircled by yellow line), which is orchard. Note the row of hardwoods still existing along the stream bank feature south of the orchard.

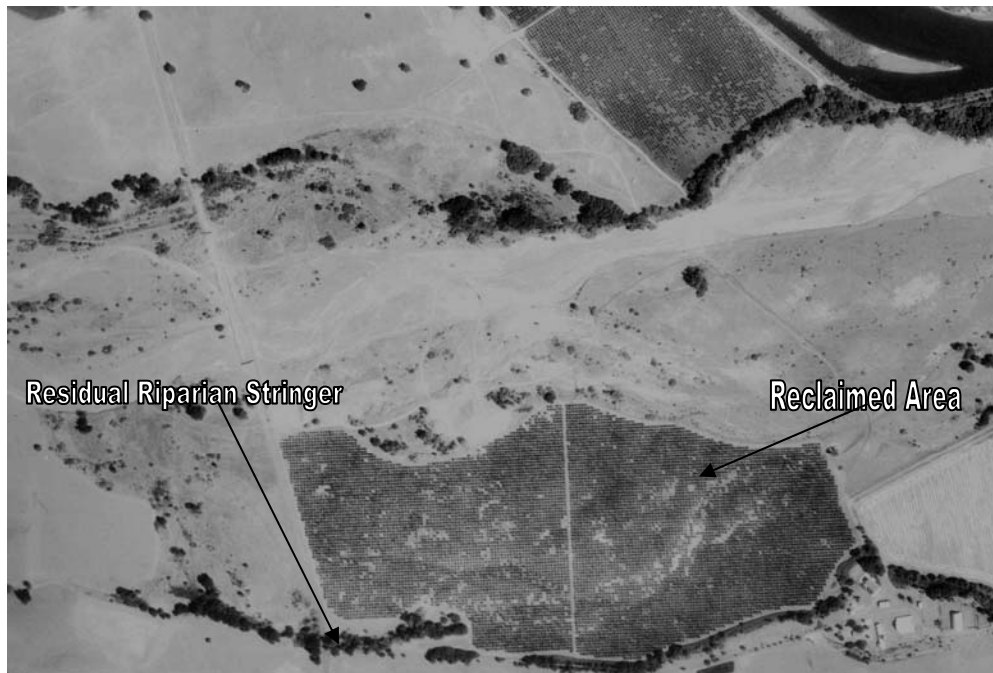
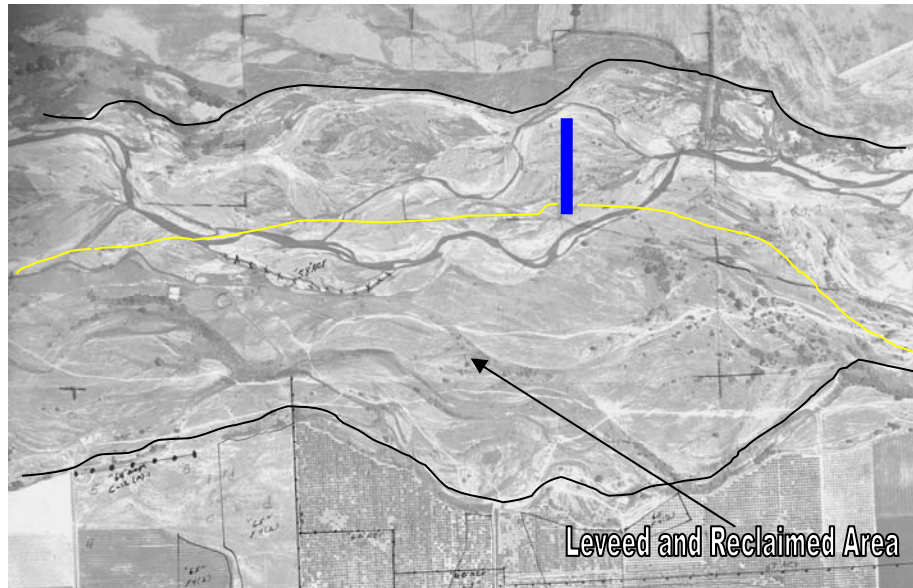
Image Comparison 4c. Thomes Creek at the Interstate 5 crossing site in 1952 (above) and 1994 (bottom). Note the braided stream condition in both images. The Interstate 5 Bridge locations and lengths are shown as a blue bar. The extent of overflow patterns in 1952 are shown by the black lines and the 1994 extent of stream constriction is shown by the yellow line. Comparing these images show the extent of channel constriction. (The feature to the west of Interstate 5 is the Corning Canal crossing.)

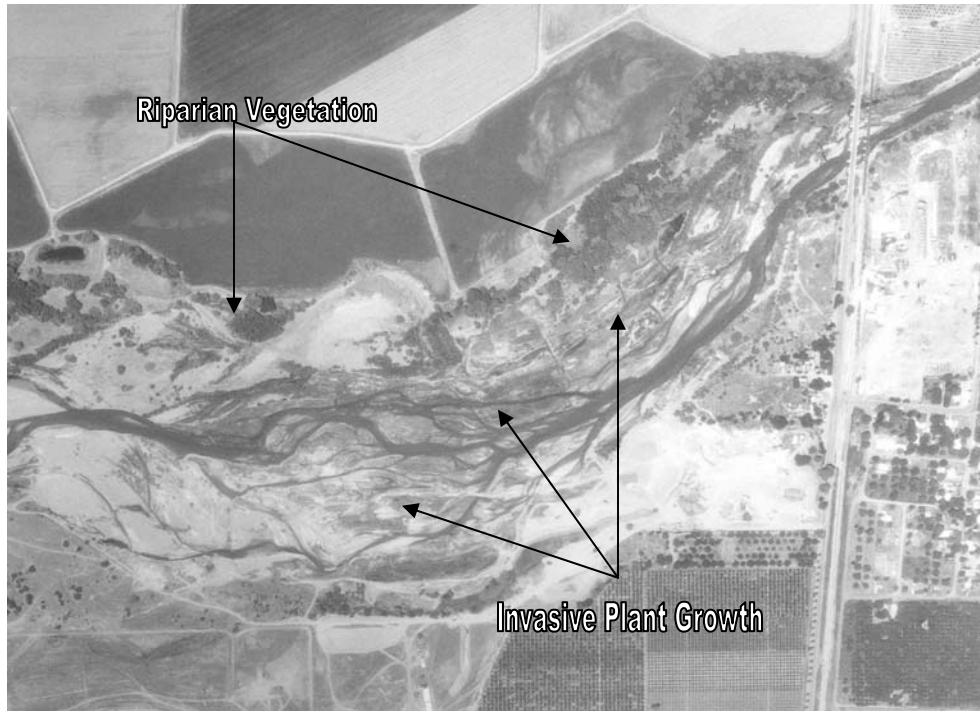
**Image 4d. Thomes Creek immediately west of Richfield, in 1994. Note the vegetation occurring within the stream braids, likely *Arundo*, and larger-statured vegetation along the sides of the channel.**

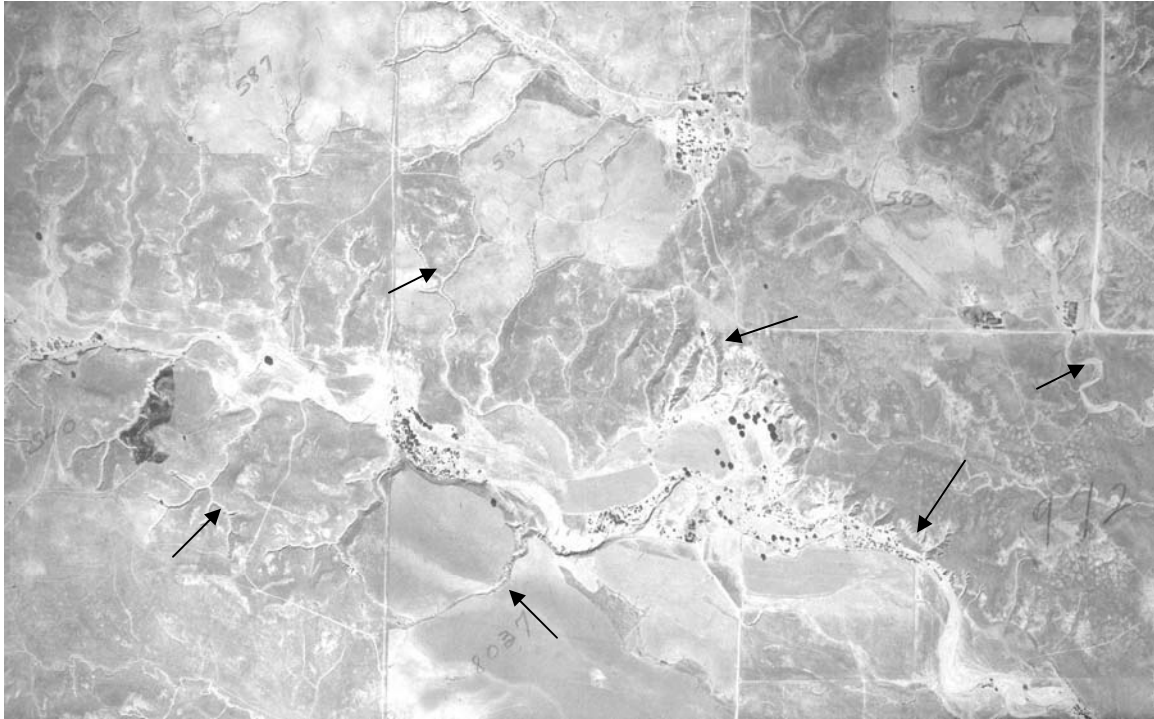
The 1938 photograph of this portion of the Brickyard Creek drainage shows a large number of sharp erosion features, apparently recent in origin. These include steep and raw cutbanks in minor gullies draining into Brickyard Creek. Many of these erosion features are dendritic, suggesting downcutting in the main channels, leading to downcutting in the feeder channels.

In the 2004 photograph (Image 5b) several features are immediately apparent—a 2004 rangeland fire has burned through the western portion of the assessment area and urban sprawl has pushed in from the east (suburbs of Red Bluff). In addition, several dams have been constructed in small draws, creating slender ponds.

The sharp erosion features noted in the 1938 photograph appear muted in the 2004 image. Although the resolution of the 1938 image is greater than the 2004 photograph, this change appears to be a product of gradual healing of the eroded gullies and suggests that the distinctive features seen in 1938 were created only shortly prior to when the photograph was taken.

**Image 5a (1938, above) and 5b (2004, below). Upland Site 1, Brickyard Creek, West of Red Bluff. Examples of sharp erosion features are pointed at by the arrows.**

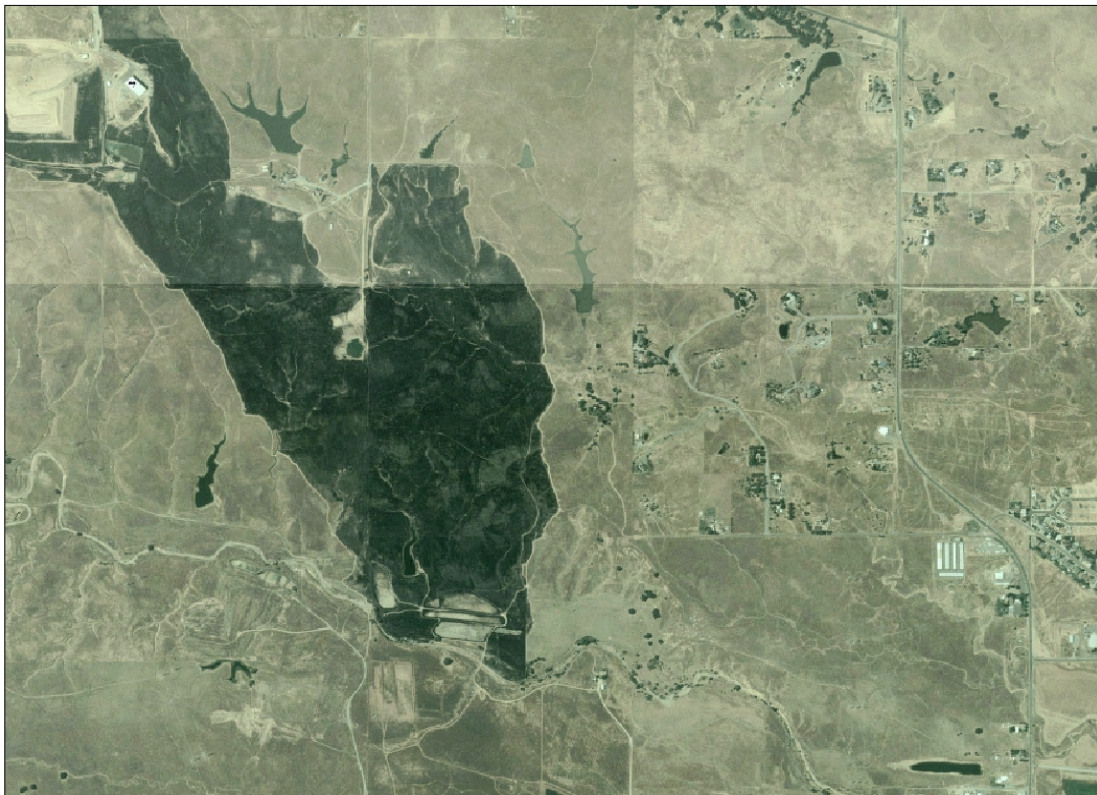
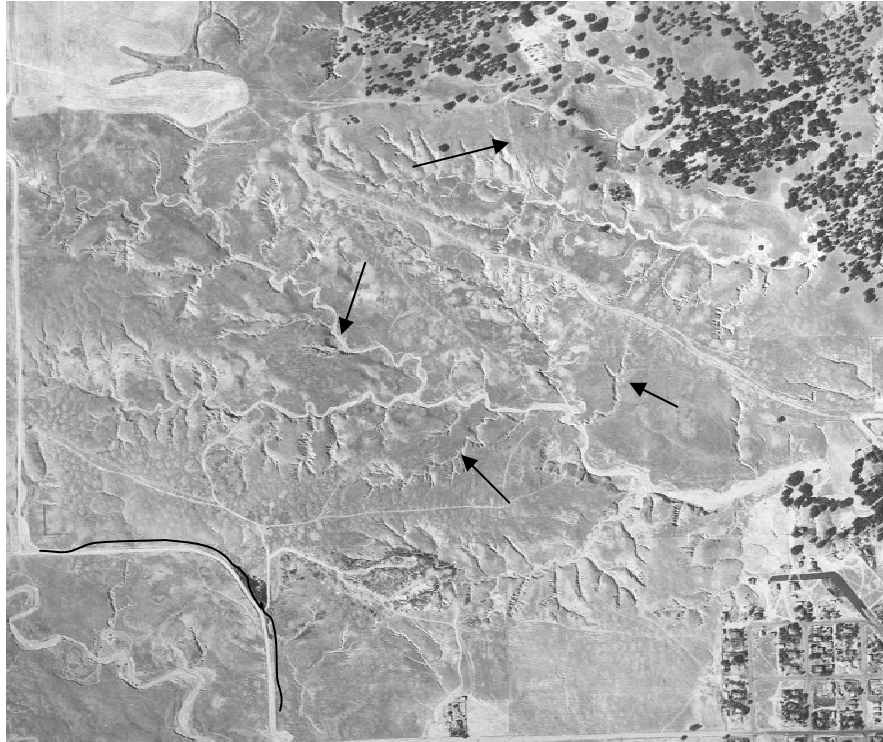
In 1938 this assessment area is laced with sharp, down-cut gullies. No urban development has occurred in the area and vegetation appears to be grassland/rangeland. No riparian vegetation exists in any of the gullies leading into Brewery Creek or along the main creek itself.

In 2004 residential areas have extended westerly from the City of Red Bluff along both Park and Waldbridge Streets. Waldbridge Street has been extended through the southern portion of the assessment area but the central portion of the assessment area has been avoided by new development, likely due to the eroded and broken terrain. As in the case of Site 1, the sharp erosion gully features are much less apparent in 2004 than in 1938, suggesting that they have rounded and begun to heal. As in 1938, there is no riparian vegetation along the gullies or Brewery Creek. Also, the assessment area continues to exist as a grassland/rangeland.

**Image 5b (top, 1938) and 5b (bottom, 2004). Brewery Creek Drainage, immediately northwest of Red Bluff (Site 2). Examples of sharp erosion features are pointed at by the arrows. For reference, the bend of Baker Road is shown as a black line in both images.**

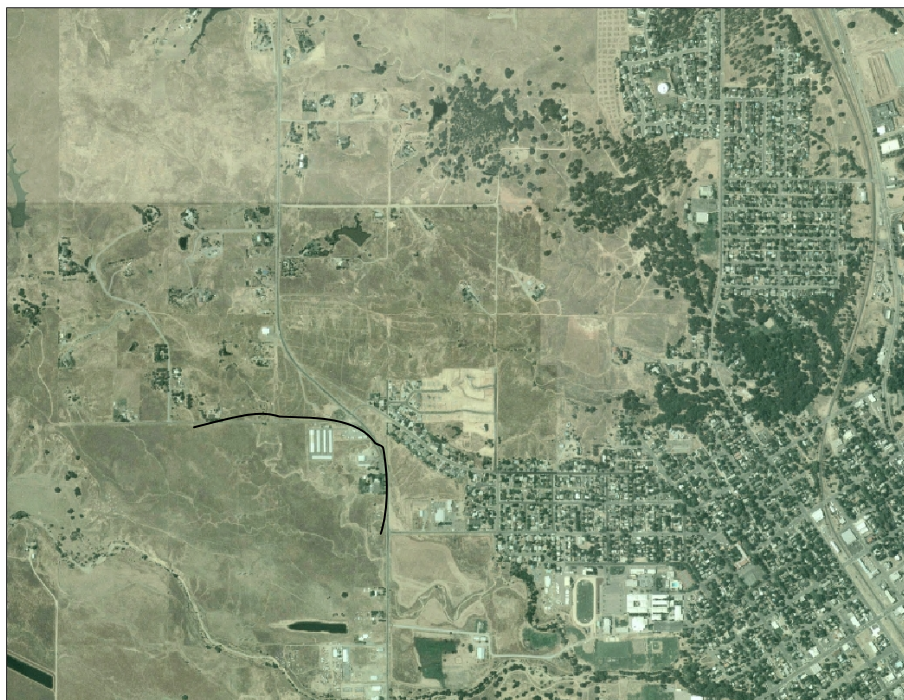
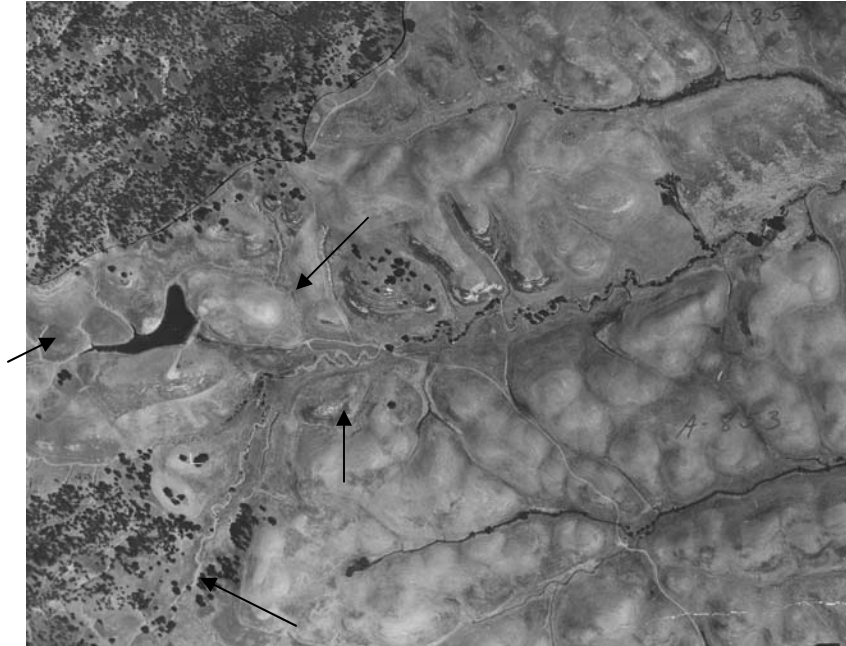
As shown by Figure 6a, in 1952 this assessment area is composed primarily of gently sloping and rounded terrain. Dry land agriculture is used on most of the land, except for the draws with steeper slopes and the hills to the northwest. The hills have moderately-heavy growth of gray pine and blue oak.

Sharp erosion features exist at Site 3, in a similar manner to Sites 1 and 2. Riparian growth is very restricted, only occurring in narrow, disconnected patches directly adjacent to Oat Creek and its larger tributaries. Riparian growth does not exist along any of the smaller gullies.

By 2004 (Figure 6b) some changes are apparent, relative to 1952. First, the oak/pine woodland north and south of the pond has been significantly thinned but not eliminated. Second, the erosion features sharply seen in 1952 appear to be more rounded and blend in with the adjacent uplands. Third, dense vegetation has encircled the pond, with some of the growth being emergent. It is possible that the pond's size has declined, due to sediment deposition, or that the emergent vegetation contributes to this perception. Riparian growth along Oat Creek is even more limited in 2004 than 1952. Riparian stringers do not exist in 2004, merely scattered individual shrubs or shrub-clusters.

**Figure 6a (top, 1952) and 6b (bottom, 2004). This assessment area (Site 3) is located along Oat Creek, approximately 2 miles south of the location called Red Banks. Significant erosion features are shown by arrows.**

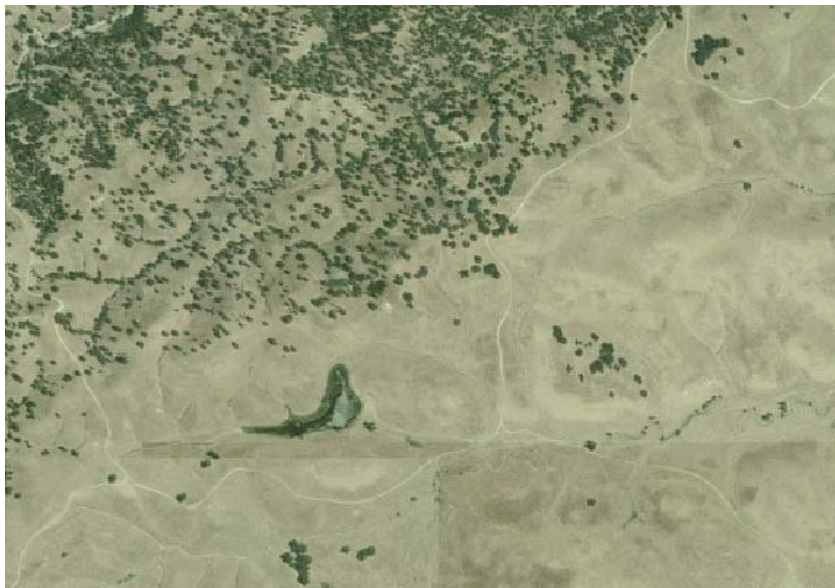
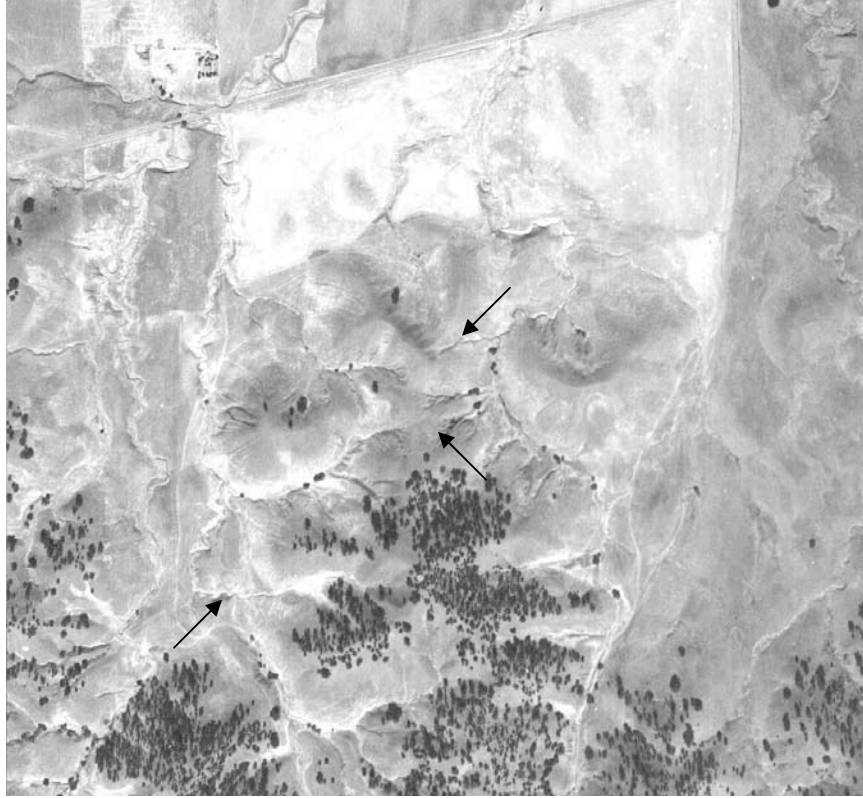
The vicinity southwest of Paskenta, shown in Figures 7a and 7b show similar erosion features in small headwater gullies and along bends of stream channels, in a manner similar to Sites 1-3. However, the gullying is less severe and less wide-spread than in the previous assessment areas.

**Figure 7a (top, 1938) and 7b (bottom, 2004). This area (Site 4) is located only 1 mile southwest of Paskenta. Sharp erosion features are shown by the arrows.**

In 1938 the area was a combination of grassland/rangeland on the flats and gentle slopes with stands of gray pine and blue oaks on the steeper, adjacent hills. Riparian vegetation does not exist on any of the gullies. In 2004 the gully erosion is less pronounced but riparian growth still is totally lacking. The pine and oak woodlands are similar in extent and density, with no evidence of thinning.

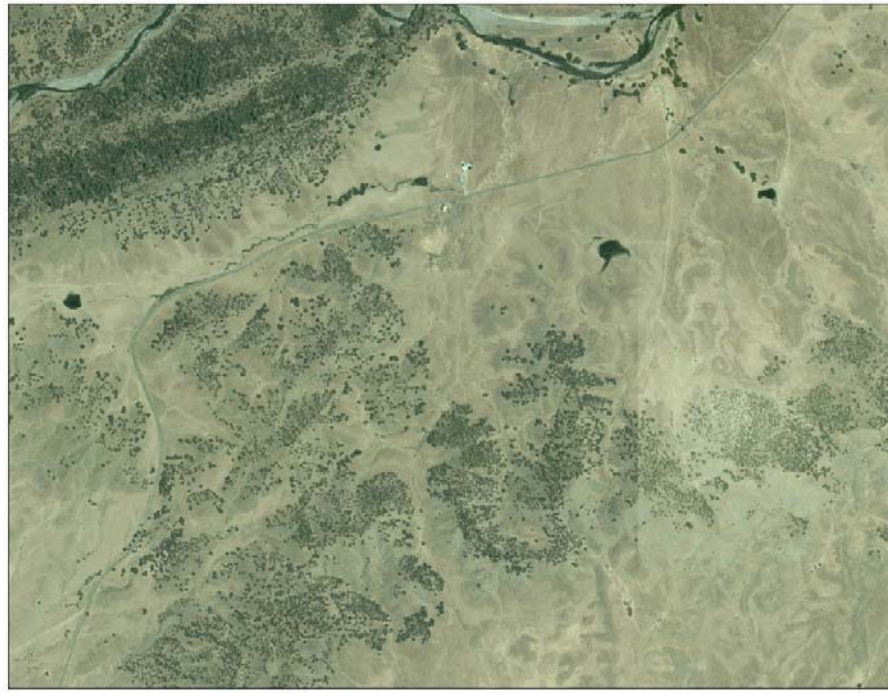
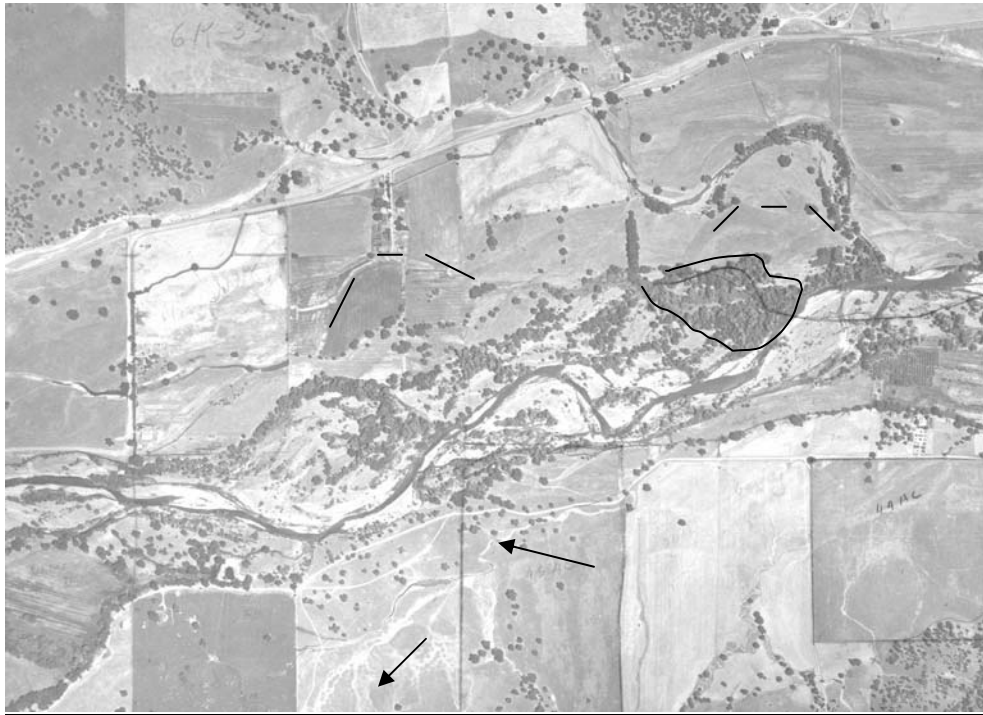
Figure 8a (top, 1952) and 8b (bottom, 2004). Significant areas of riparian growth that have been affected are circled by black lines. Gully erosion features are shown with arrows. Note old stream bend features shown with broken lines. This is Site 5.

Some gully erosion can be seen in Figure 8a; however, the degree of upland erosion is less than in Sites 1-3.

Riparian vegetation shows significant change between 1952 and 2004. Specifically, Thomes Creek has eaten away at large portions of the riparian habitats that existed in 1952. Evidence of past stream bends, extending hundreds of feet to the north of the existing Thomes Creek channel, can be seen on both photographs. This suggests that the stream has varied in width and path in the past. Even so, the amount of riparian cover along the lower portion of McCarthy Creek, in the northeast quadrant of the 1952 image, is very similar in both years. In both 1952 and 2004 riparian vegetation and other shrub or tree cover is very sparse along gullies feeding into Thomes Creek.

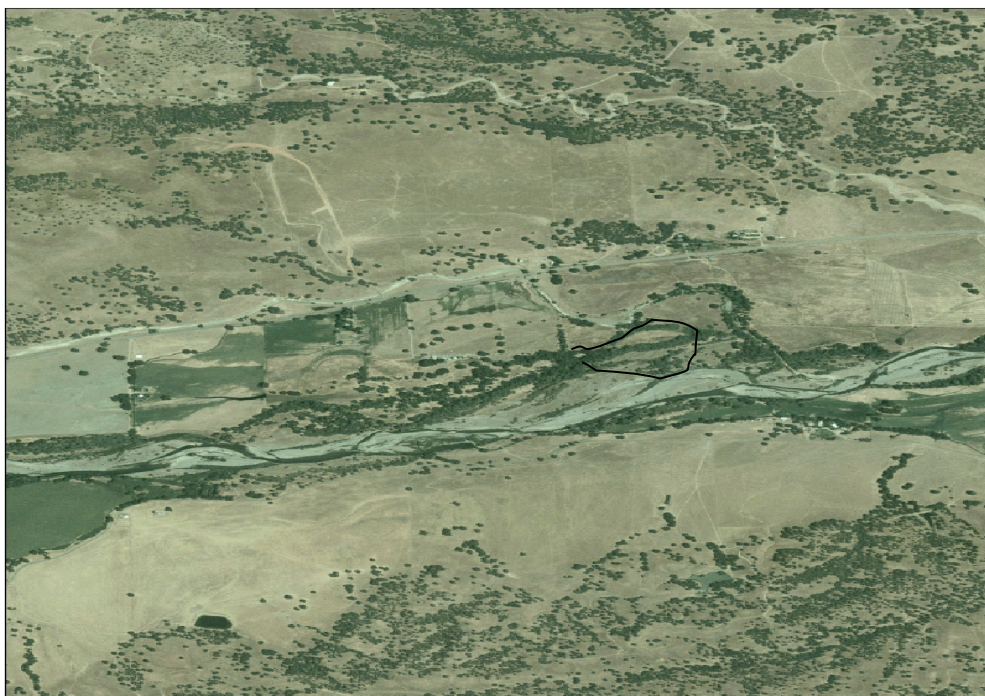
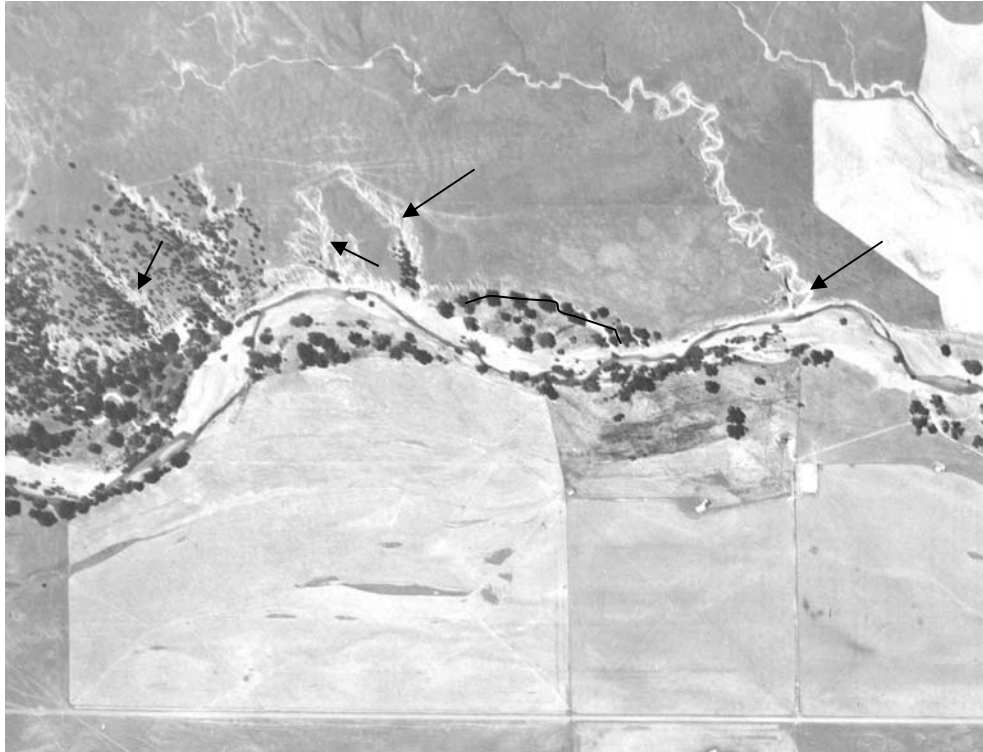
**Figure 9a (top, 1947) and 9b (bottom, 2004). This is Site 6, along Elder Creek and approximately 1 mile west of the Paskenta Road. Note significant erosion features shown by the arrows. An old stream erosion feature is shown with the wavy line.**

Along the northern bank of Elder Creek there are a number of significant erosion features, similar to what was seen in Sites 1-3. Sharp cut banks exist in the 1947 photograph, along with dendritic gully erosion patterns (as shown on Figure 9a). Riparian growth is very scant along Elder Creek and not present in side gullies.

In 2004 the erosion features appear less noticeable than in 1947, with the possible exception of the gully shown by the furthest east arrow on Figure 9a. Riparian growth - all of which exists directly along Elder Creek - appears mostly unchanged between 1947 and 2004. Finally, agricultural efforts appear to have been curtailed south of Elder Creek between 1947 and 2004, with only grasslands/rangelands south of Elder Creek during more recent years.
