Feather River Coordinated Resource Management Watershed Monitoring Program

2011 Report

Prepared by Plumas Corporation
Quincy, CA
April 2012

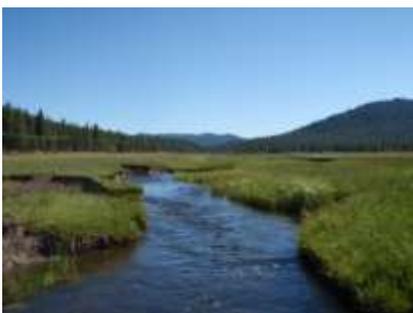
X-Sec 2 looking downstream

It appears that Goodrich Creek is still adjusting after the last big flow event. Visually the bankfull width seems to have become narrower over the past 12 years, but based on Figure 31 there is no significant difference in the width of the channel. The difference in channel width could also be due to the difficulty in interpreting bankfull. Figure 32 shows that there has been a significant difference in mean channel depth. Goodrich Creek within the monitoring reach has become significantly shallower over time.

Stream flows in 2011 probably moved sand and gravel into the reach aggrading the channel. Despite the shallow water depth, the water temperature remained cool throughout the summer. There were no days with weekly average water temperatures exceeding 66F, and no single days with absolute maximum water temperature above 75F. Despite the cool water temperatures, the number of tolerant macroinvertebrate taxa was relatively high (compared with the other sites), and has increased since 1999.

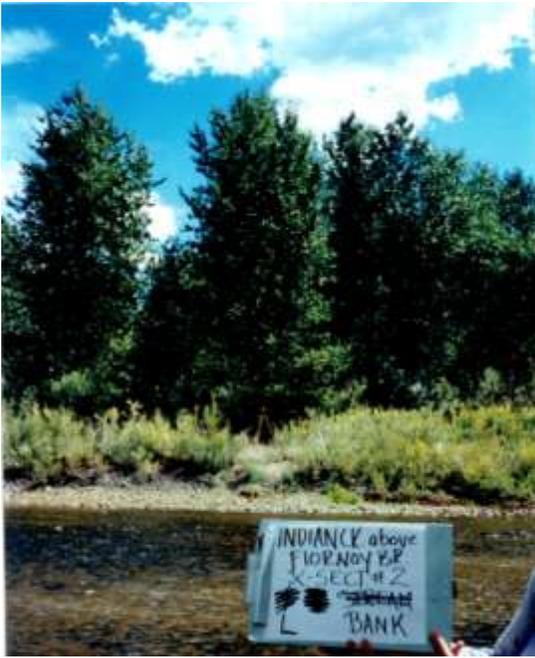
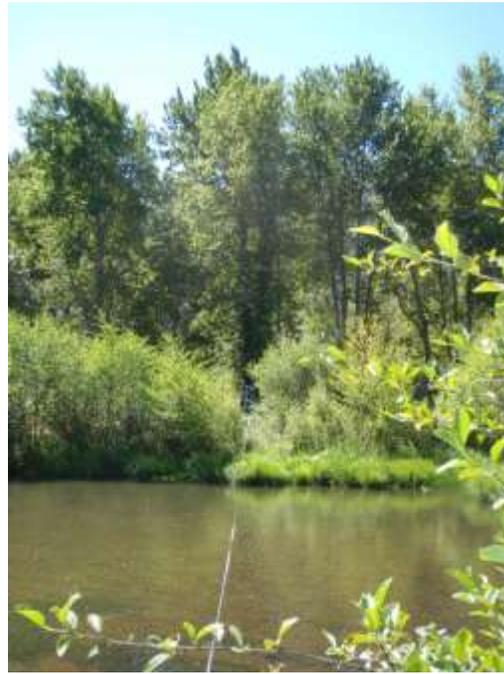
Indian Creek above Flourney Bridge (below the confluence of Red Clover Creek) appears to be relatively stable. There has been an increase in bank stability due to the increased vegetation (see below photos). There has been a decrease in tolerant macroinvertebrate taxa. The riffles in the reach have moved downstream over the past eight years, and the pool depth is deeper. Floodprone width decreased in 2011, but Figure 33 shows there is no significant difference between the floodprone widths from 1999, 2003, or 2011. The difference in width is possibly due to errors in interpreting bankfull width, or because of riffle location shifts.

X-Sec 2 Left Bank, 1999

X-Sec 2 Left Bank, 2011

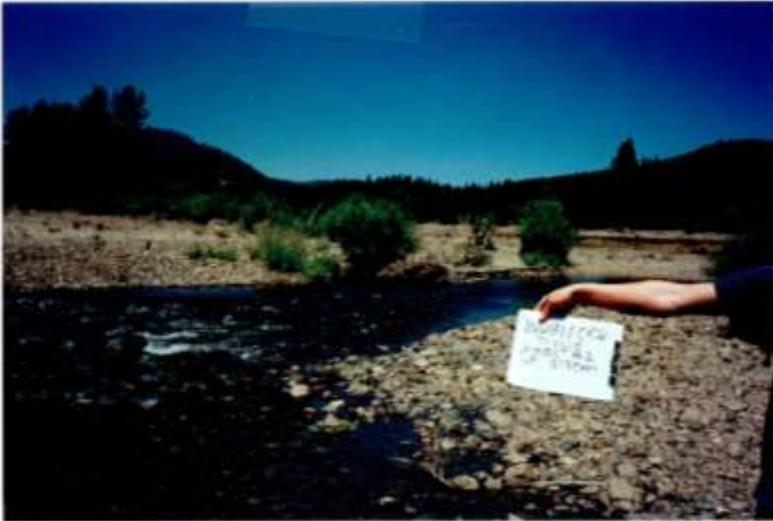
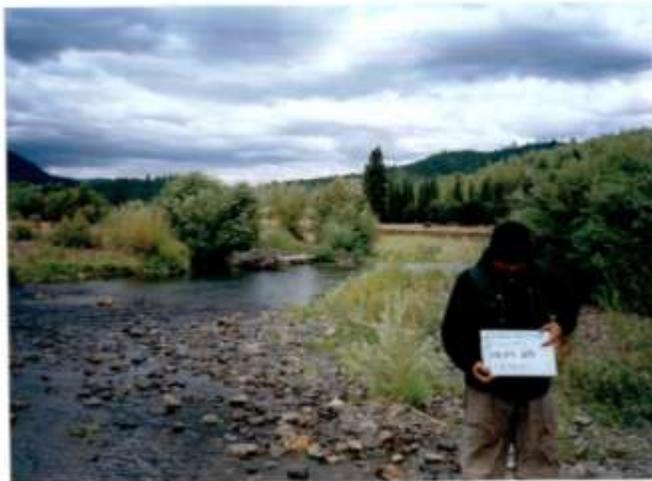
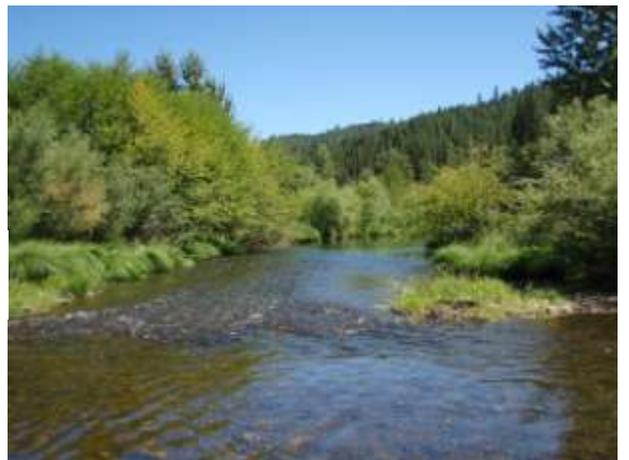
Like Indian Creek above Flournoy Bridge, Indian Creek below Taylorsville Bridge has become more stable since 1999, and since the 1997 flood. This is due to the amount of vegetation present on the stream banks. The Taylorsville monitoring reach has also shown a decrease in tolerant macroinvertebrate taxa. Some of the habitat types have changed throughout the reach due to a beaver dam downstream of cross-section two. This caused cross-section two to be in a pool/backwater area. We did not move this cross-section. Floodprone width through the reach has narrowed since 1999-2003, but Figure 34 displays no statistically significant difference in the floodprone widths from 1999, 2003, or 2011. The difference is probably due to problems identifying bankfull width, or the shift in riffle crest location.

X-Sec 1, Downstream, 1999

X-Sec 1, Downstream, 2001

X-Sec 1, Downstream, 2011

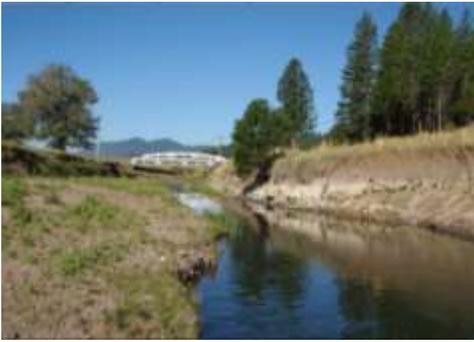
X-Sec 1 looking downstream

Lights Creek channel cross-sections have shown a decrease in cross-sectional area over the past twelve years. Residual pool depths have gotten deeper, as well as sediment size getting smaller. The percent tolerant macroinvertebrate species has increased notably since 1999. Lights Creek above Deadfall Lane Br. continues to be an unstable site.

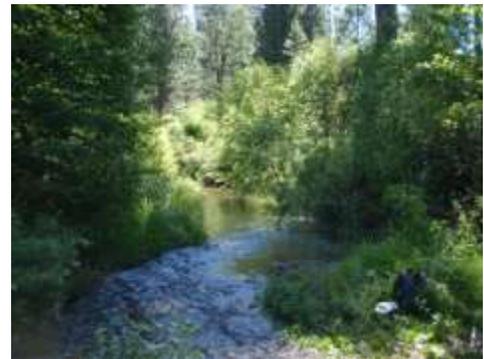
Wolf Creek appears to be relatively stable since 1999. The monitoring reach has had very little change in cross-section bankfull width, floodprone width, and depth. The channel has increased in bank stability due to increased vegetation throughout the reach. There also has been a notable decrease in pool tail fines throughout the reach.

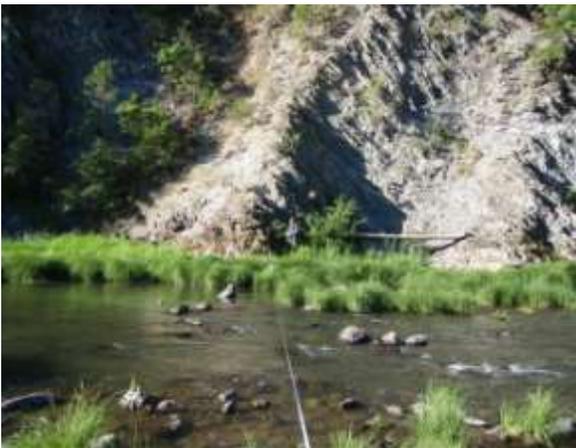
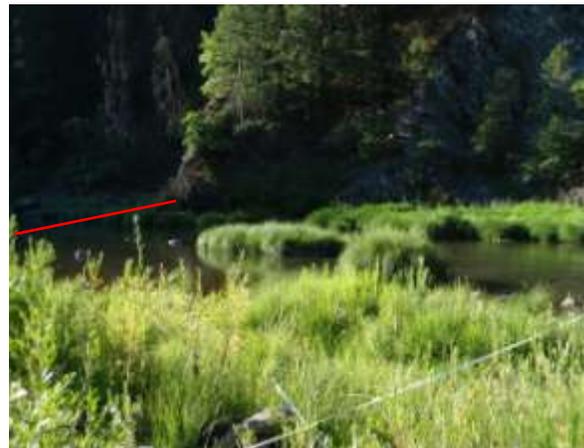
This monitoring reach is comprised of several bedrock sections; because of this, the Indian Creek above Spanish Creek monitoring reach is somewhat stable. The major alteration to the reach in 2011, was the location of cross-section one. The cross-section one riffle moved downstream considerably in the past eight years. The cross-section in 2011 was located directly through a pool. Due to the high water and higher flows, still present in September, the cross-section was moved downstream approximately 100 feet to the pool-tail crest.

X-Sec 1, 2011

X-Sec 1, 1999-2003 (red) X-Sec 1, 2011 (white)

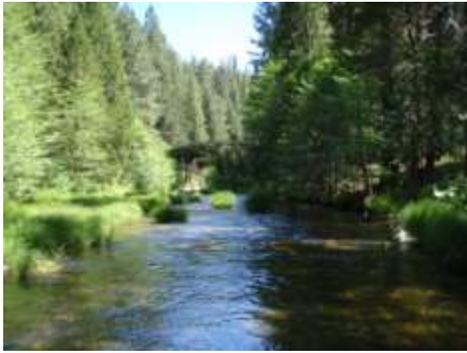
X-Sec 3 looking upstream

Rock Creek is another monitoring reach where a significant portion of the reach is comprised of bedrock. There have not been many changes throughout the Rock Creek reach over the past 12 years. There has been a slight increase in percent tolerant macroinvertebrate taxa.

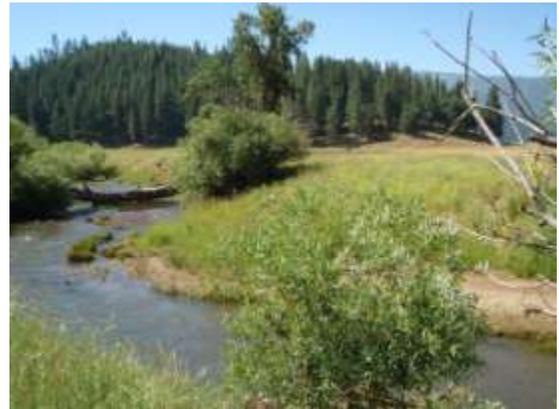
X-Sec 2 looking upstream

While the bankfull width, floodprone width, and mean bankfull depth have remained relatively stable throughout the Greenhorn Creek monitoring reach, residual pool depth and percent intolerable macroinvertebrate taxa have increased. Residual pool depths have gotten deeper and sediment size has decreased. There is no perceivable trend with stream temperature. Maximum weekly average stream temperature >66F continues to decrease, but number of days where the temperature exceeded 75 degrees has increased.

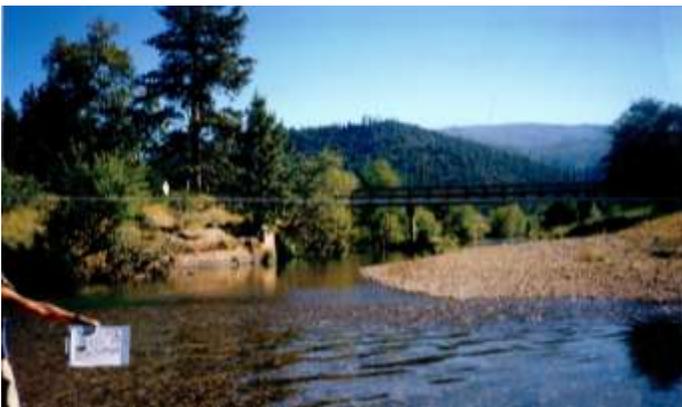
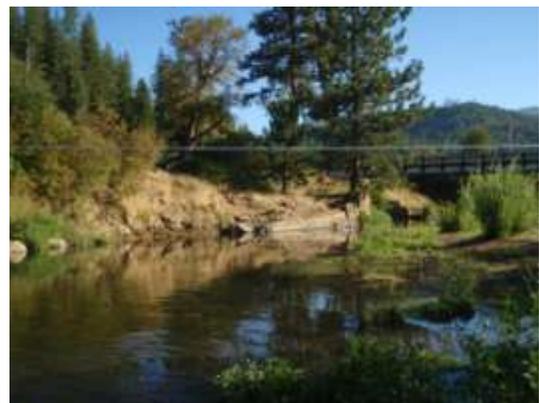
Spanish Creek above confluence with Greenhorn Creek shows a significant change in mean bankfull depth, floodprone width, and bankfull width in 2011, which signifies a significant decrease in cross-sectional area. The riffles at cross-sections one and three have moved upstream (see below photos). Bank stability has increased in the reach since 1999. This is due to the vegetation increase from lack of high flows since the 1997 flood. Spanish Creek continues to show high bedload transport.

X-Sec 1 1999, looking downstream
**note position of riffle*

X-Sec 1 2011, looking downstream

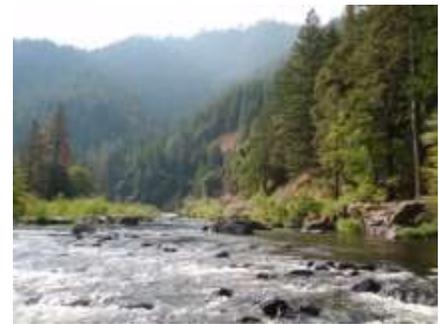
X-Sec 1 looking upstream

The East Branch North Fork Feather River (EBNFFR) monitoring reach is showed a significant decrease in bankfull width and mean bankfull depth in 2011. This decrease signifies a significant decrease in cross-sectional area. Residual pool depth has increased, as well as the percent tolerant macroinvertebrate taxa. Substrate size has decreased over the past ten years.

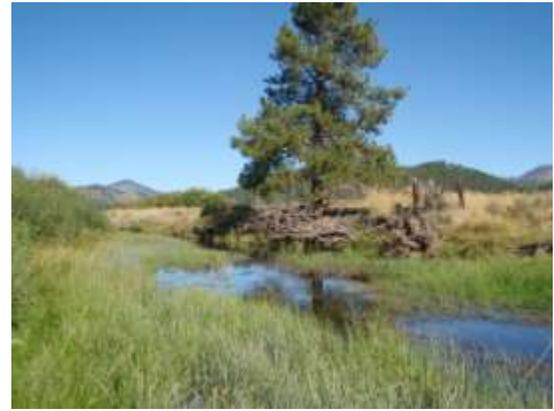
X-Sec 1 and downstream

The Middle Fork Feather River has been a problematic site since 1999. In the past there has been a lack of continuous surface water through the monitoring reach during the summer months. In 2011 water from a downstream beaver dam backed up through the monitoring reach. The influence from the beaver dam rendered the reach incompatible with the Stream Condition Inventory protocol. All the riffles in the reach were flooded with minimum depths of two and a half to three feet deep. The below photos display the three cross-sections in the monitoring reach and the lack of fast water in the reach.

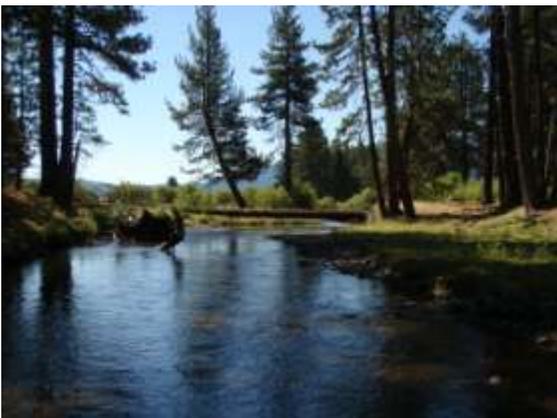
X-Sec 1 looking upstream

The Sulphur Creek reach has shown an increase in pool depth, large woody debris, and pools formed by large woody debris. There has been an increase in shade throughout the reach with corresponding decreases in water temperature. Despite the cooler water temperatures there was still an increase in tolerant macroinvertebrate taxa from past surveys. The mean bankfull depth in 2011 was significantly shallower from the mean bankfull depth in 1999 and 2003.

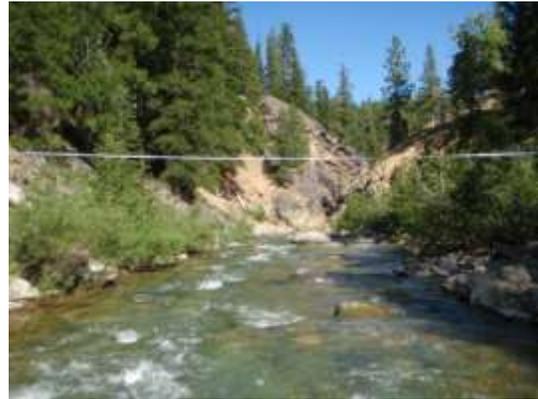
X-Sec 1 looking downstream

The most noticeable difference in the Jamison Creek monitoring reach was the reduction of slow water habitat. Slow water habitat went from an average of 18% in 1999-2003 to 4% in 2011. This could be attributed to erosion from mining upstream. This erosion, combined with several years of low stream flow, could have filled in much of the slow water habitat.

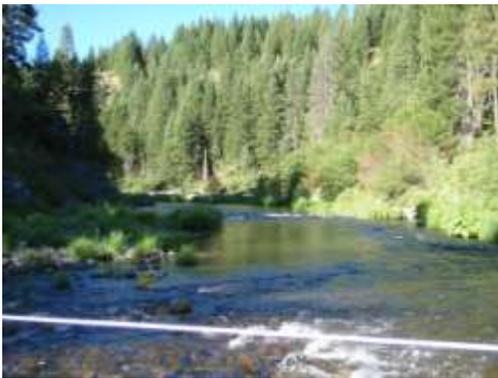
X-Sec 2 looking downstream

The Middle Fork Feather River at Nelson Point appears to be relatively stable. There have been no significant changes to channel morphology through the reach. There has been a change in substrate size, which has steadily gotten smaller.
