Appendix 1-2

**STREAM REACH PHOTOGRAPHIC ASSESSMENT**

## TEHAMA WEST STREAM REACH PHOTOGRAPHIC ASSESSMENT REEDS, RED BANK, ELDER, AND THOMES CREEKS

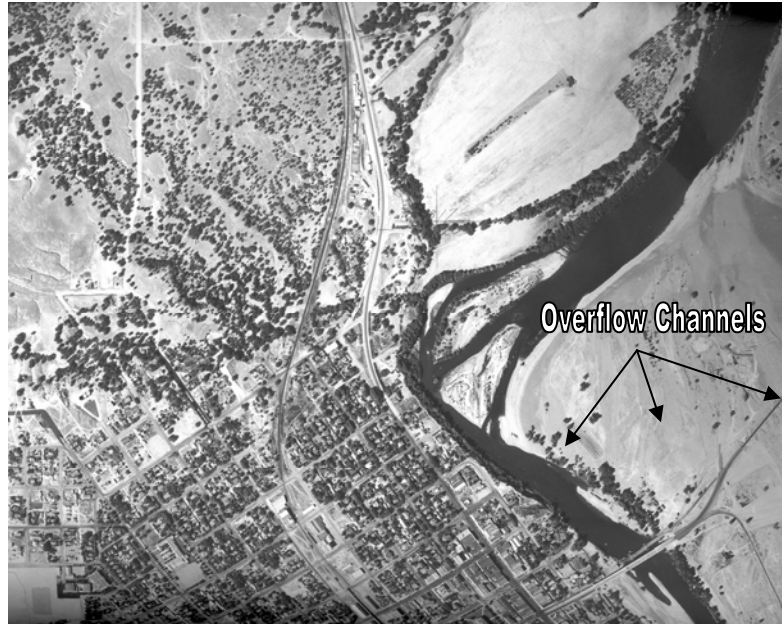
- Two large islands existed within the Sacramento River at the northeastern tip of Red Bluff. Both showed evidence of recent bed material movement and had modest amounts of short and moderate-height vegetation. River flow was split relatively equally between the three channels around and between the islands (see Image Comparison 1a).

- During high river flows the Sacramento River's progress appeared to be slowed by the sharp bend at Red Bluff. This resulted in water spilling out into overflow channels known as (from west to east) East Sand, Sampson, and Paynes Creek Sloughs. These sloughs flowed through most of today's eastern Red Bluff.

**Image Comparison 1a. Red Bluff and the Sacramento River in 1938 (top) and 2004 (bottom). Note the two large islands at the bend of the river and the large overflow area to the east of Red Bluff in 1938 and compare the 2004 situation. These changes are likely due to Shasta Dam's moderation of river flows during floods.**

Also, there is only one island on the bend of the Sacramento River (see Image 2a) and it is heavily covered by riparian vegetation.

- Floods to the Antelope Blvd. area have been reduced, allowing for the eastern portion of Red Bluff to develop.
- The two islands evident in the Sacramento River in 1938 have been reduced to one and it has become heavily vegetated.
- The Red Bluff Diversion Dam backs up water during the summer to the Southern Pacific Railroad Bridge.

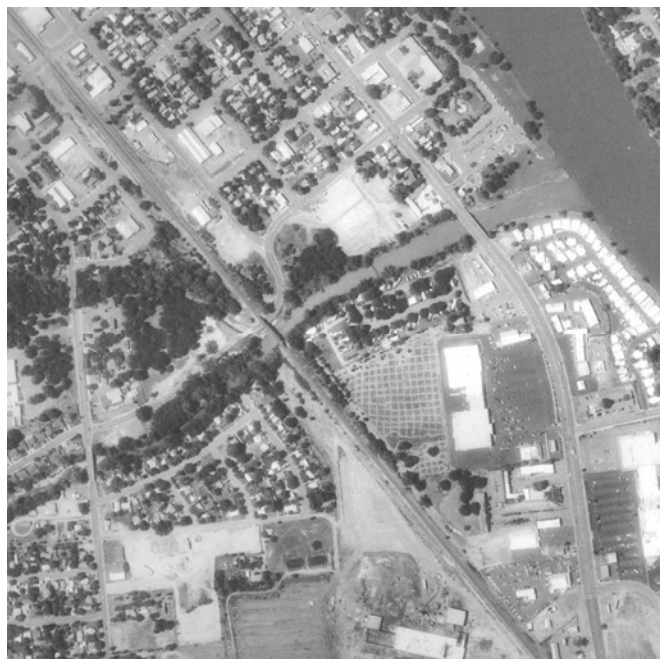
Evidence of scour, cut-bank formation, and possible riparian vegetation clearing was noted along Reeds Creek and its tributary Brickyard Creek. This suggests that sometime shortly before 1938 one or more significant floods occurred. It is possible that the 1928 or 1937 flood events (see Table 1) may have been responsible for the stream conditions noted. Graphic down-cutting and bank-cutting occurred in the lower 1,000 feet of Brickyard Creek, as well as its tributary immediately west of Red Bluff (see Image Comparisons 1b and 1c).

**Image Comparison 1b. Red Bluff, Reeds Creek, and Brickyard Creek in 1938 (top) and 1994 (bottom). Note vegetation and stream channel changes at Brickyard Creek's confluence with Reeds Creek, immediately west of the railroad bridge; the density of riparian cover along Reeds Creek; and the degree of urban sprawl to the south of the stream.**

The lower 1,000 feet of Brickyard Creek is densely covered by riparian vegetation (see Image Comparison 1b). West of Red Bluff, Brickyard Creek's tributaries have riparian vegetation becoming established and the sharp bank cuts, apparent in the 1938 photograph, are much more muted (see Image 2c).

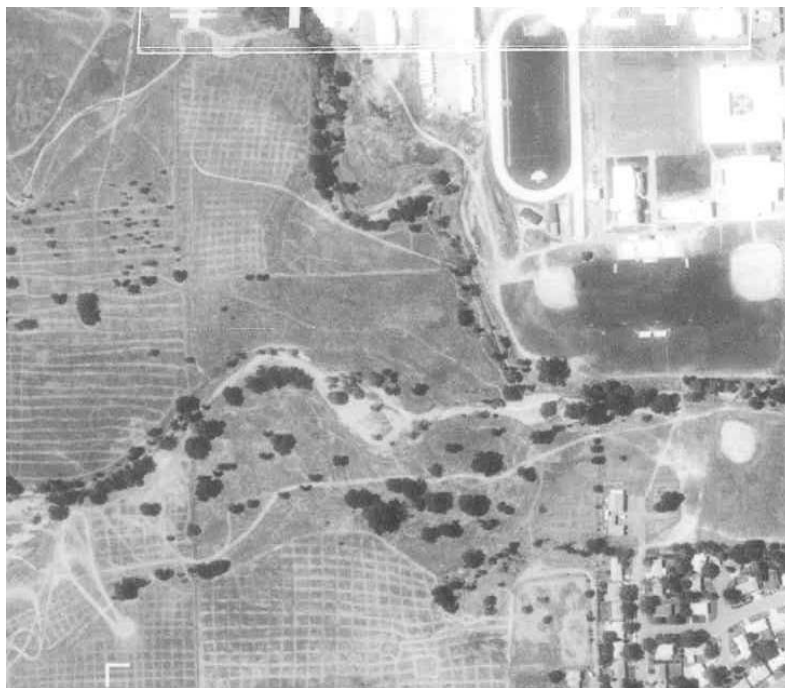
**Image Comparison 1c. North and South Forks of Brickyard Creek and western Red Bluff in 1938 (top) and 1994 (bottom). Note evidence of stream bank cutting on both forks of the stream and the lack of riparian cover in 1938, along with changes in 1994.**

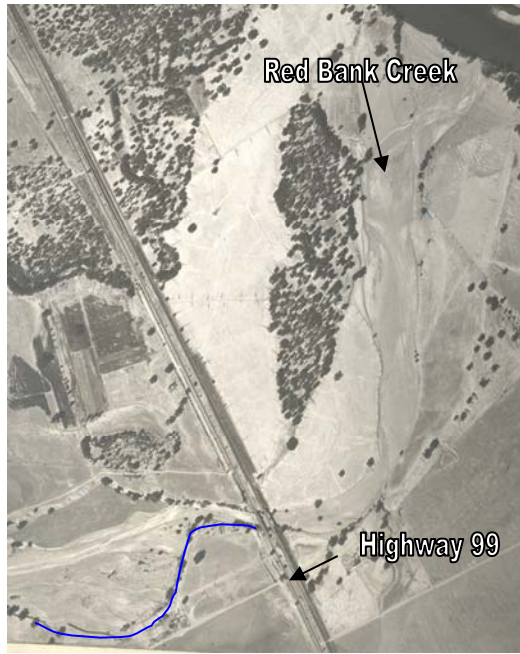
- Red Bank Creek throughout the entire assessment area is a braided stream showing evidence of recent high stream flows and bank cutting. Very little riparian growth exists along the outer stream banks or on island features within the banks, except for small stringers at the stream's confluence with the Sacramento River (see Image Comparisons 2a).
- A sharp stream bank feature exists upstream from the Highway 99/Southern Pacific Railroad Bridges (see Image Comparison 2a).
- Red Bank Creek stream crossings consist of the adjacent Southern Pacific Railroad and Highway 99 bridges.
- Adjacent lands consist of dry land agriculture and oak woodlands. Scattered home sites with outbuildings exist south of the stream.

Image Comparisons 2a—Lower Red Bank Creek in 1938 (above) and 1952 (below). Note braided stream conditions and scarcity of riparian growth both above and below the Highway 99 and Southern Pacific Railroad Bridges. Also, note the stream bank feature lined by scattered hardwoods in the extreme southwest portion of the images (blue line). The area bound by blue and yellow lines has been reclaimed for agricultural uses.

Infrastructure changed little from 1938 to 1952 in the stream’s vicinity; however, agriculture encroached upon the stream channel site located slightly upstream from the Highway 99/Railroad bridges, as shown in the Image Comparison 2a

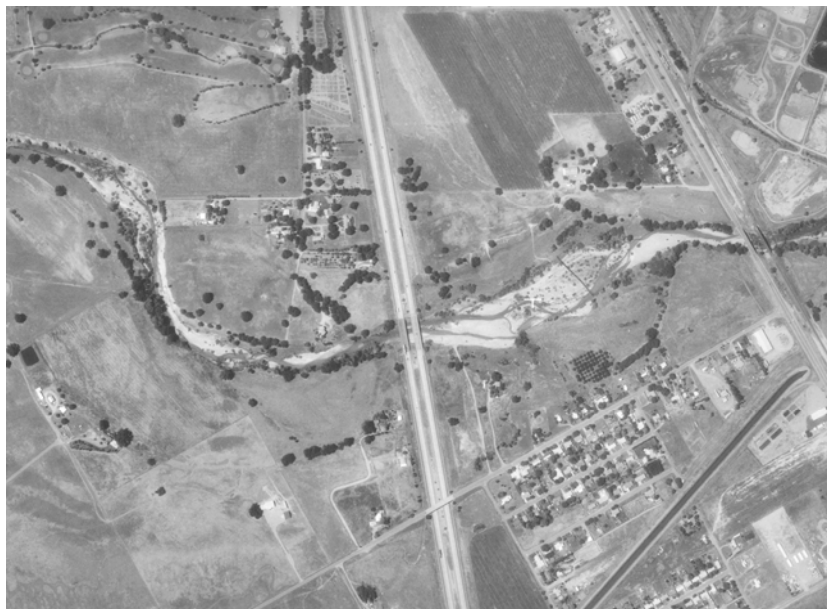
Image Comparison 2b. Red Bank Creek in 1952 (top) and 1994 (below). Highway 99 crosses the stream near the right edge of both images and I-5 crosses in the center of the 1994 image. Note wide stream channel features between Highway 99 and the I-5 crossing site that has been converted to agricultural land in 1994. (Stream cut bank shown with blue line and reclaimed land bound by yellow and blue lines.) Also note the “riparian” hardwood stringers that line the historic stream banks that are now distant from the stream.

- Additional stream channel portions have been reclaimed to agricultural uses, both between Interstate 5 and Highway 99 crossings and immediately upstream from Interstate 5 (see Image Comparisons 2b).
- Stream bank and within-channel vegetation appears to have increased modestly in Segments 2 and 3 above Highway 99 (see Table 3).

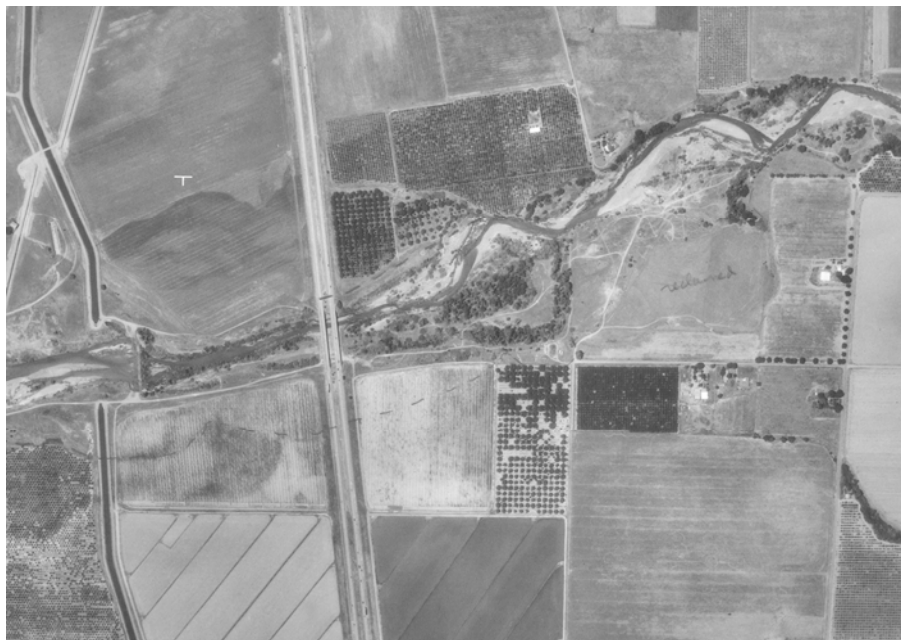
Image Comparison 3a. Elder Creek at the I-5 crossing in 1938 (top) and 1994 (bottom). The 1938 stream channel extent is shown with black lines and the site and length of the Interstate 5 crossing is shown as a blue bar. The areas between black and yellow lines are reclaimed farmland following Interstate 5 and levee construction, resulting in much more constrained stream. Also, note the vegetation changes either side of the I-5 crossing between the two images. Much of the 1994 vegetation is likely *Arundo* or *Tamarisk*.

- Stream bank cover in the lowest portion of Elder Creek (Segment 1) is similar to what it was in 1952 but the riparian corridor width is much reduced with nearly all trees outside the levees having been removed (see Image Comparison 3b).
- In Segments 3 and 4 the hardwood canopy cover is much reduced in 1994 and 2004 relative to 1938. This reduction may be due to enlargement of levees (see Image Comparison 3c).
- Large areas of stream overflow channel have been converted to farmland (see Image Comparison 3a).

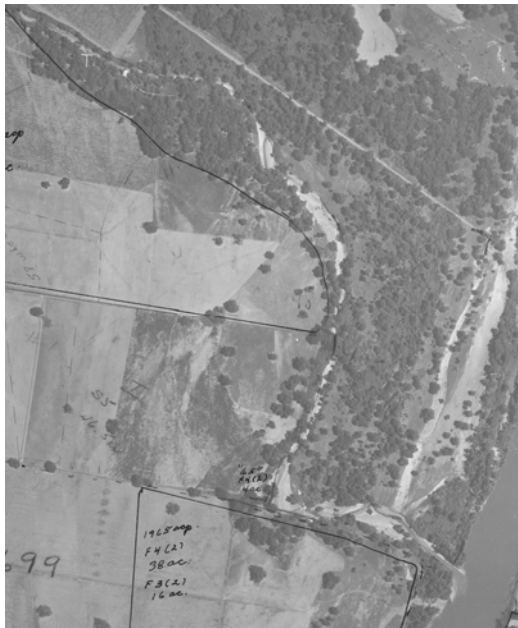
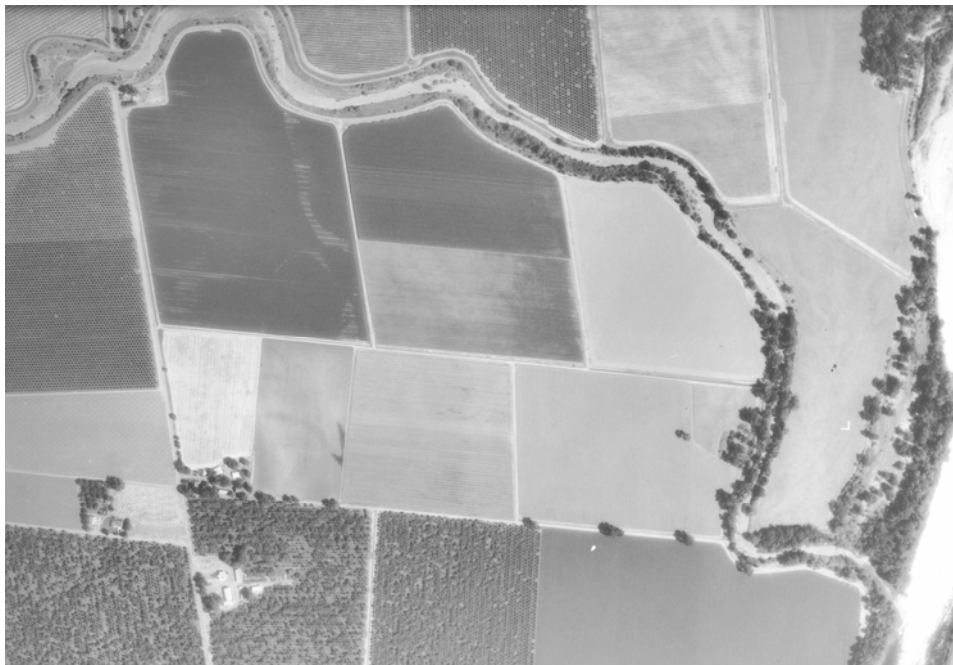
**Image Comparison 3b. The lowest reach of Elder Creek in 1952 (top) and 1994 (bottom). Note the distinctive levee system along the stream in 1994, along with the reduction in hardwood cover along the stream and adjacent areas compared with 1952. This area is stream “Segment 1”.**

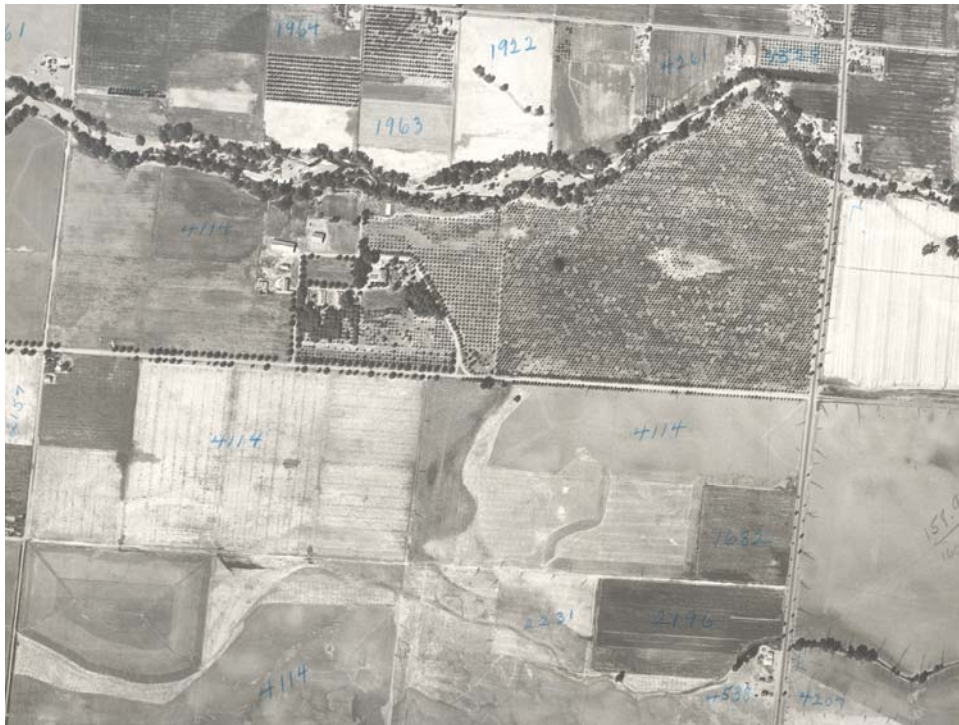
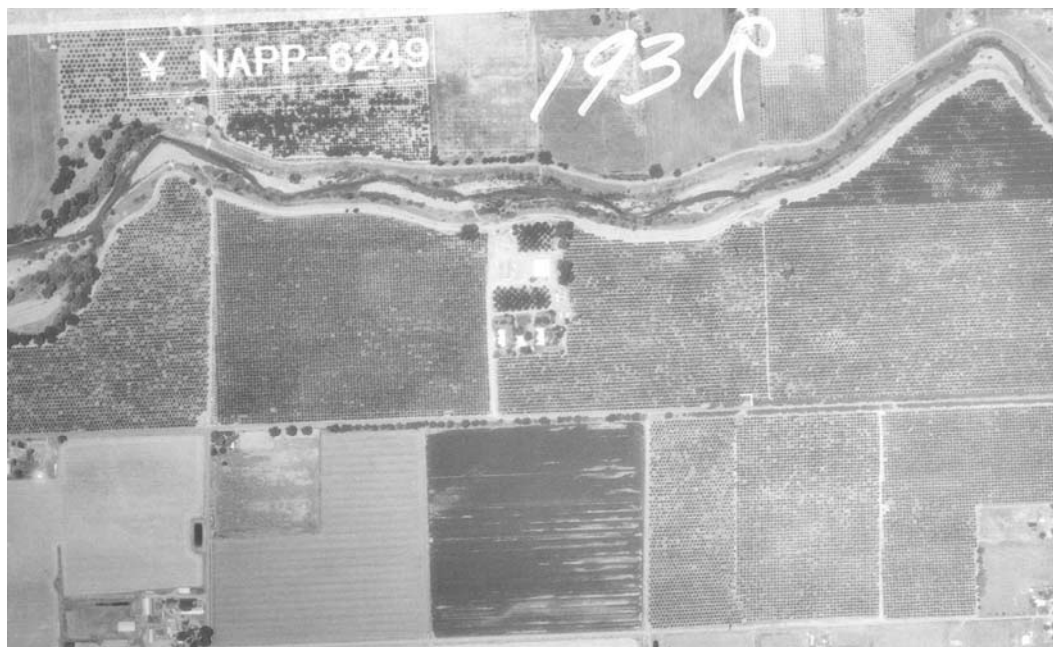
Image Comparison 3c. Elder Creek's Segment 4 in 1938 (top) and 1994 (bottom). The constrained nature of this segment in 1938 is likely due to early levees which allowed the surrounding land to be used for agricultural purposes. The large hardwoods along the stream may be residual oaks, from woodlands that pre-dated agricultural development. The 1994 image shows the enhanced levee system, possibly built in the 1960s, and the elimination of nearly all large hardwoods.

Elder Creek differs from the other assessed streams because it may have had levees much earlier. The relatively narrow condition of the stream shown in the 1938 image may be due to early directing efforts, which allowed agriculture to extend to the levee walls. Image Comparison 3c shows a portion of Segment 3 that is tightly constrained in 1938, with a narrow stringer of hardwoods within the old levees. When the levees were enlarged (possibly in the 1960s) much of the residual hardwood cover was removed.
