Section 4

**GEOLOGY AND SOILS**

## Section 4 **GEOLOGY AND SOILS**

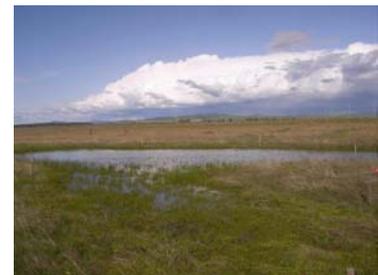
**Vernal pool on Redding soils**

The Corning-Redding soil association consists of gravelly, medium-textured soils of stratified deposits of alluvium derived from Coast Range sedimentary and metamorphic rocks. These nearly level to sloping soils are found on the high western terraces of the Sacramento River and its tributaries between 350 to 800 feet in elevation, with an annual rainfall from 19 to 30 inches. Most areas of this association exhibit “hogwallow microrelief,” which is characterized by hummocky mound and depression relief. Corning and Redding soils are typically reddish-brown gravelly to slightly gravelly loams, are moderately deep to shallow, to claypan (Corning) or cemented hardpan (Redding), that is slight to moderately acidic. The association includes minor Red Bluff Series soils, which have smooth surfaces, are strongly acidic, and have moderately dense clay subsoil. The topography and shallow depth to claypan cause the formation of vernal pools in these soils. These vernal pools are an important resource in the watershed.

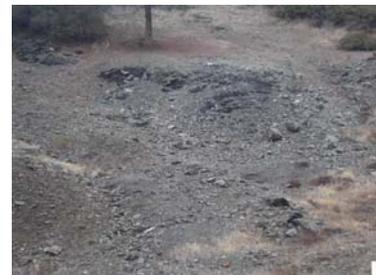
**Serpentine soils and associated rock**

Henneke soils are typically shallow and rocky, and are formed from underlying serpentine rock. Greenstone, which is comprised of altered basalt and andesite, is the parent material to the reddish-brown Stonyford and minor brown Goulding soils commonly associated with this series. Both of these soils are rocky and shallow to moderately shallow.
