**UPPER DEER CREEK
ASSESSMENT
&
RESTORATION PLAN**

*FINAL DRAFT
3/23/06*

**FRIENDS OF DEER CREEK
&
NATURAL HERITAGE INSTITUTE**

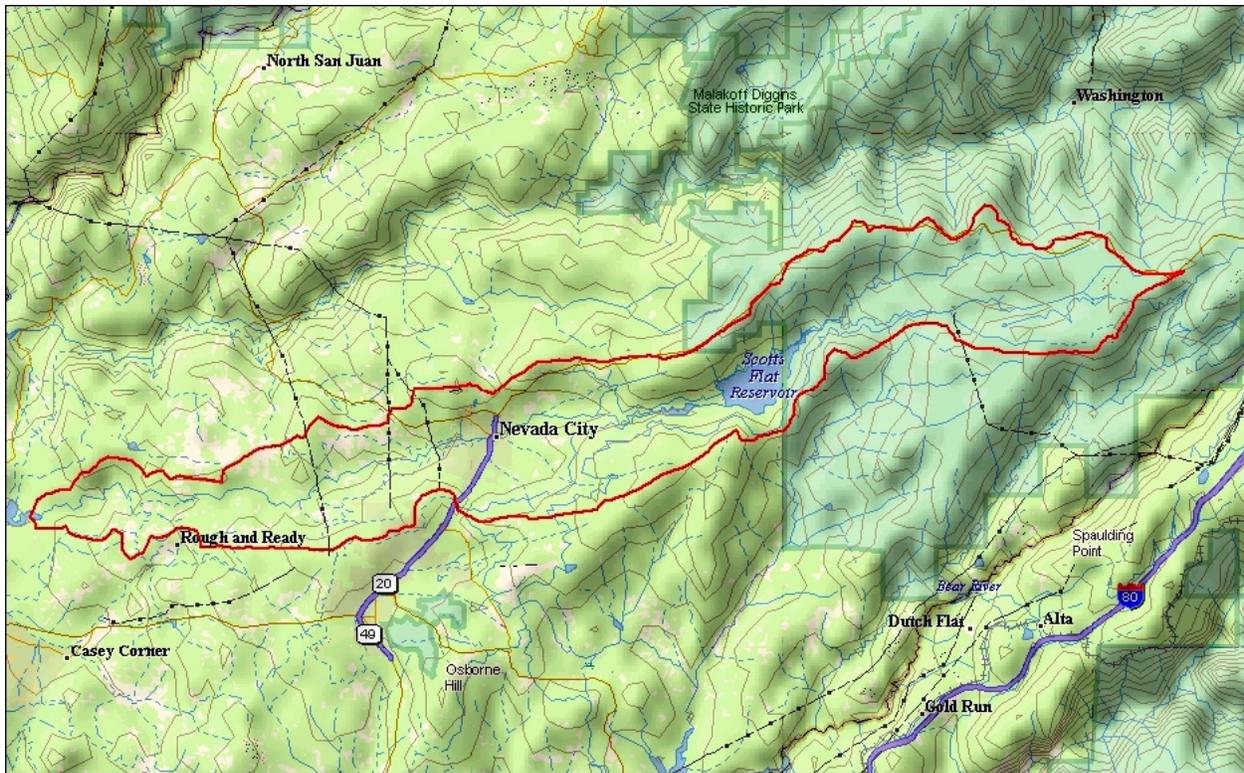
Figure 1: Area of Focus within Deer Creek Watershed

The goal of the Upper Deer Creek Assessment and Restoration Plan is to develop a scientifically sound and implementable plan to improve the geomorphic and ecological function of Deer Creek from Scott's Flat Reservoir to Lake Wildwood (Figure 1). The reach of Deer Creek below Lake Wildwood was not included because that section was the subject of a separate study. This project is funded by the CALFED Watershed Program and is jointly implemented by Friends of Deer Creek (FODC) and Natural Heritage Institute (NHI). More specifically, the five objectives of the Upper Deer Creek Assessment and Restoration Plan are to:

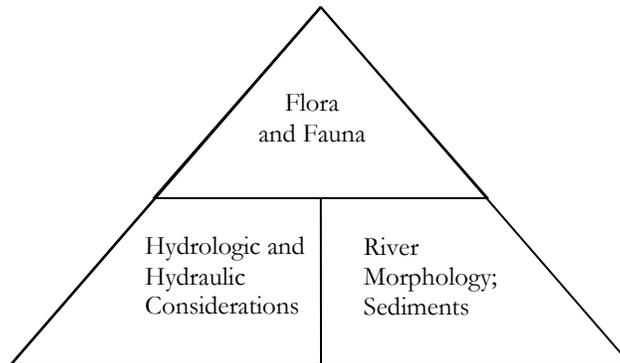
Figure 2: Basic Structure of a River System (Brookes and Shields, 1996)

Figure 2 illustrates the basic structure of a river system and the foundational role that river hydrology and morphology play. Key inputs, processes, and attributes that contribute to a healthy river (from McBain and Trush, 2004) include:

- ❖ channel morphology that is scaled to flow conditions;
- ❖ sediment supplies that are balanced with sediment transport capacity;
- ❖ frequent scour of bed surface and periodic scour of bed subsurface;
- ❖ channel migration (in alluvial sections);
- ❖ frequent floodplain inundation;
- ❖ self-sustaining diverse river corridor.

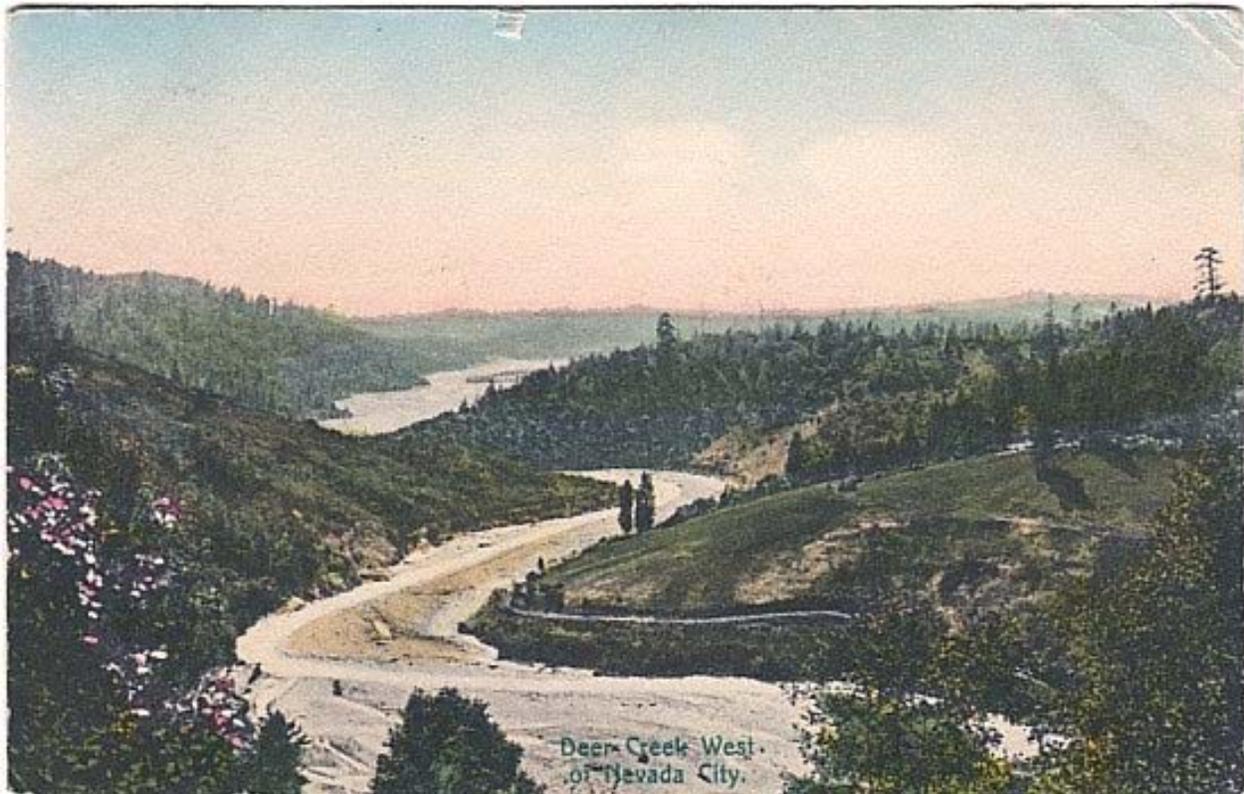
Figure 3: Deer Creek circa 1908, looking west from immediately downstream of Champion Mine. Note that channel is filled with gravels from mining activities.

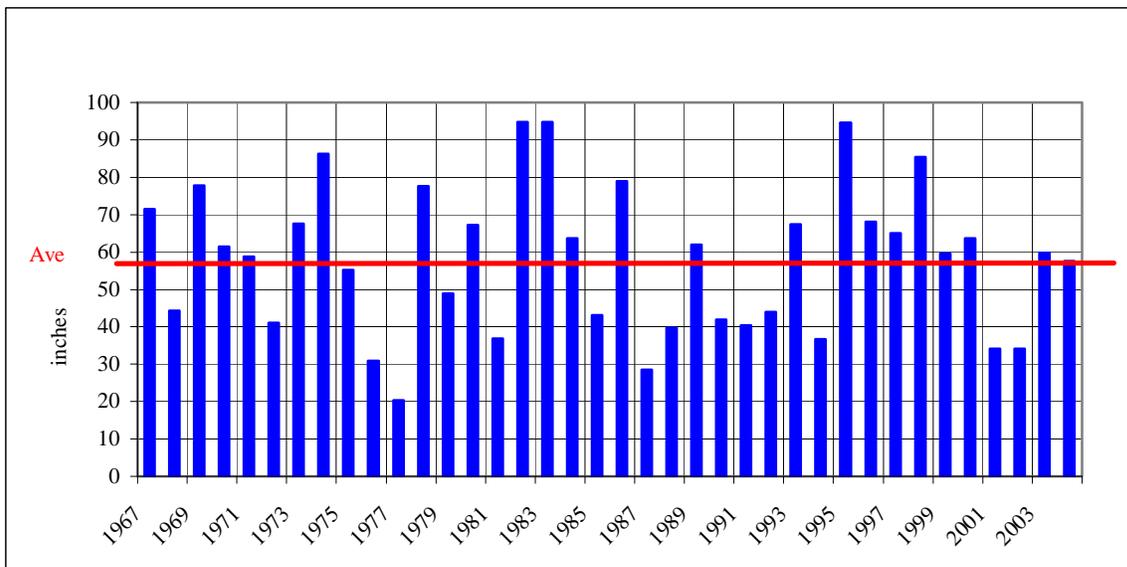
Figure 4: Annual Nevada City Precipitation, 1967 to 2004

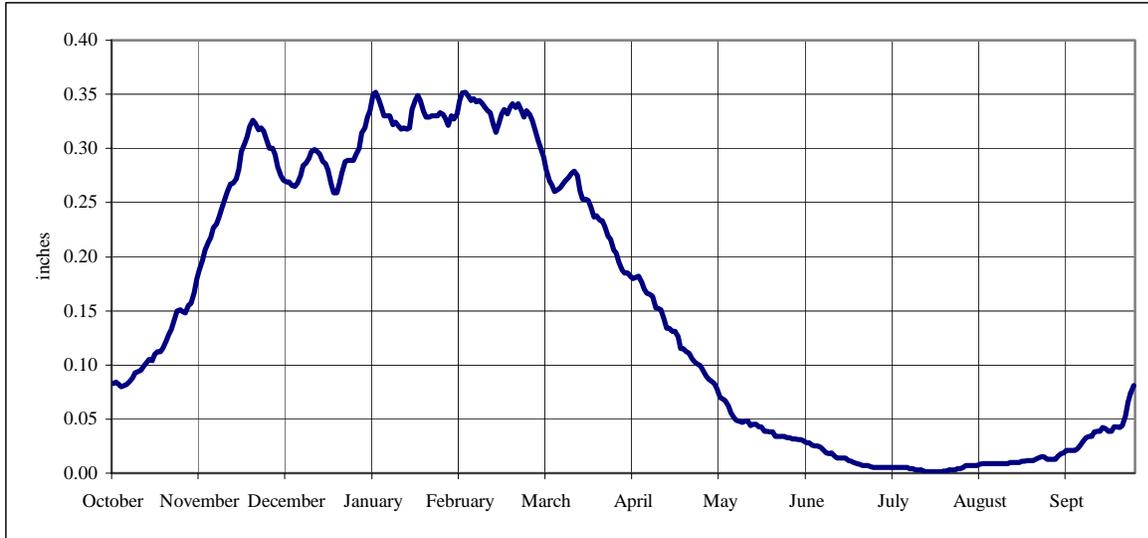
Figure 5: Nevada City Average Daily Precipitation, 1967 to 2004

A review of available rainfall data from the mid 1800's kept by the Yuba Canal Company indicates that the average annual rainfall for the Nevada City area has not changed significantly from what it is today. Figure 4 below shows the annual rainfall from 1967-2004 with an average of 58 inches per year, which is the same as the average in the mid 1800s. Rainfall is assumed to have been concentrated between the months of November and April, as it is today. The daily average rainfall is shown in Figure 5 below.

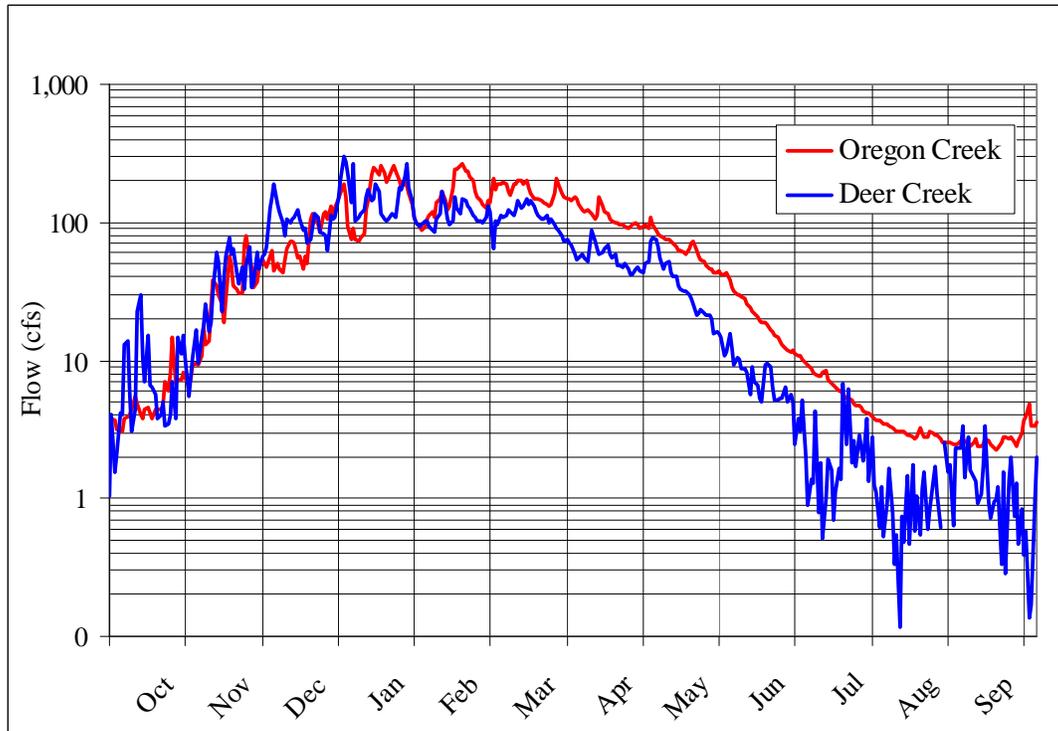
Figure 6: Average Daily Flows in Deer Creek (into Scotts Flat) and in Oregon Creek at Camptonville (USGS gauge 11409300 1967-2002)

No information describing the hydrologic or geomorphic conditions of Deer Creek prior to extensive modification of the watershed was found. Because Oregon Creek, a tributary to the Middle Yuba River, is similar to the upper portions of the Deer Creek watershed in many respects (*e.g.*, size, shape, orientation, elevation and vegetation), it is a useful proxy to estimate Deer Creek flows under more natural conditions. USGS gauge 11409300 captures 23 mi² of the Oregon Creek watershed, similar to the 22 mi² area above the Scotts Flat reservoir. Since approximately 1970, NID has been estimating natural inflows from Deer Creek into Scotts Flat reservoir. Figure 6 shows average daily Oregon Creek and Scotts Flat inflows.

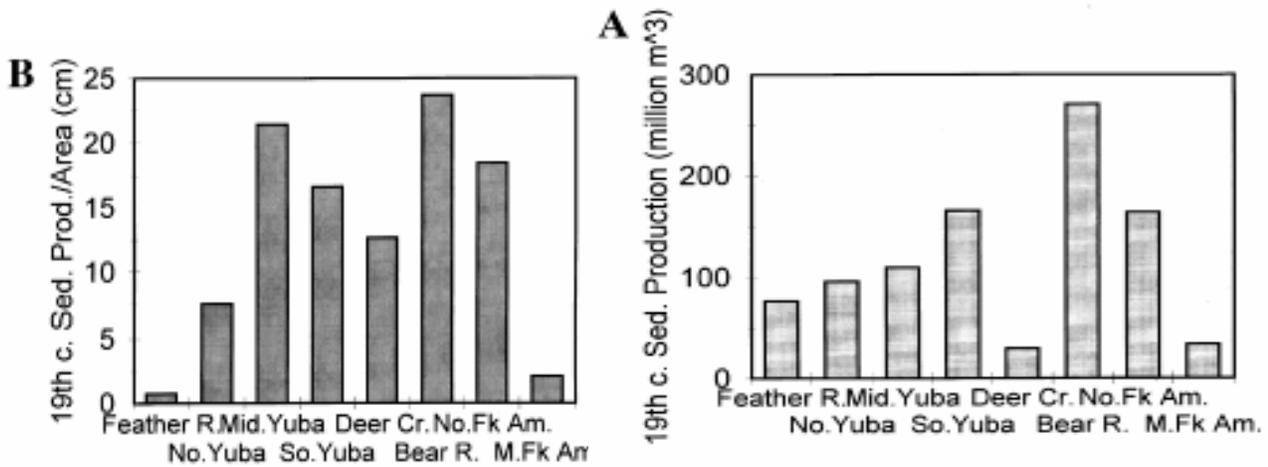
Figure 7: Amount and Depth of Sediment Produced During Mining Era (James 1999)

sediment production and widespread channel aggradation (James, 1999), particularly in the lower-gradient stretches of Deer Creek. While much of the material produced in 19th and 20th century mining has been distributed far downstream by now, significant amounts of sediment are likely still stored in the main channel and tributaries to Deer Creek. Certain lower-gradient reaches downstream of Nevada City appear to have experienced significant deposition of sediment many years ago.

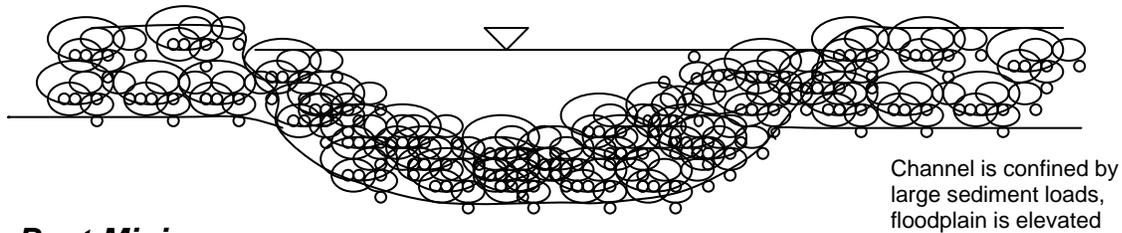
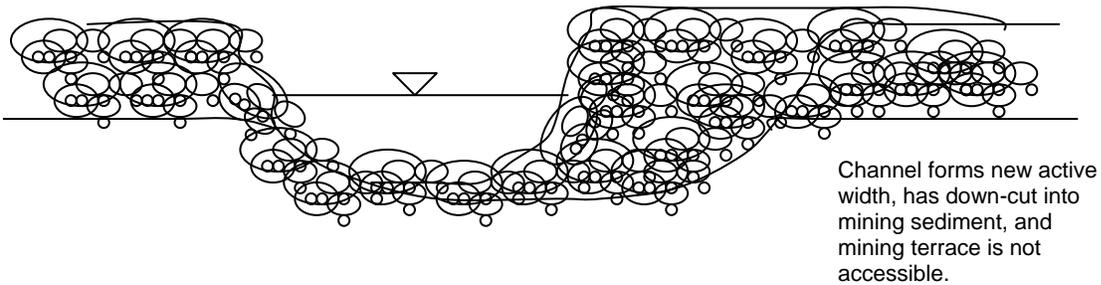
Figure 8: A Conceptual Diagram of a Three Channel Cross-Sections:
1) Pre-Mining, 2) During the Mining Era, and 3) Post Mining

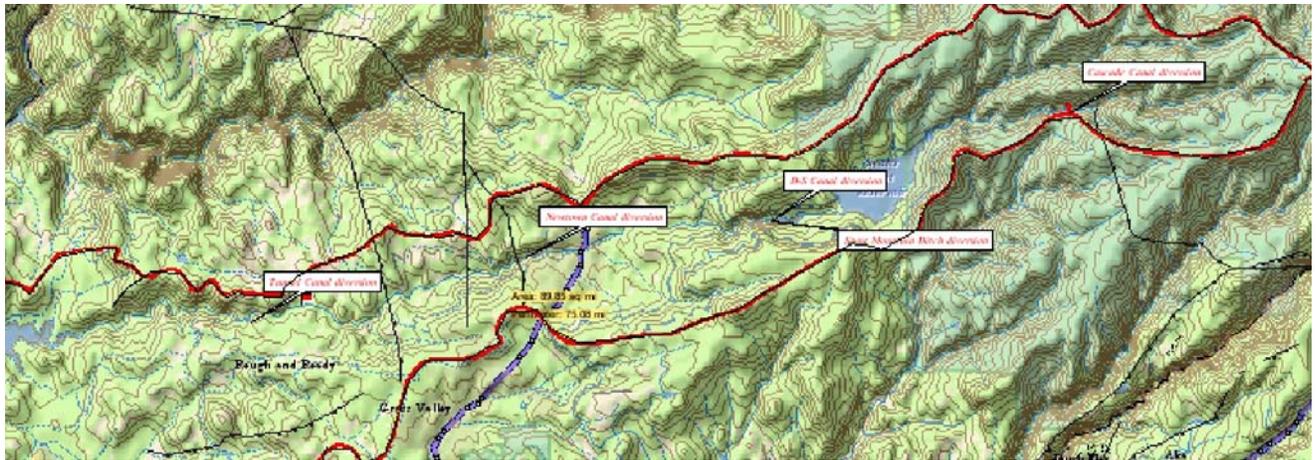
Figure 9: Location of NID diversions on Deer Creek.

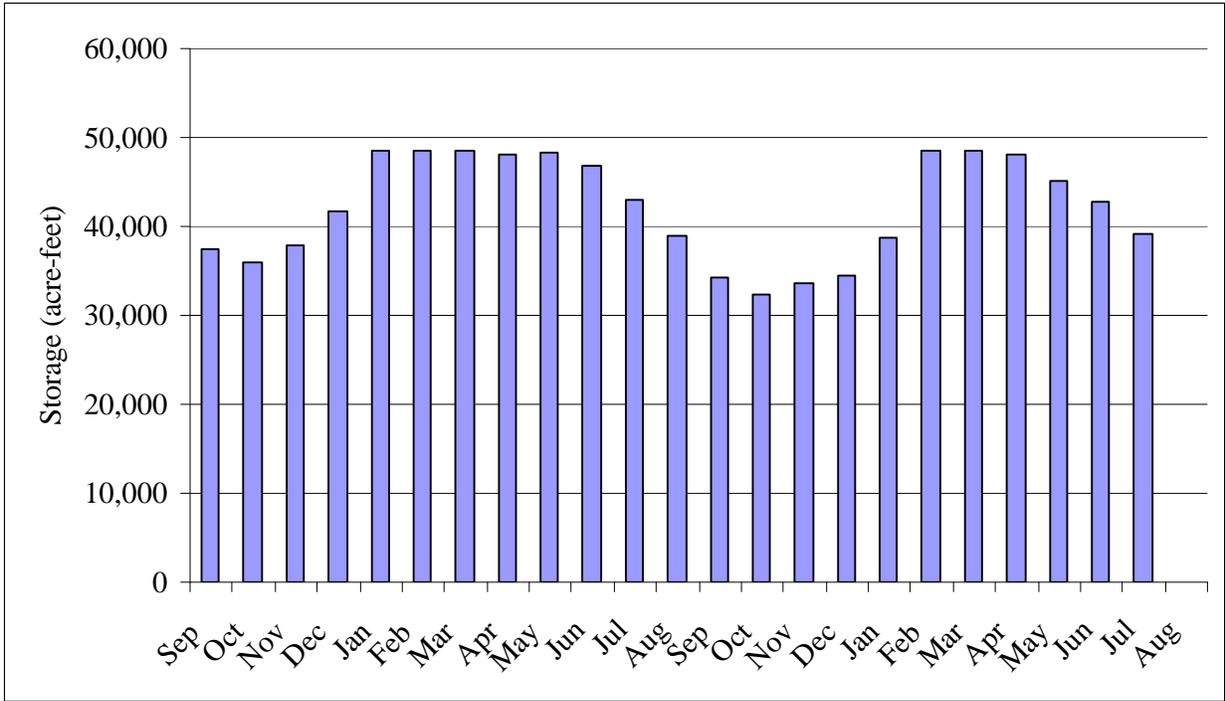
Figure 10: Typical End of Month Storage Levels in Scotts Flat Reservoir

NID operates its water supply system in two periods each year, a “winter season” typically from mid- October to mid-April, and an “irrigation season” typically from mid-April to mid-October. In late October each year, Scotts Flat reservoir storage levels usually reach their lowest and imports from the South Yuba typically have reduced to 35 cfs. NID begins to refill the reservoir during fall and early winter as natural runoff increases (See Figure 10). In wet years, Scotts Flat can fill as early as November, while in dry years Scotts Flat will not fill until as late as March, and sometimes only then with significant imports from the South Yuba (S. Sindt, pers. comm.).

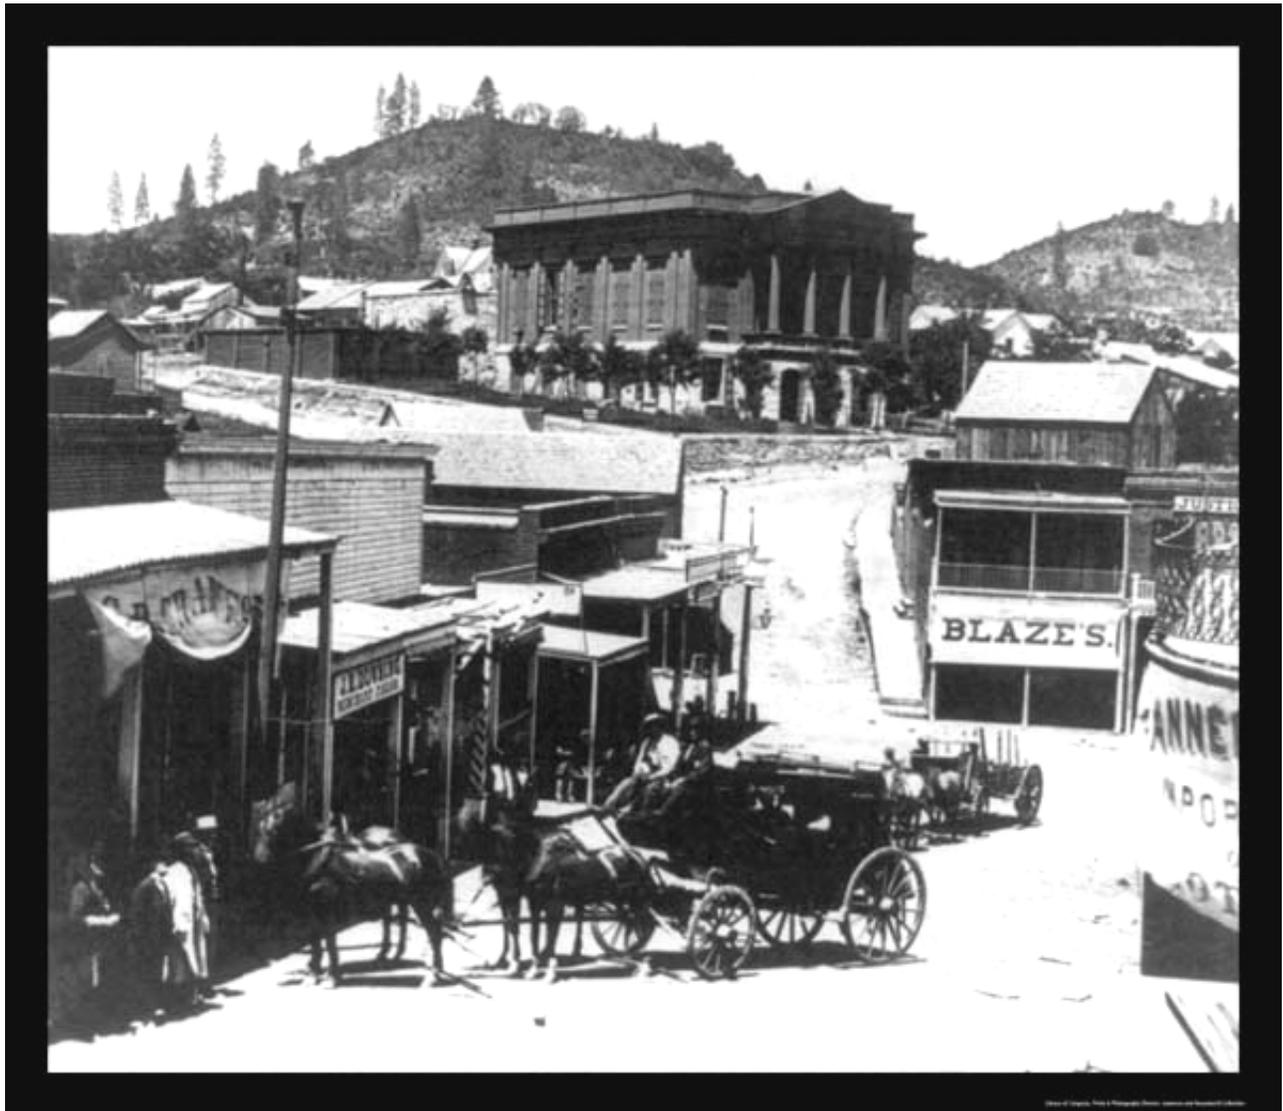
Figure 11: Photo of Nevada City and hills behind show extent of logging, circa 1890.

Logging can cause significant adverse impacts to stream ecosystems. Timber harvests can affect aquatic systems by increasing the sediment load, decreasing coarse particulate organic matter and removing canopy cover which results in more extreme temperature fluctuations and a shift from a heterotrophic community to an autotrophic community. Historic photographs indicate that much of the land in the Deer Creek watershed was logged from the 1850s to the early 1900s (Figure 11).

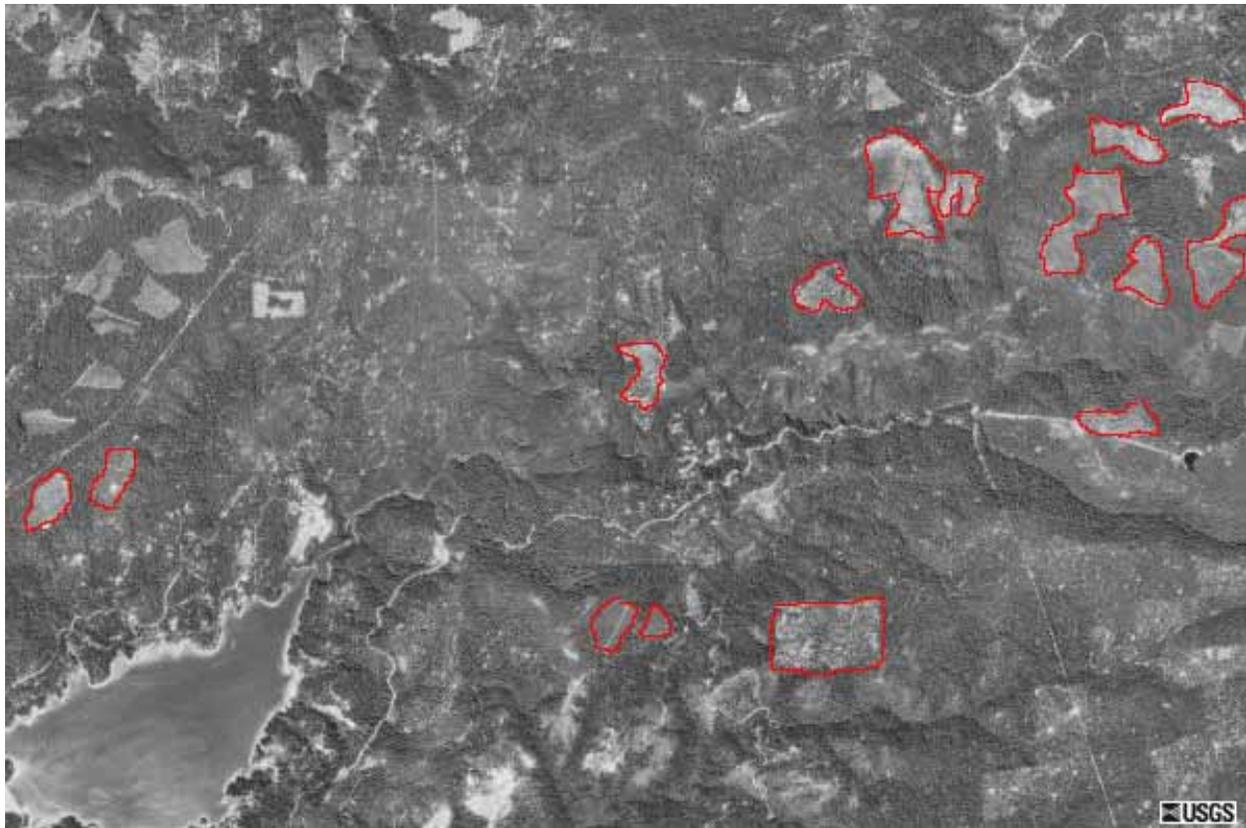
Figure 12: 1998 Aerial Photo Showing Recently Logged Areas above Scotts Flat

Since 1990, Nevada County has supplied each year less than 3 percent of the state's total timber harvest of between 1.5 and 3.0 million board feet (CA Board of Equalization, 2004). Typically less than 20% of the county's timber harvest has come from public lands. An analysis of recent aerial photos indicates that ongoing timber harvests in the Deer Creek watershed are primarily concentrated on Tahoe National Forest lands above Scotts Flat, although some logging is occurring on relatively small private parcels below Scotts Flat (Figure 12).

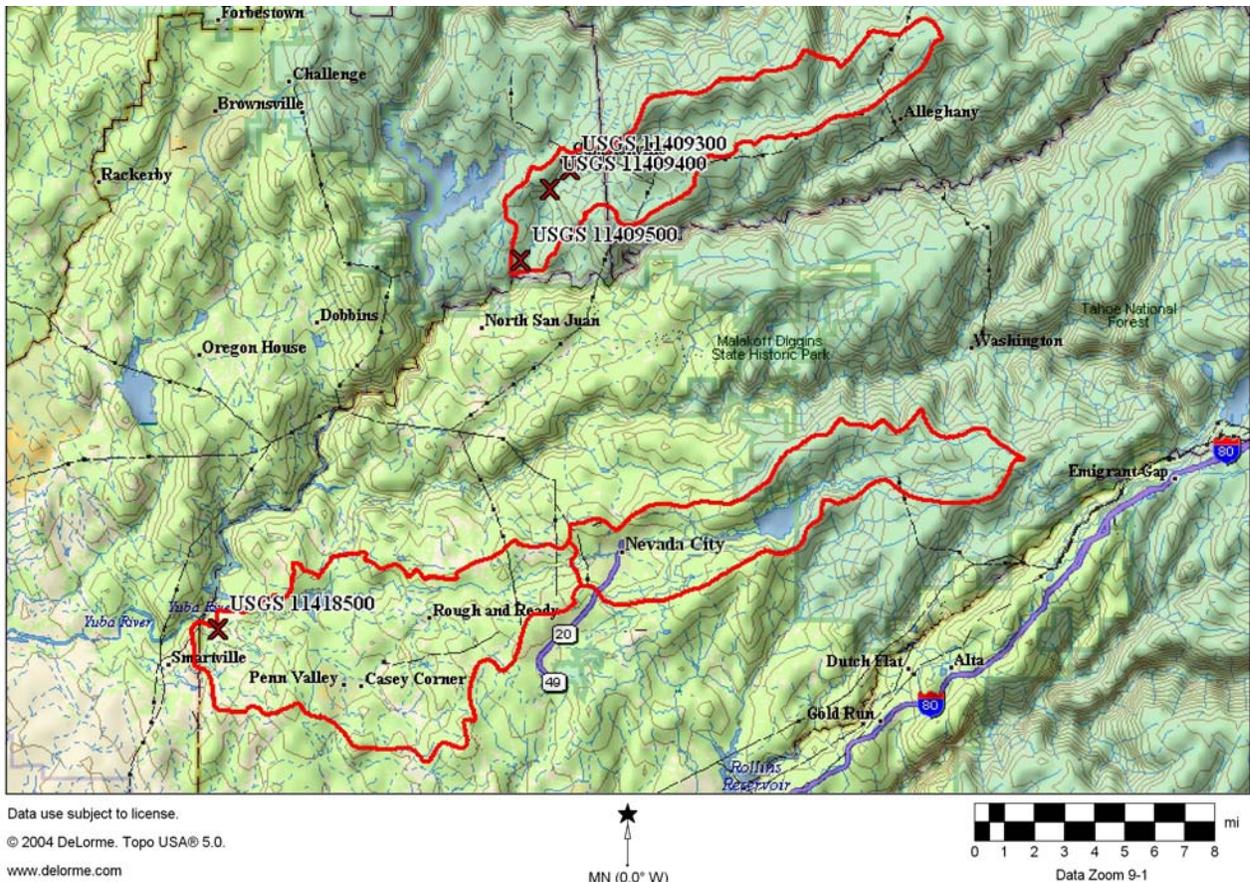
Figure 13: Locations of USGS Streamflow Gauges on Deer Creek and Oregon Creek

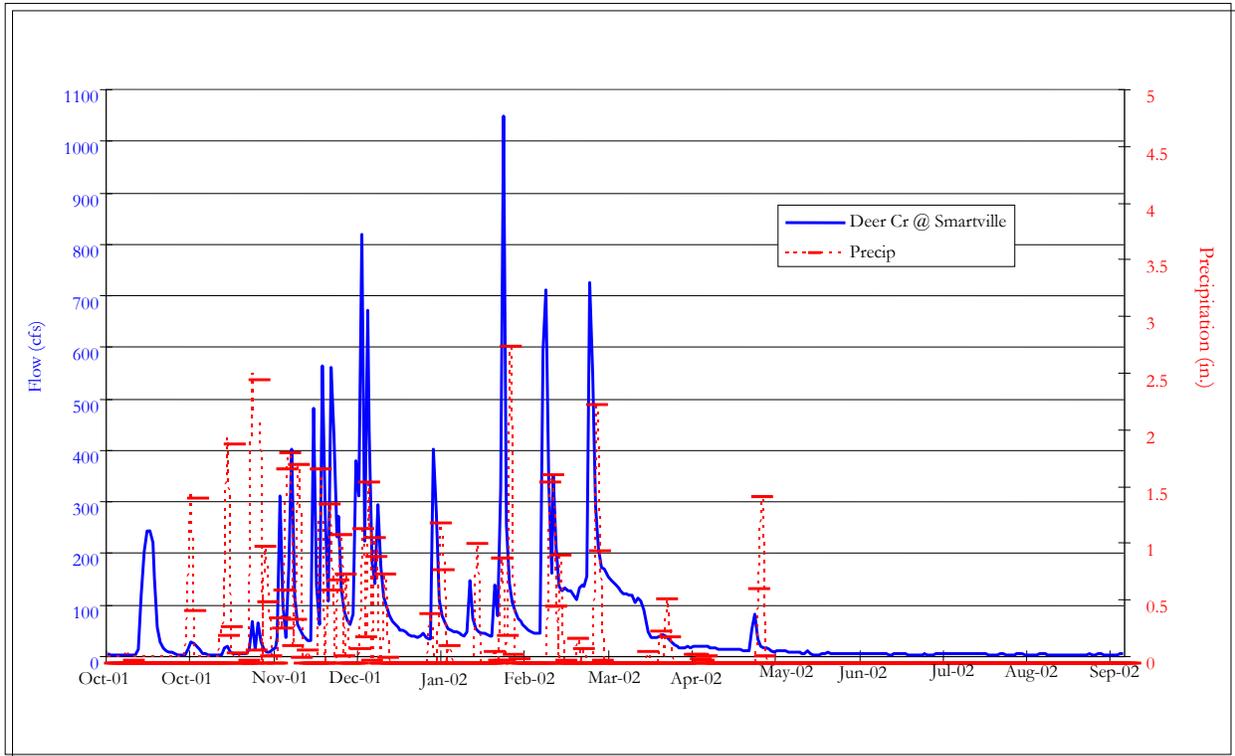
Figure 14: Water-Year 2001 Precipitation at Nevada City and Deer Creek Streamflow at Smartville (USGS 11418500)

The higher portions of the Deer Creek watershed receive approximately 60 inches of precipitation each year while the lower elevations receive roughly 50 inches. Although a portion of the precipitation falls as snow each year, typically above 2500 ft, the hydrograph is dominated by rainfall events (see Figure 14).

Storms that cause rain to fall on snow typically generate the higher flows each year. For example, Figure 14 shows the highest flow in Water Year (WY) 2001 of 1050 cfs at Smartville (USGS 11418500) occurred in early February when 2.3 inches of rain fell on several inches of snow that had accumulated in the upper watershed above 3500 ft elevation.

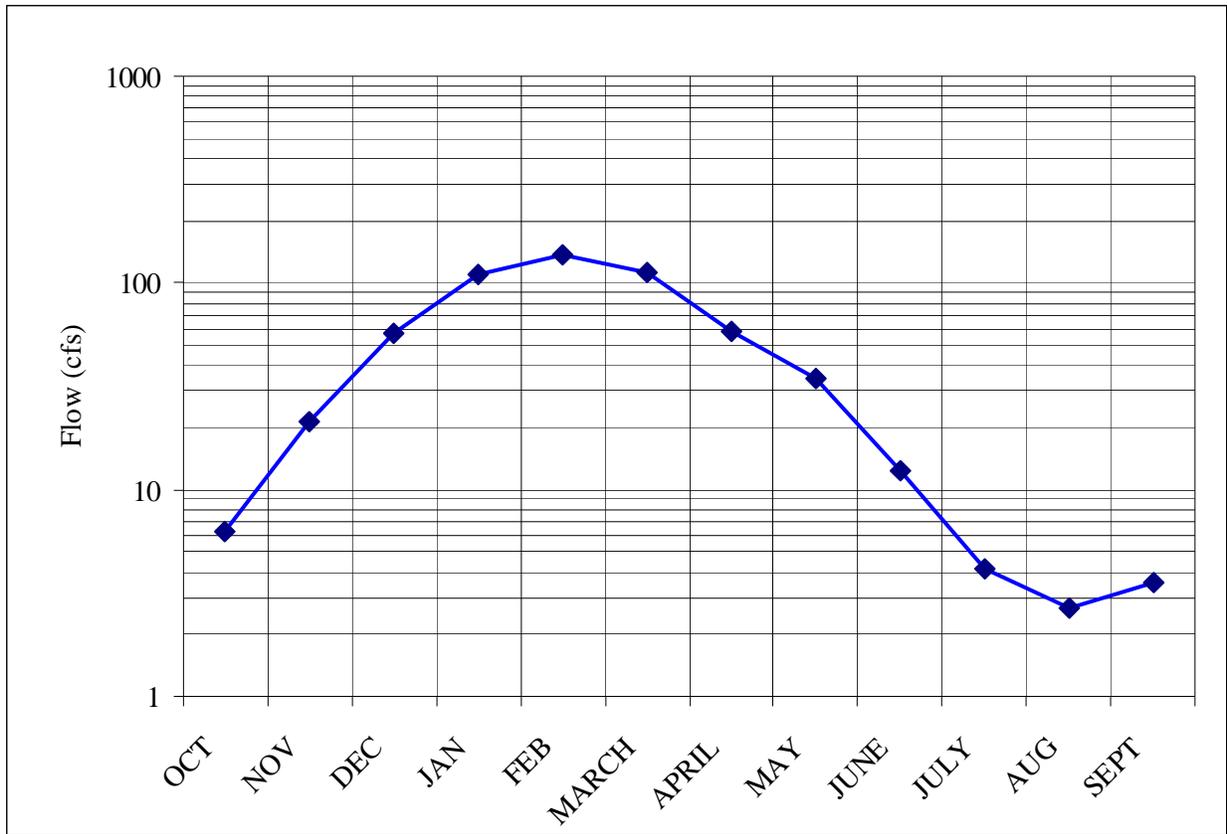
Figure 15: Average Monthly “natural” Flow into Scotts Flat Reservoir (NID data 1984-2004)

Nevada Irrigation District estimates “natural” flow into Scotts Flat reservoir by monitoring reservoir storage levels, volume of imported water from the South Yuba River and water deliveries from Scotts Flat. Estimates are made on a daily basis, and monthly average flow estimates are shown in Figure 15.

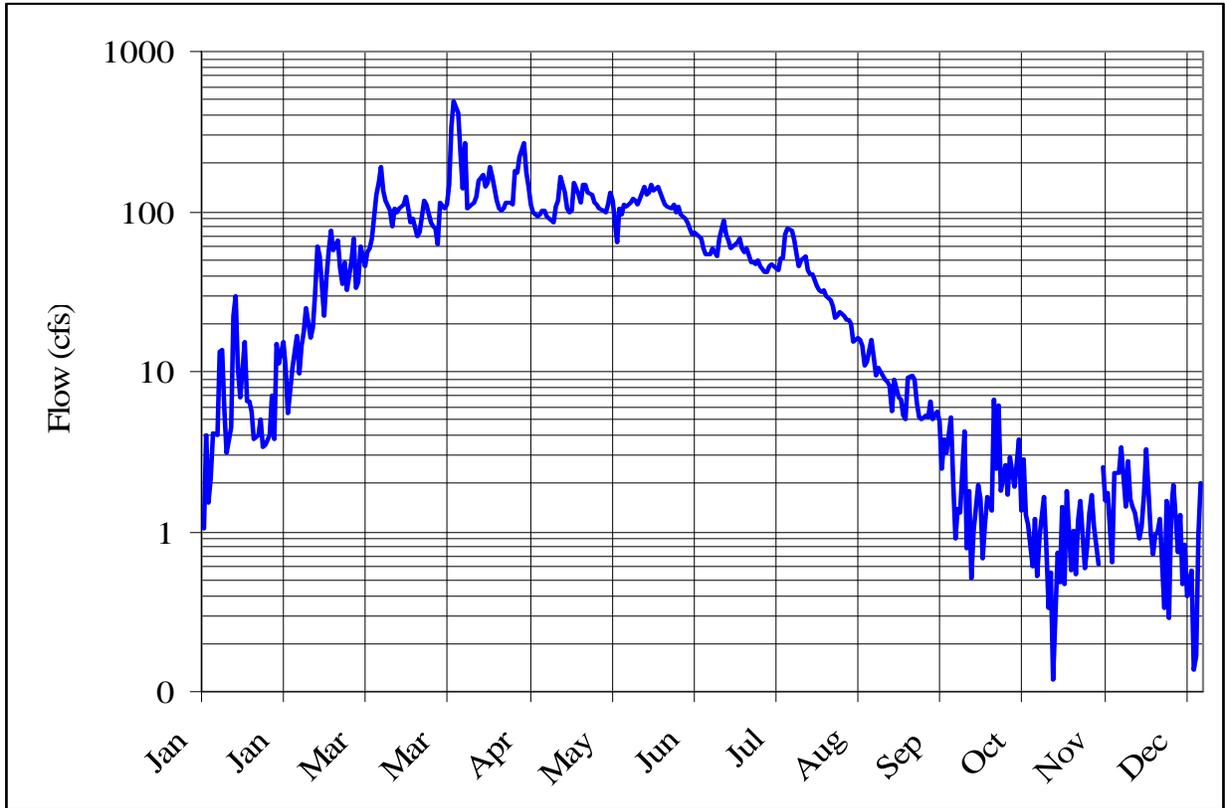
Figure 16: 30-year Average of NID Estimates of Natural Inflow into Scotts Flat

Applying this formula to the 30-plus years of data NID has collected suggests that under natural conditions Deer Creek flows at Scotts Flat that would have dropped to less than 5 cfs in most years, and less than 1 cfs in drier years (Figure 16), although these low flow estimates may have substantial error. It is likely that natural flows below Scotts Flat would have been higher than this as a result of contributions from numerous perennial tributaries and a much larger watershed area.

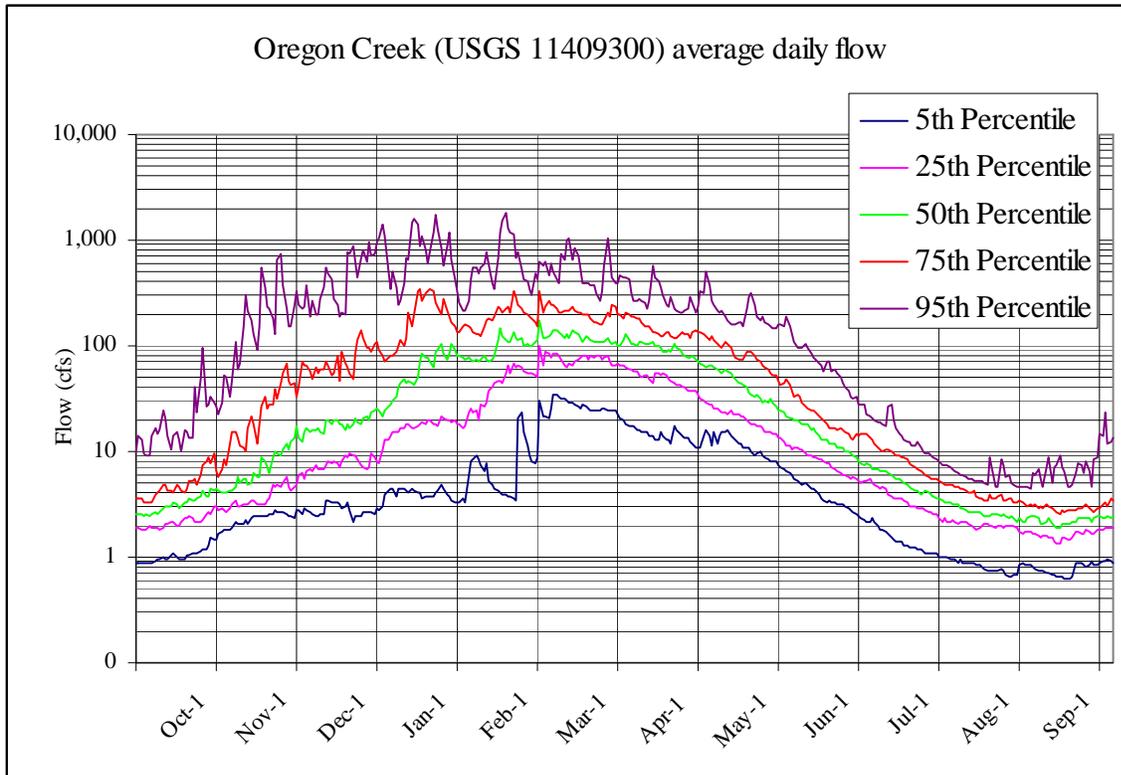
Figure 17: Oregon Creek Average Daily Flows at USGS gauge 11409300

Method 2. Oregon Creek flows as proxy – Because Oregon Creek is so similar to the upper portions of Deer Creek, it is a useful proxy to estimate Deer Creek low flows in the upper quarter of the watershed under more natural conditions. USGS gauge 11409300 captures 23 mi² of the Oregon Creek watershed, similar to the 22 mi² area above the Scotts Flat Reservoir. Figure 17 below shows average daily flow levels for Oregon Creek at USGS gauge 11409300 over a 35-year period from 1967 to 2002. The 5th Percentile curve represents the lowest 5% of daily flows for each date averaged over the 35-year record, *i.e.*, 95% of flows for each day were above those in the 5th Percentile curve. The 50th Percentile curve is roughly equivalent to the average of flow value for that date over the 35-year period.

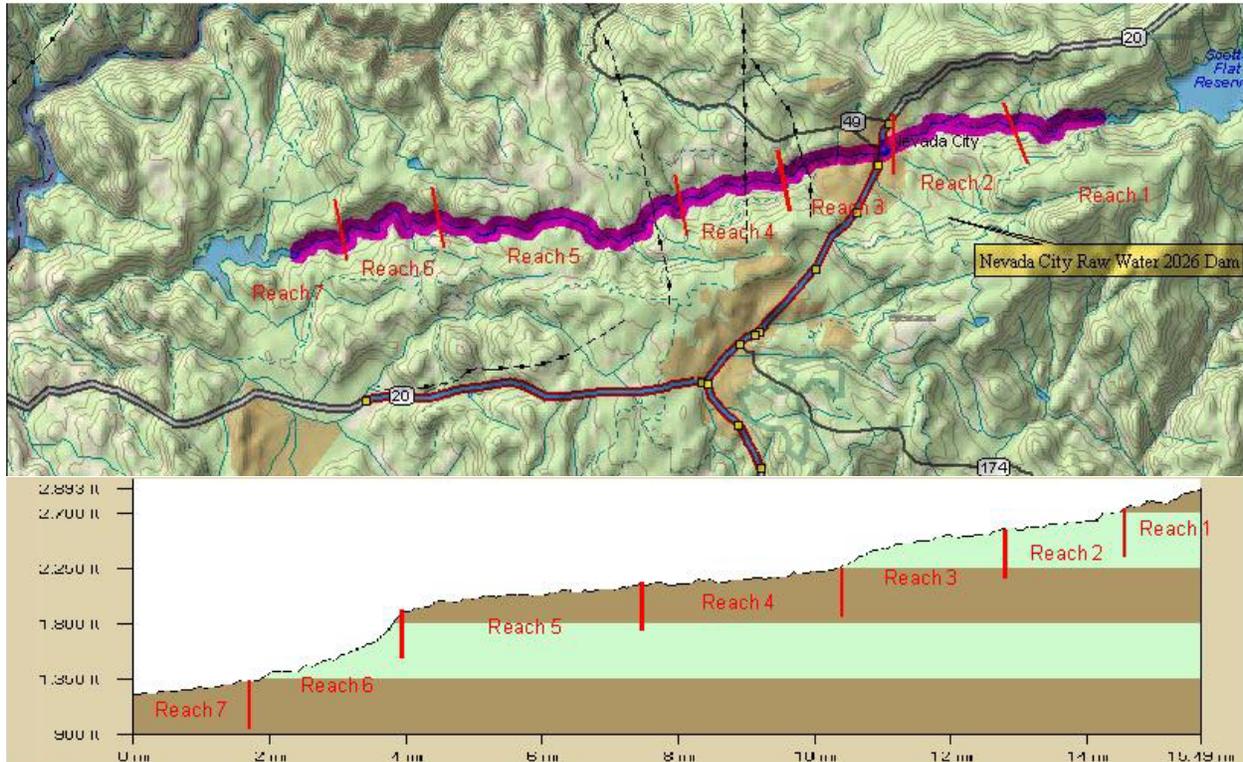
Figure 18: Plan View of Reach Divisions along the Mainstem of Upper Deer Creek

By analyzing aerial photos, topographic maps, and aerial video footage of the entire length of Upper Deer Creek, nine distinct reaches were identified between the confluence of the north and south forks of Deer Creek in the upper watershed and Lake Wildwood. Figure 18 below shows the reach divisions (see Appendix D for a detailed description of the reach classification analysis). Reach divisions correspond with significant slope breaks, adjusted slightly to allow easy identification in the field.

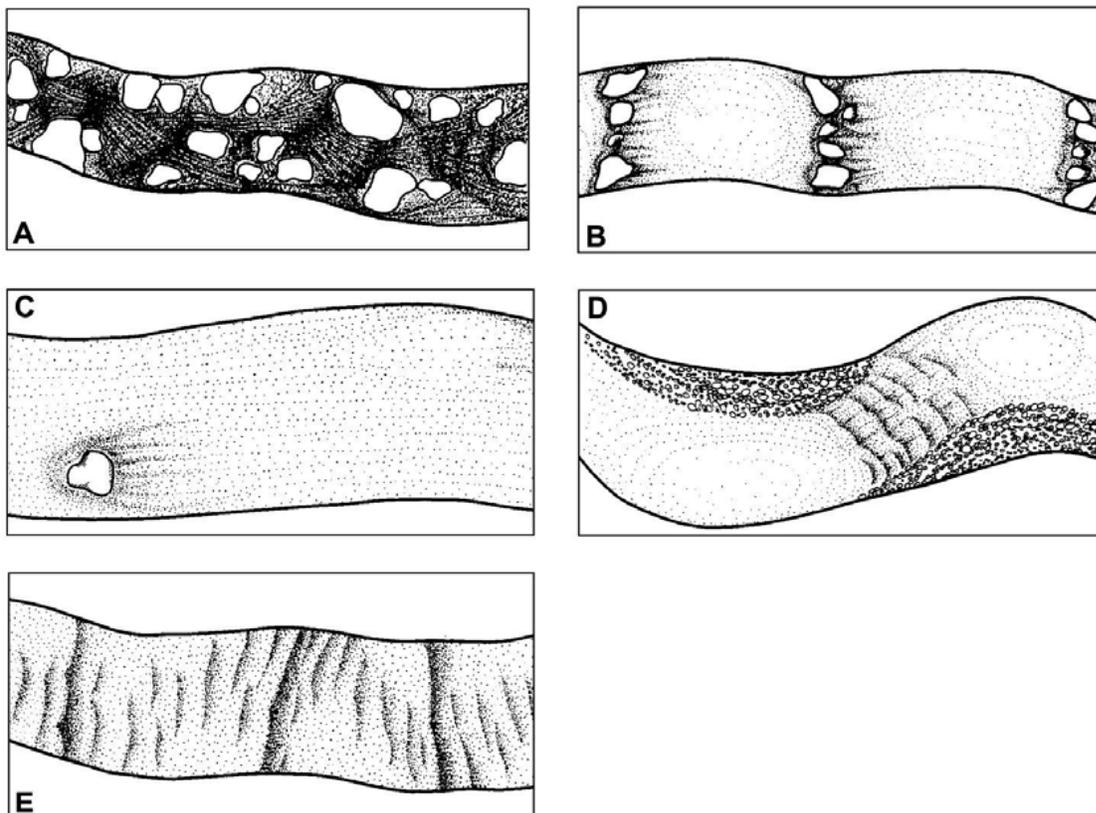
Figure 19: Schematic Plan Form of Mountain Stream Channel Classifications: A) Cascade; B) Step Pool; C) Plane Bed; D) Pool Riffle E) Dune Riffle (Reprinted from Montgomery and Buffington, 1997).

Within each of the reaches described above, we determined the channel morphology type as part of our field assessment. The most appropriate classification system for channel type morphology for Upper Deer Creek is the Montgomery-Buffington classification of channel-reach geomorphology in mountain drainage basins (Montgomery and Buffington, 1997), which offers a “process-based framework within which to assess channel condition and response potential.” Mountain drainages exhibit seven channel morphologies: colluvial, bedrock, cascade, step pool, plane bed, pool riffle, and dune riffle. The classifications are represented in the schematic plan form and idealized long profile below.

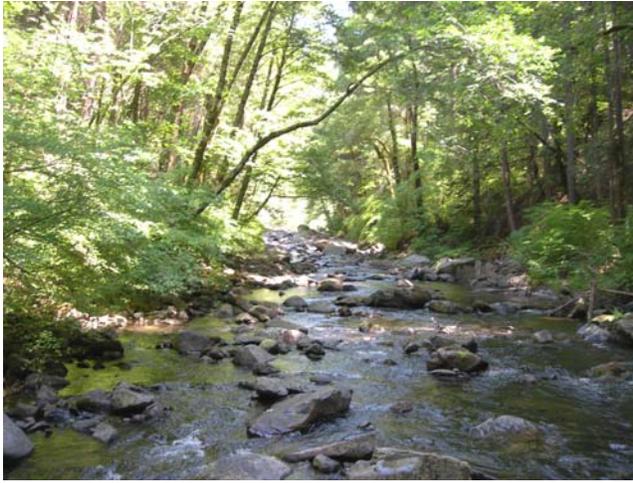
Figure 20: Example of a cascade reach (Type A), one mile below Scotts Flat

Examples of these channel types on Upper Deer Creek are shown in Figures 21 – 24. Note that Upper Deer Creek does not feature Dune Riffle habitat, Type E.

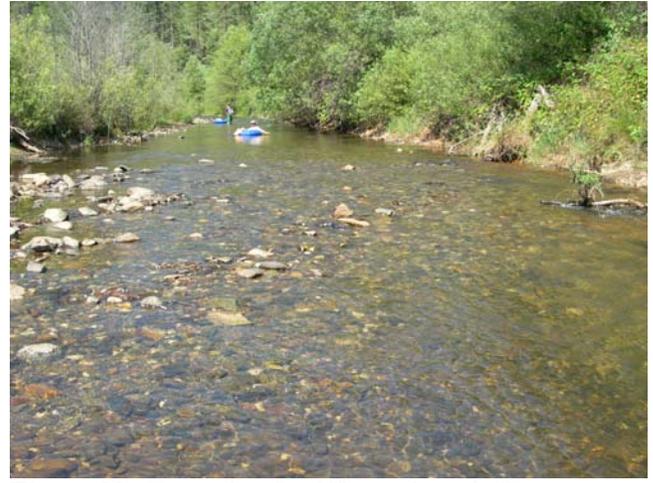
Figure 23: Example of a riffle pool reach (Type D), 1/2 mile above Bitney Springs Road

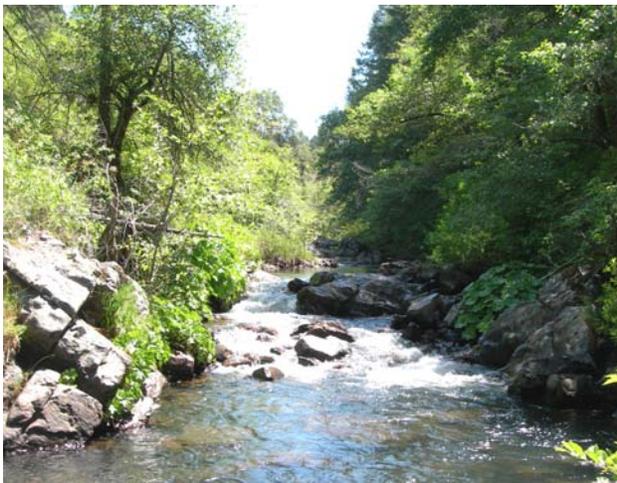
Figure 21: Example of a step pool reach (Type B), 1/4 mile below Scotts Flat

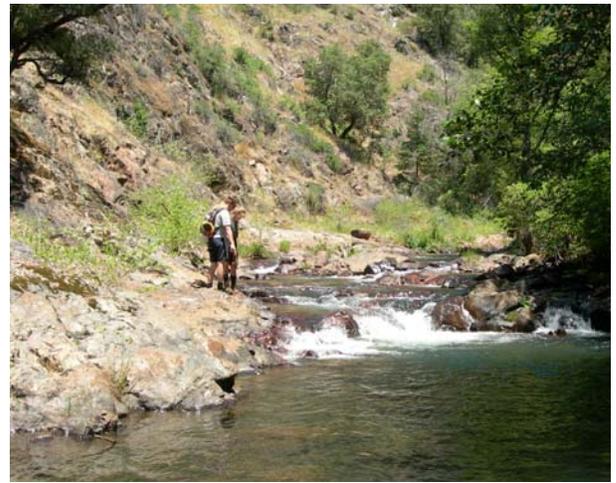
Figure 24: Bedrock reach, 3/4 mile below Scotts Flat

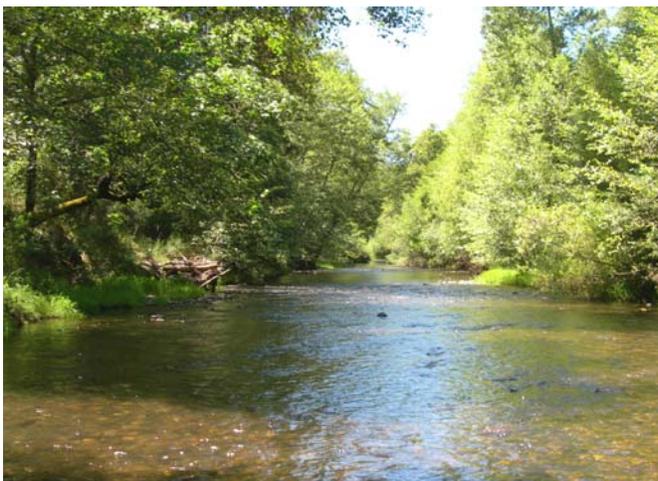
Figure 22: Example of plane bed reach, (Type C), 1/4 mile above Bitney Springs Road

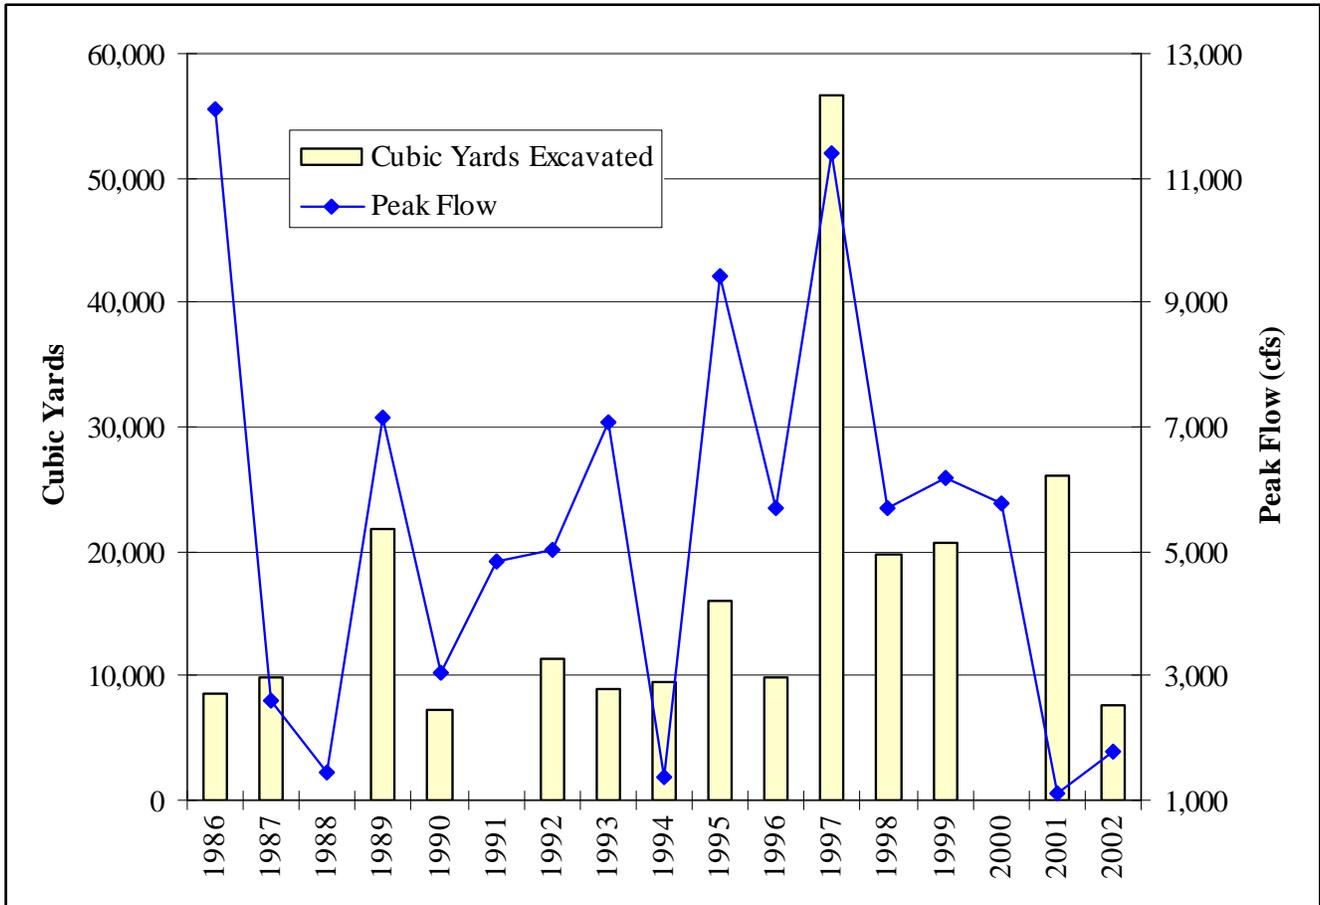
Figure 25: Amount of Sediment Excavated from Lake Wildwood compared to Peak Flows on Deer Creek at the Smartville Gauge (USGS 11418500)

The amount of sediment currently transported by Deer Creek can be estimated by examining records of sediment excavated from Lake Wildwood. Figure 25 shows the volume of annual sediment excavated from Lake Wildwood since 1986. The average volume excavated each year is 12,300 yd³. It is possible, however, that Lake Wildwood managers do not remove completely the sediment that is transported into the reservoir. The area of excavation is focused on the upstream end of the reservoir, and the finest material might be transported beyond the typical zone of excavation, particularly during the extreme flood events. Thus, these excavation data likely underestimate the amount of sediment transported by Deer Creek.

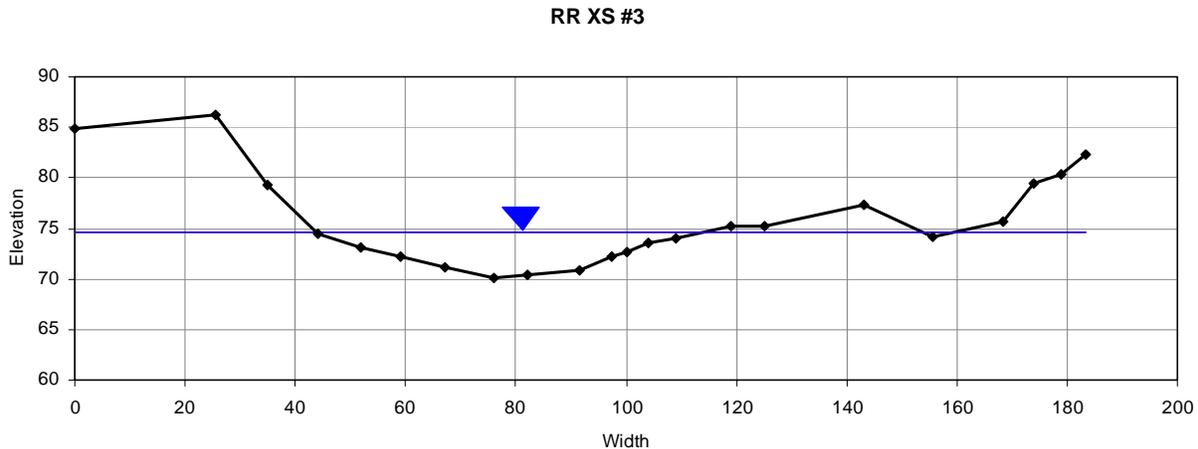
Figure 26: Channel Cross-Section Showing Elevated Terrace of Mining Debris, River Left
