**UPPER DEER CREEK
ASSESSMENT
&
RESTORATION PLAN**

*FINAL DRAFT
3/23/06*

**FRIENDS OF DEER CREEK
&
NATURAL HERITAGE INSTITUTE**

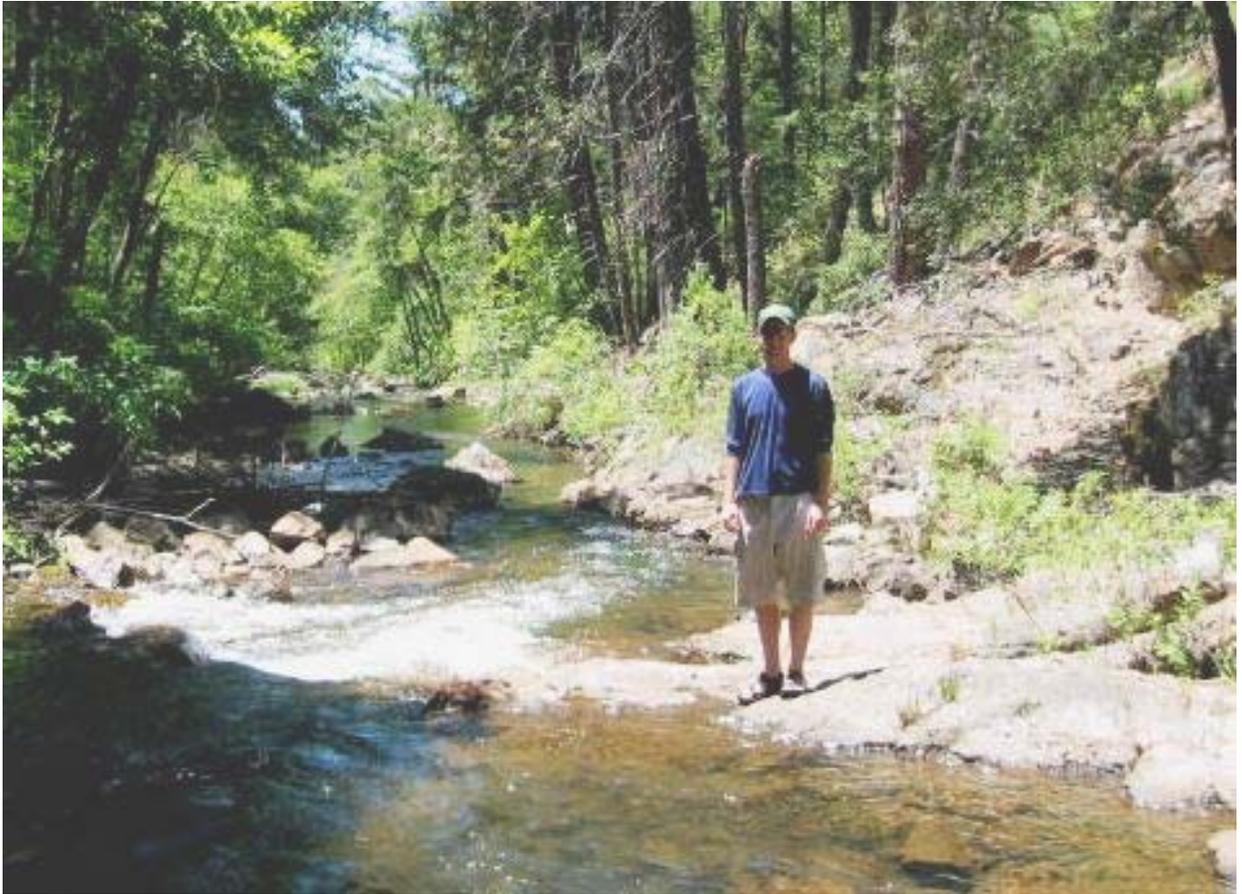
Figure 27: Bedrock Outcropping Below Scotts Flat

In general, rivers downstream from dams initially adjust by channel degradation. Typically, a river will scour, and thus lower, its channel bed as the sediment-depleted water emerging from the dam attempts to replenish its sediment load. Typically, channel degradation initiates near the dam following closure and eventually may migrate a considerable distance downstream (Williams and Wolman, 1984). Deer Creek is an exception to this rule because a series of bedrock outcroppings occurs approximately 500 feet below Lower Scotts Flat (Figure 27), thus limiting its ability to adjust.

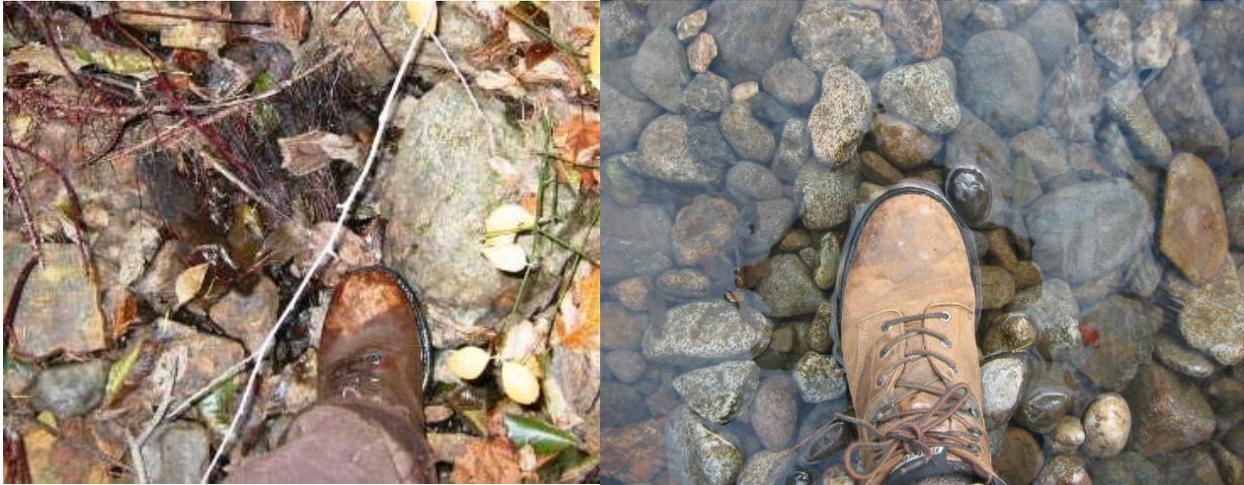
Figure 28: Substrate Immediately Below Scotts Flat (L), and 3 miles Downstream (R)

Below Scotts Flat, current sources of sediment are limited to bed and bank erosion and input from the tributaries. Similar to many studies of rivers downstream of dams, stream surveys we conducted including pebble counts indicated that Scotts Flat has caused the channel substrate in the first 1.5 miles below the dam (until the confluence with Willow Valley Creek) to become larger than sediments found in similar reaches further downstream and above the dam. The average diameter of channel substrate below the dam is 100mm, whereas at a location of similar channel slope three miles downstream, below the confluences of three significant tributaries, the average diameter is 47mm. Above the dam, the D_{50} is 55mm. In addition, the substrate immediately below the dam is largely angular, suggesting the sediment comes from the nearby hillslopes and the creek has had little chance to abrade the sharp edges. At the survey site three miles downstream, the sediment shape is significantly more rounded, indicating the substrates has been worked by the creek to a greater degree (see Figure 24). This is a common effect of dams (Grant et. al., 2003). Clearly, the dams have altered the channel substrate size and shape.

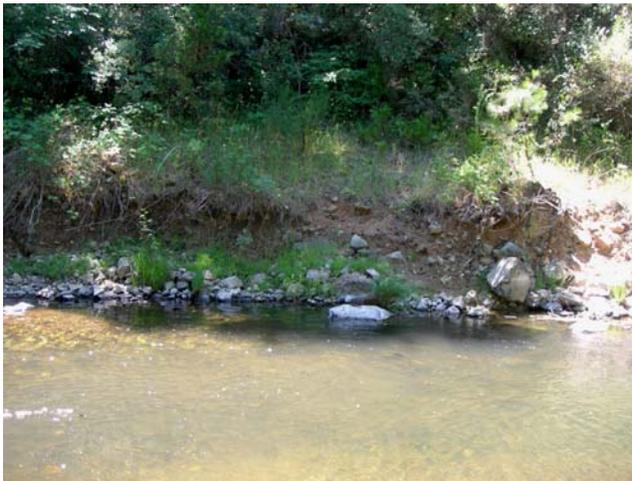
Figure 29: Example of unstable bank.

The stability of the banks of Deer Creek was evaluated on two levels. Aerial photographs were evaluated to determine the history of large-scale channel movements, and local channel stability was evaluated using the methodology described by Johnson et al 1998 as part of our field assessment. Stable banks were characterized by the presence of boulders, rocks, or rooted vegetation that reduces the bank's susceptibility to erosion, while unstable banks were characterized by the presence of exposed raw dirt, lack of rooted vegetation, steep sloped banks, undercuts, and often slumping banks (See Appendix E for a full description of the methodology used). Below are photographs of both stable and unstable banks on Deer Creek.

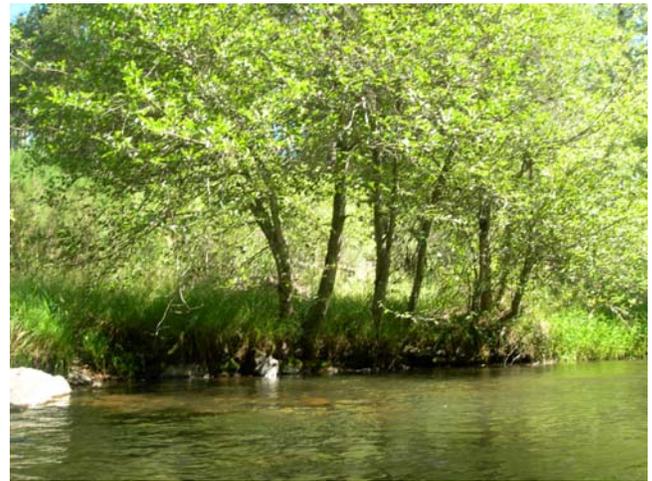
Figure 30: Example of stable bank.

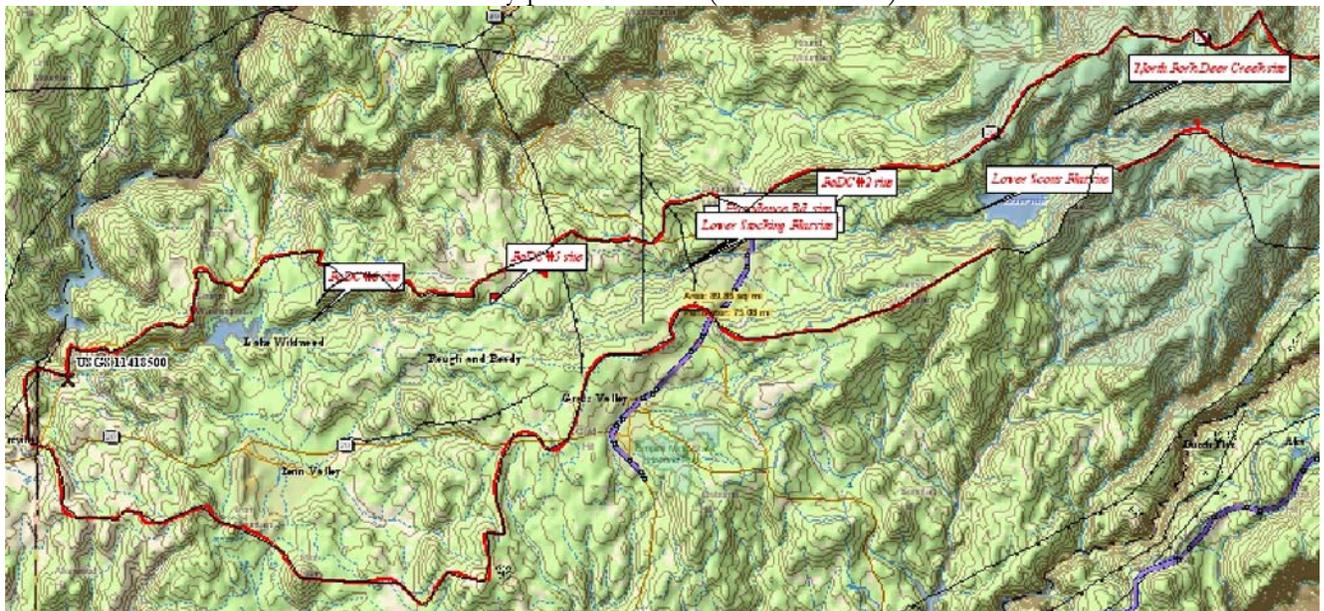
Figure 31: Location of Survey Sites

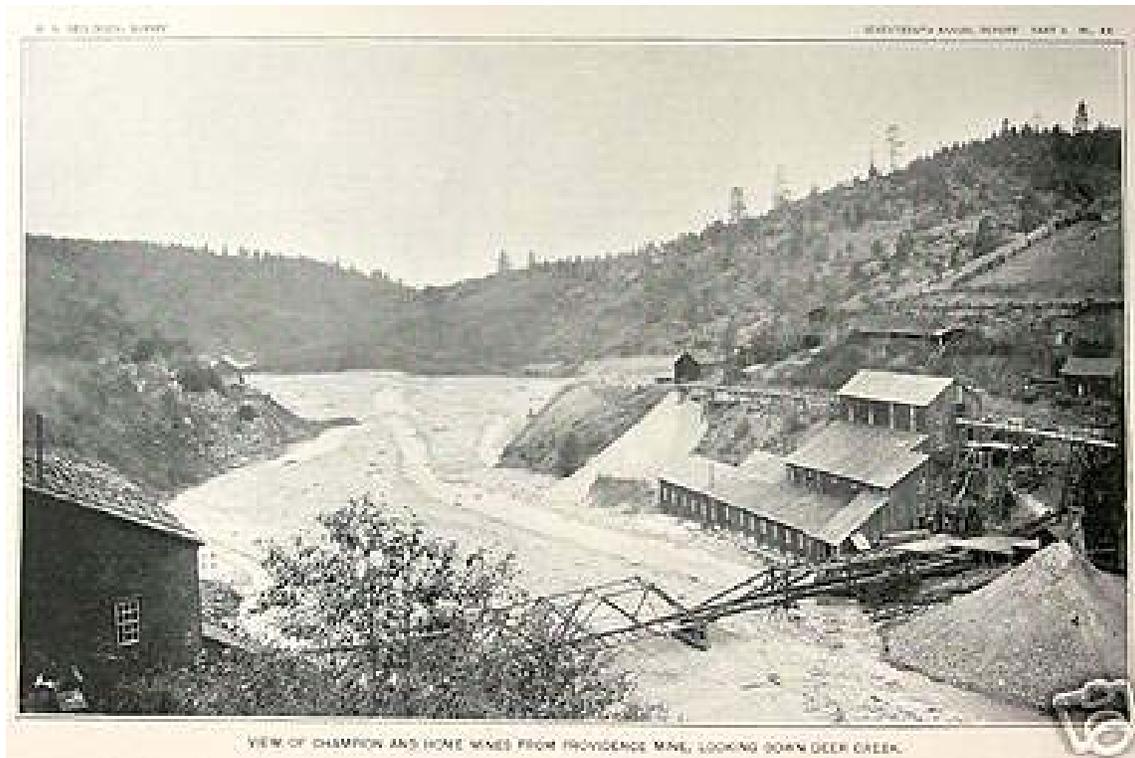
Figure 32: Massive amounts of sediment filled the Deer Creek channel at the height of the mining era. This photo is of Champion Mine, 1.5 miles West of Nevada City, circa 1880.

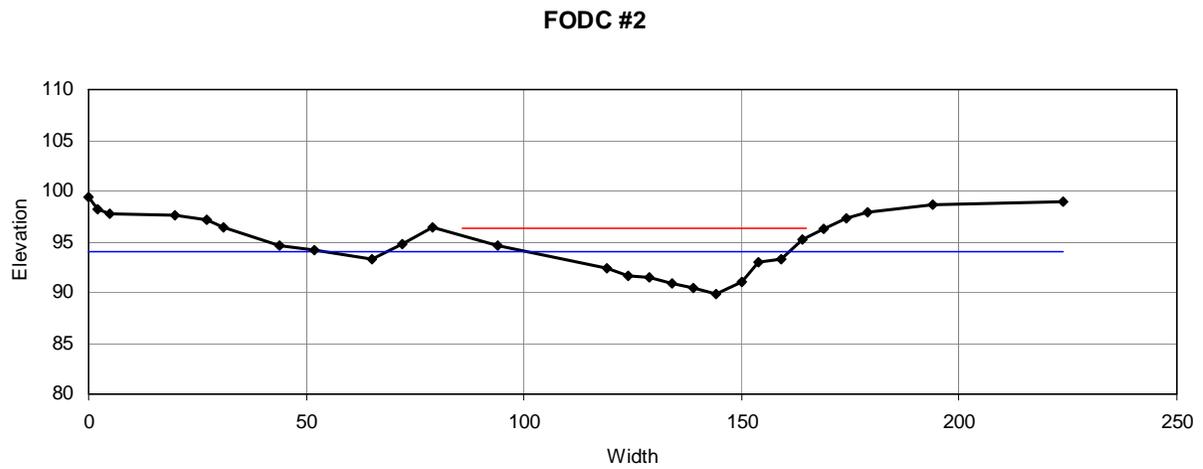
Figure 33: Cross-sections showing the estimated water surface elevation during a 2-year (blue) and 10-year flood event (red) at the Friends of Deer Creek Monitoring Site #2

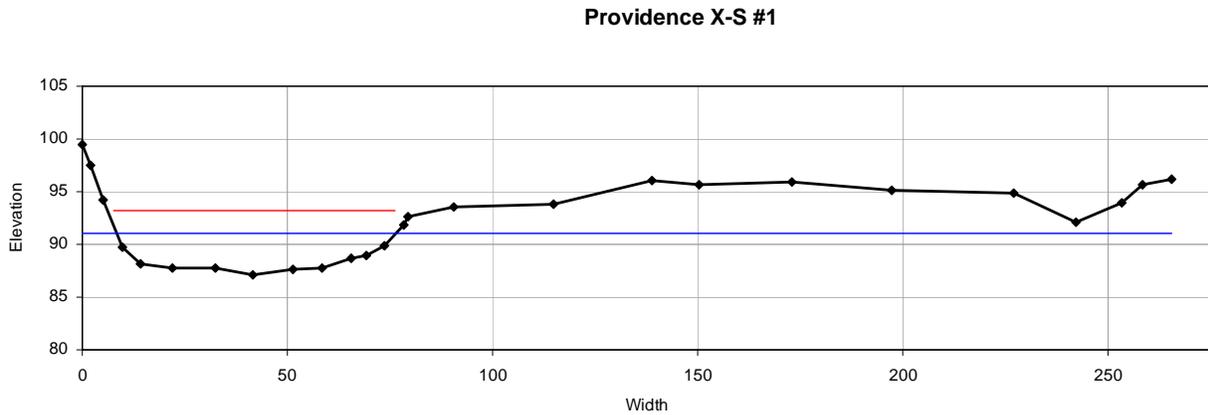
Figure 34: Cross-sections showing the estimated water surface elevation during a 2-year (blue) and 10-year flood event (blue) at the Providence Road reach cross section #1

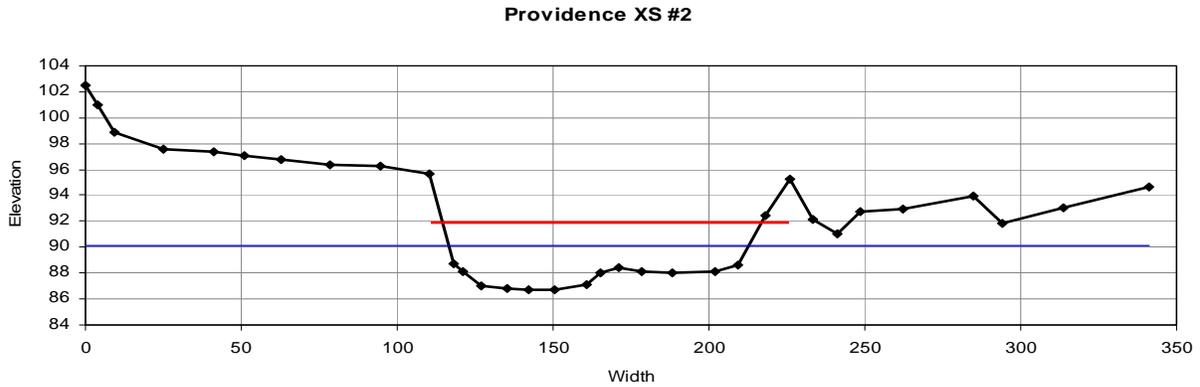
Figure 35: Cross-sections showing the estimated water surface elevation during a 2-year (red) and 10-year flood event at the Providence Road reach cross section #2

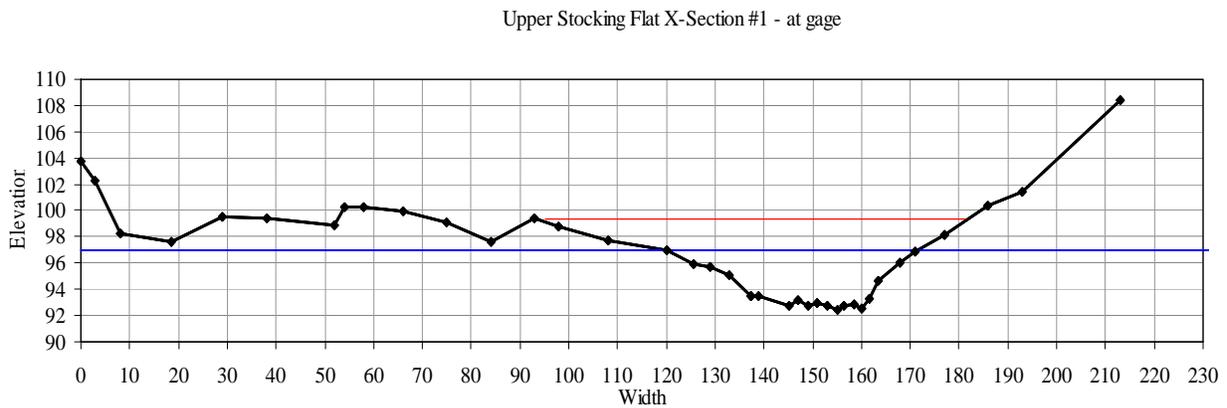
Figure 36: Cross-sections showing the estimated water surface elevation during a 2-year (blue) and 10-year flood event (red) at the Upper Stocking Flat reach at cross section #1

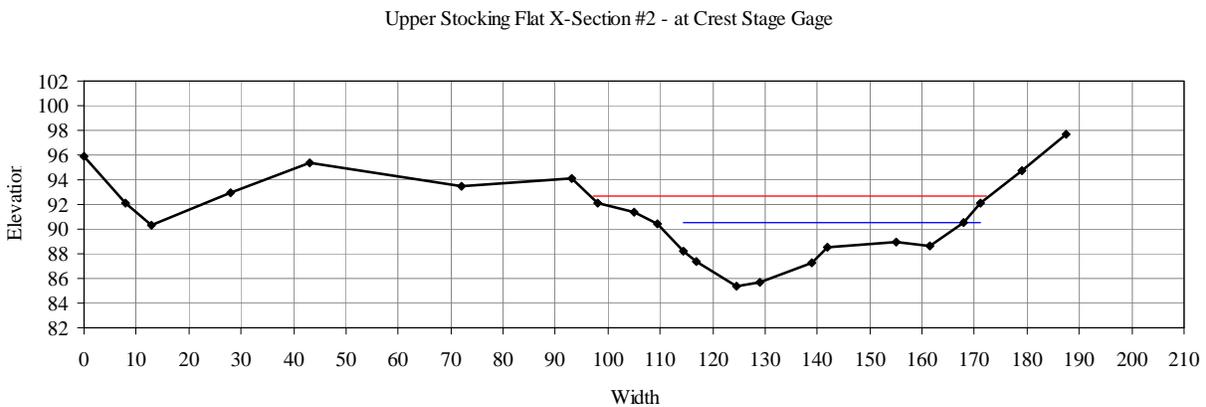
Figure 37: Cross-sections showing the estimated water surface elevation during a 2-year (blue) and 10-year flood event (red) at the Upper Stocking Flat reach at cross section #2

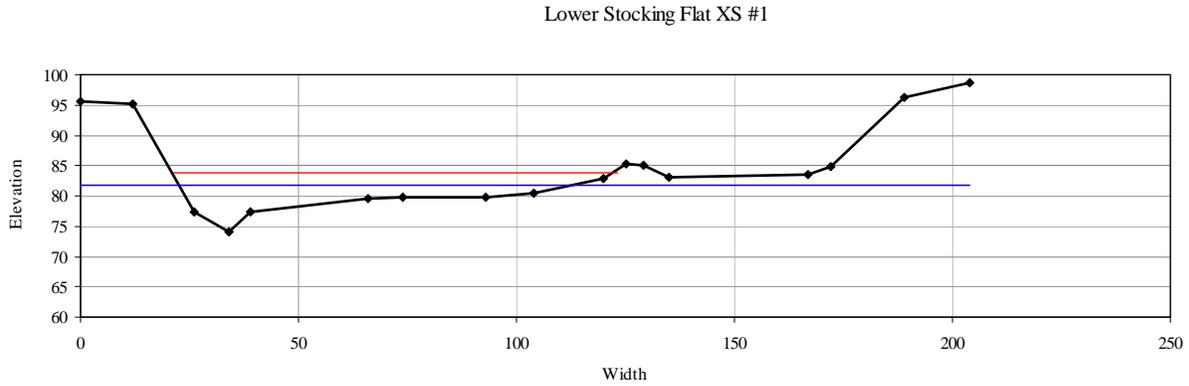
Figure 38: Cross-sections showing the estimated water surface elevation during a 2-year (blue) and 10-year flood event (red) at the Lower Stocking Flat reach at cross section #1

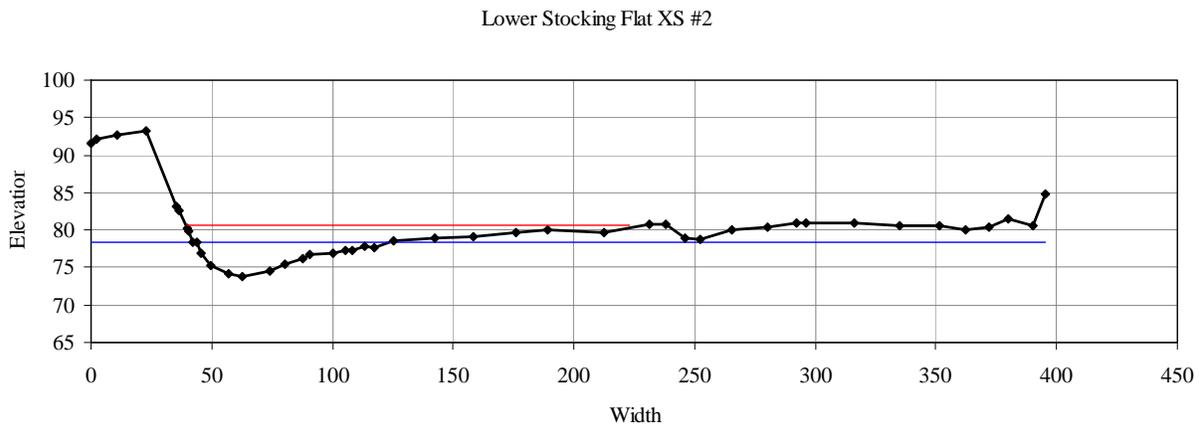
Figure 39: Cross-sections showing the estimated water surface elevation during a 2-year (red) and 10-year flood event at the Lower Stocking Flat reach at cross section #2

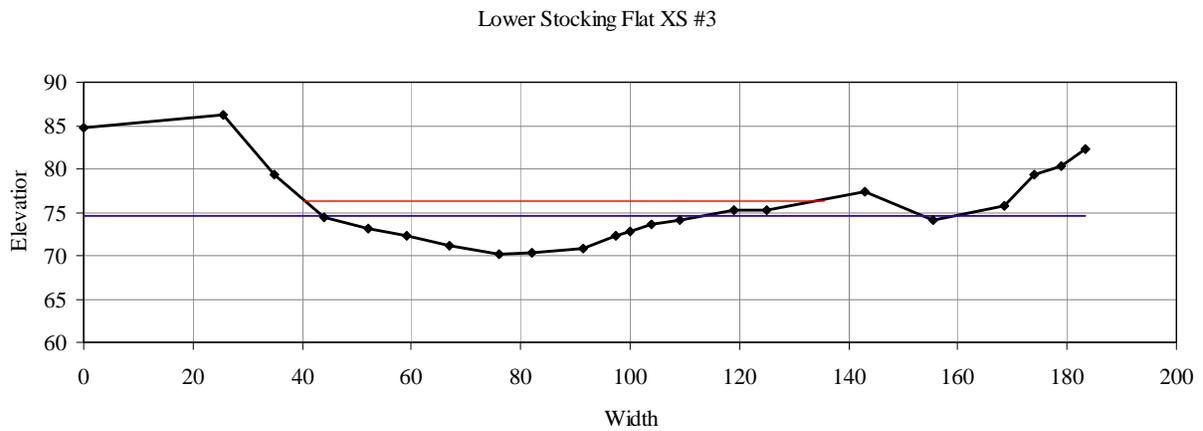
Figure 40: Cross-sections showing the estimated water surface elevation during a 2-year (blue) and 10-year flood event (red) at the Lower Stocking Flat reach at cross section #3

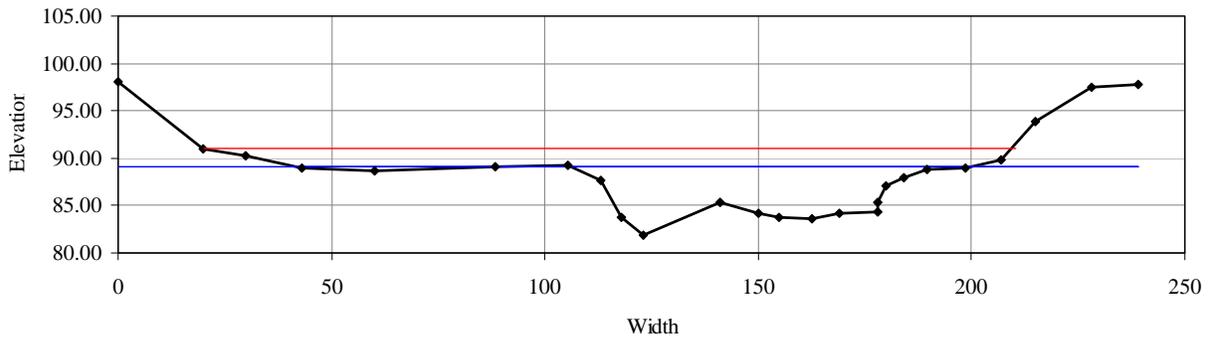
FODC #5

Figure 41: Cross-sections showing the estimated water surface elevation during a 2-year (blue) and 10-year flood event (red) at the Lower Stocking Flat reach at cross section #3

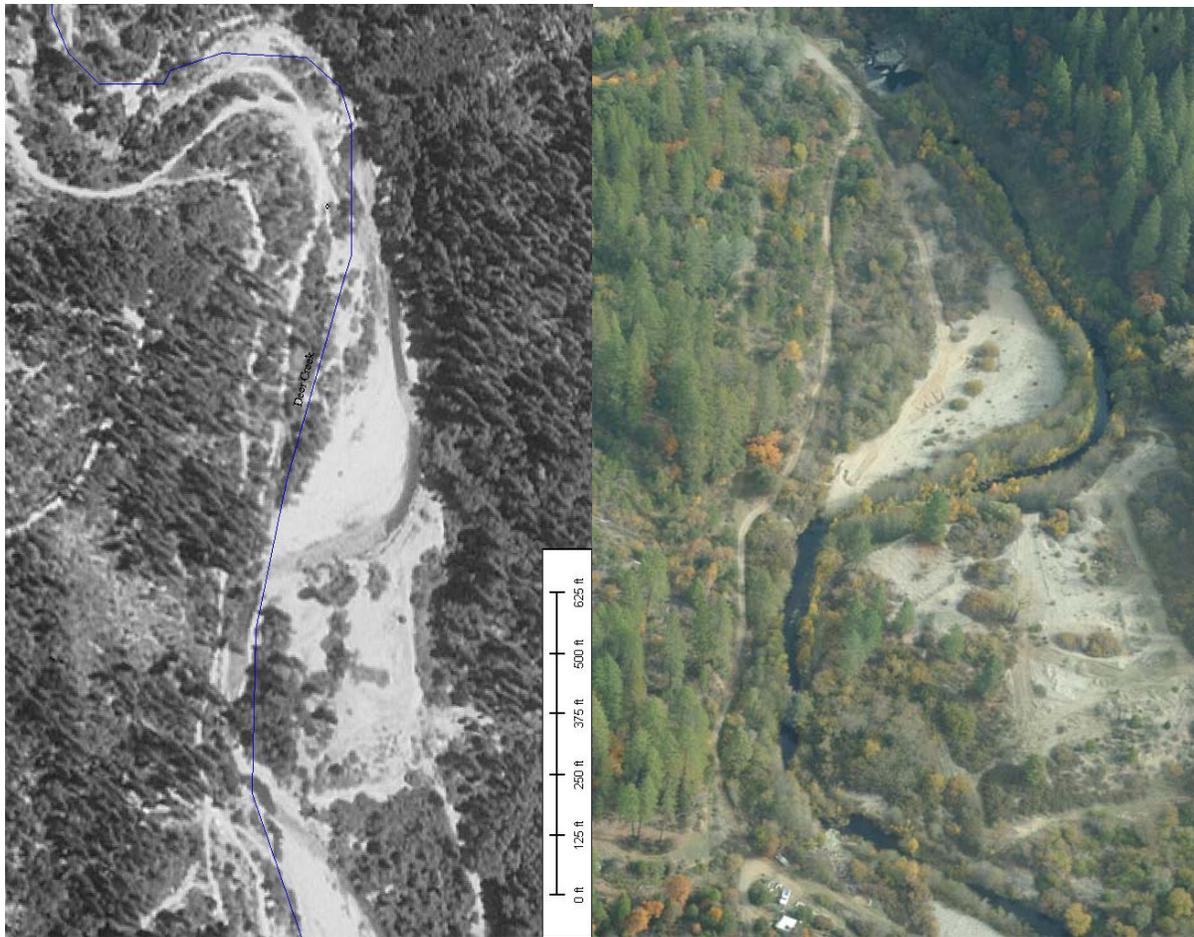
Figure 42: Aerial of Lower Stocking Flat in August 1998 (left) and Oblique Aerial of Lower Stocking Flat in October 2004 (right)

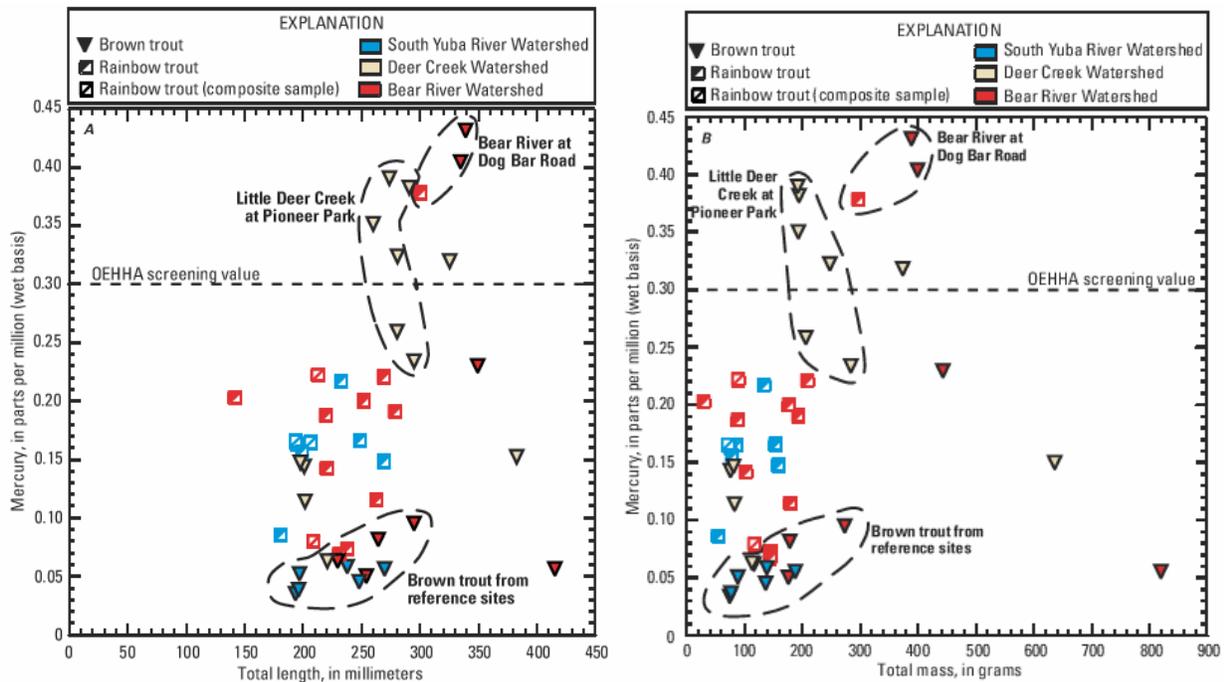
Figure 43: Mercury concentration for stream fish samples collected from the South Yuba River, Deer Creek, and Bear River. *A* in relation to total length, and *B* in relation to total mass. Dashed horizontal line at mercury concentration of 0.3 ppm represents a screen level value provided by the Office of Environmental Health Hazard Assessment. (From May et. al., 1999.)

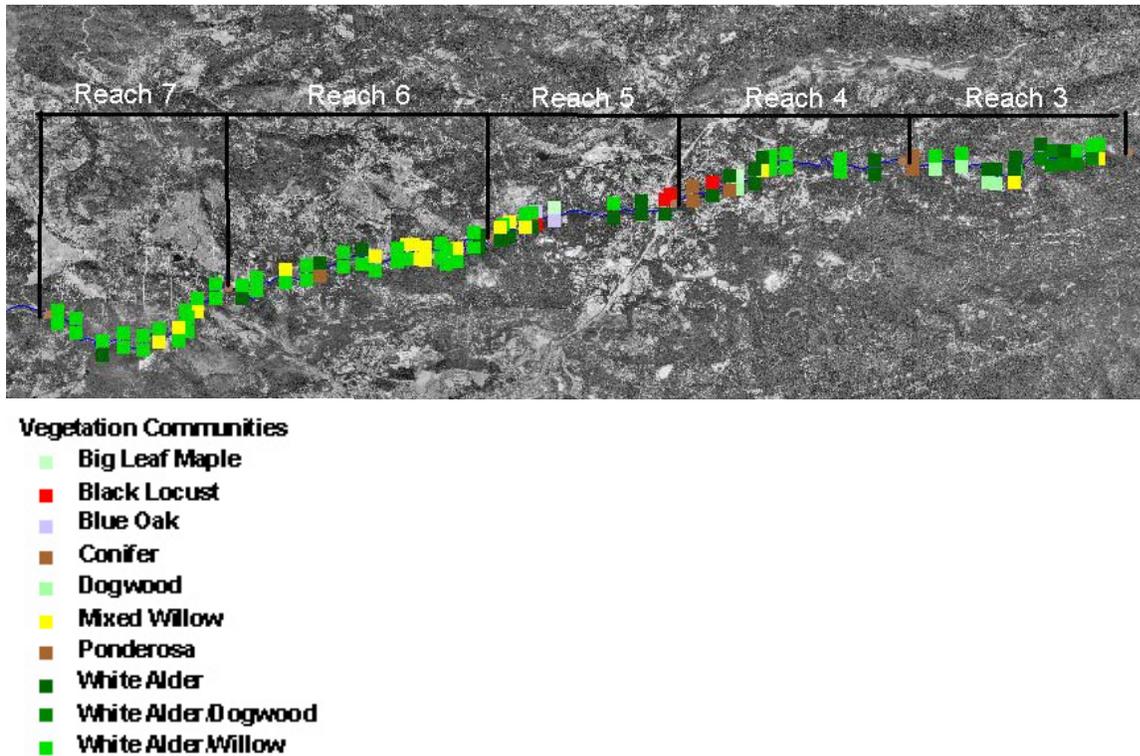
Figure 44: Map of Dominant Riparian Species along Upper Deer Creek

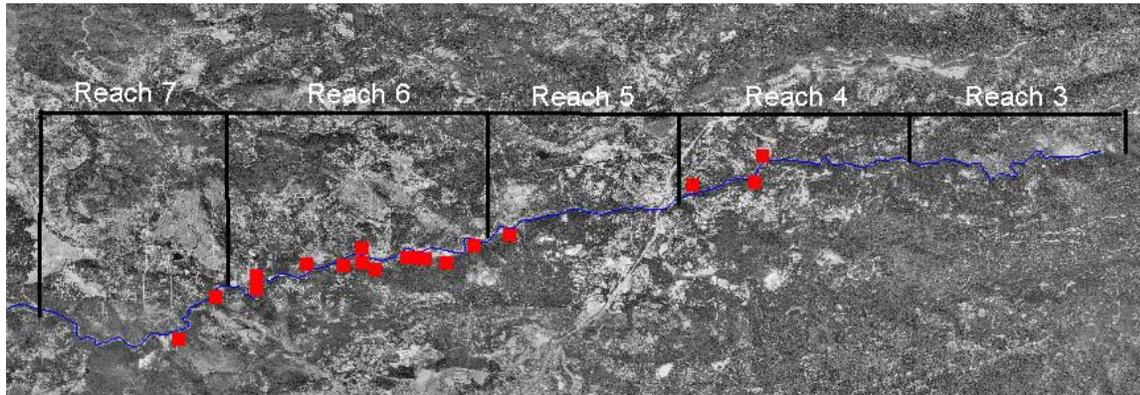
Figure 45: Location of Flood Terraces 5 feet or Higher above Estimated Bankfull Discharge

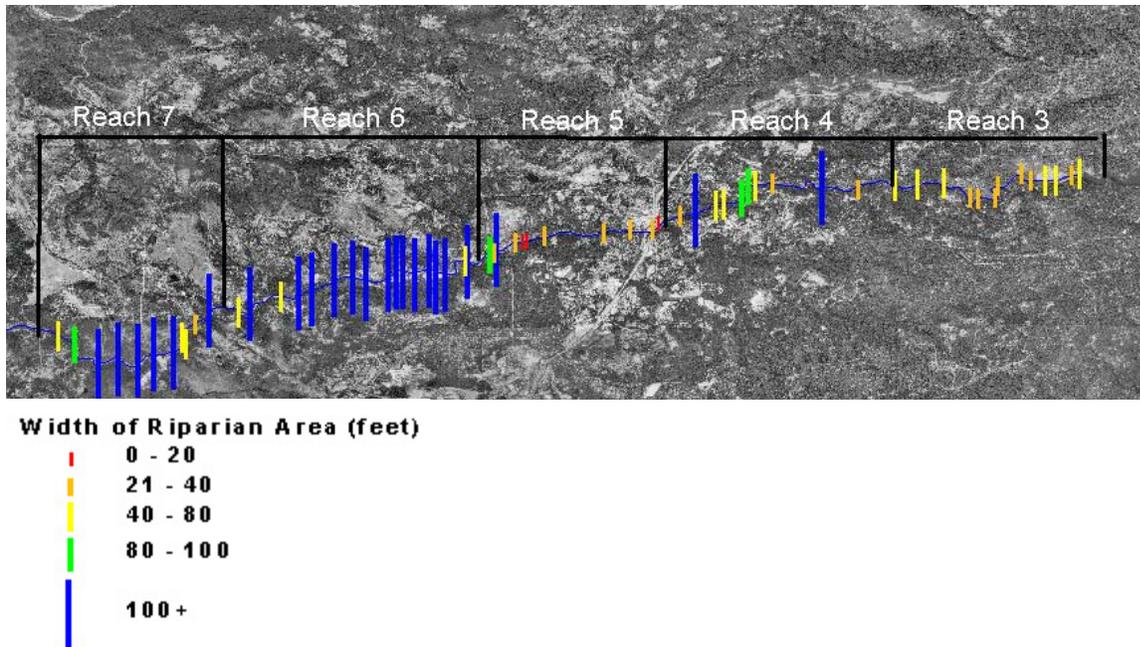
Figure 46: Width of Riparian Area

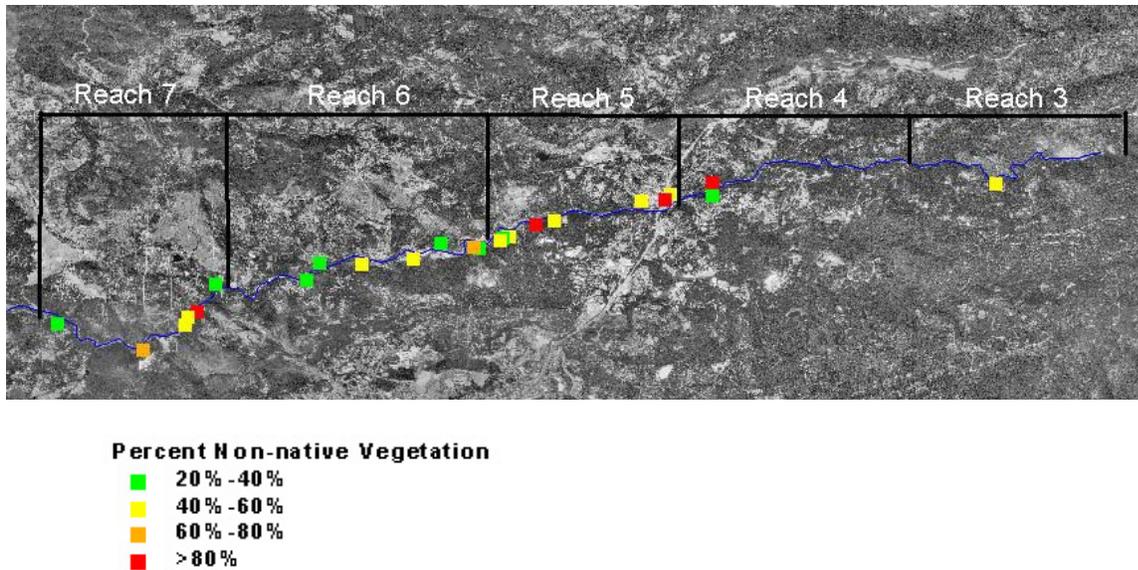
Figure 47: Percent Non-Native Vegetation

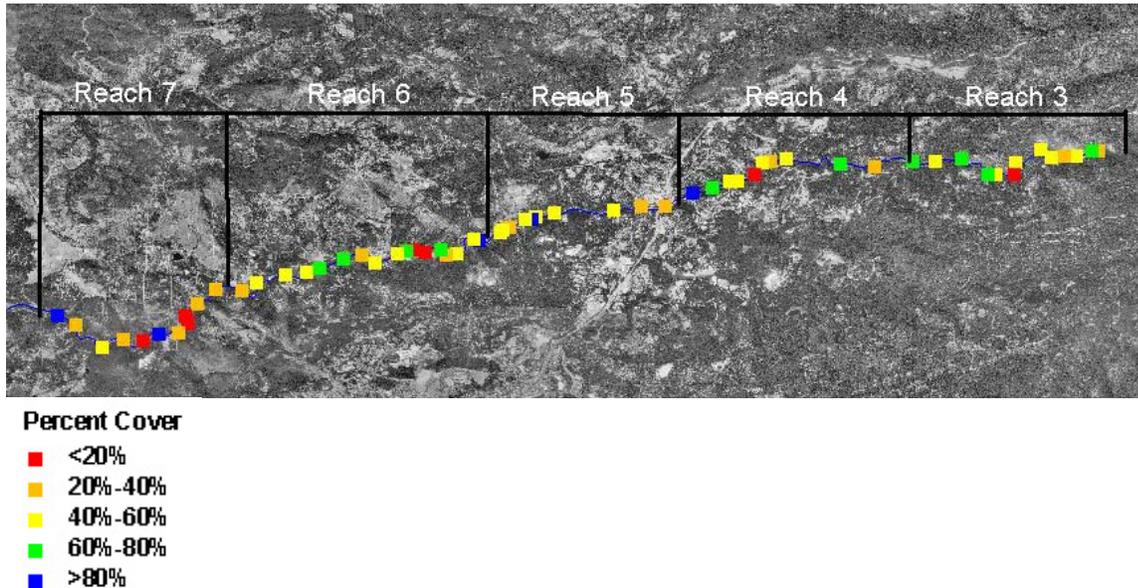
Figure 49: Percent Canopy Cover Mid-stream

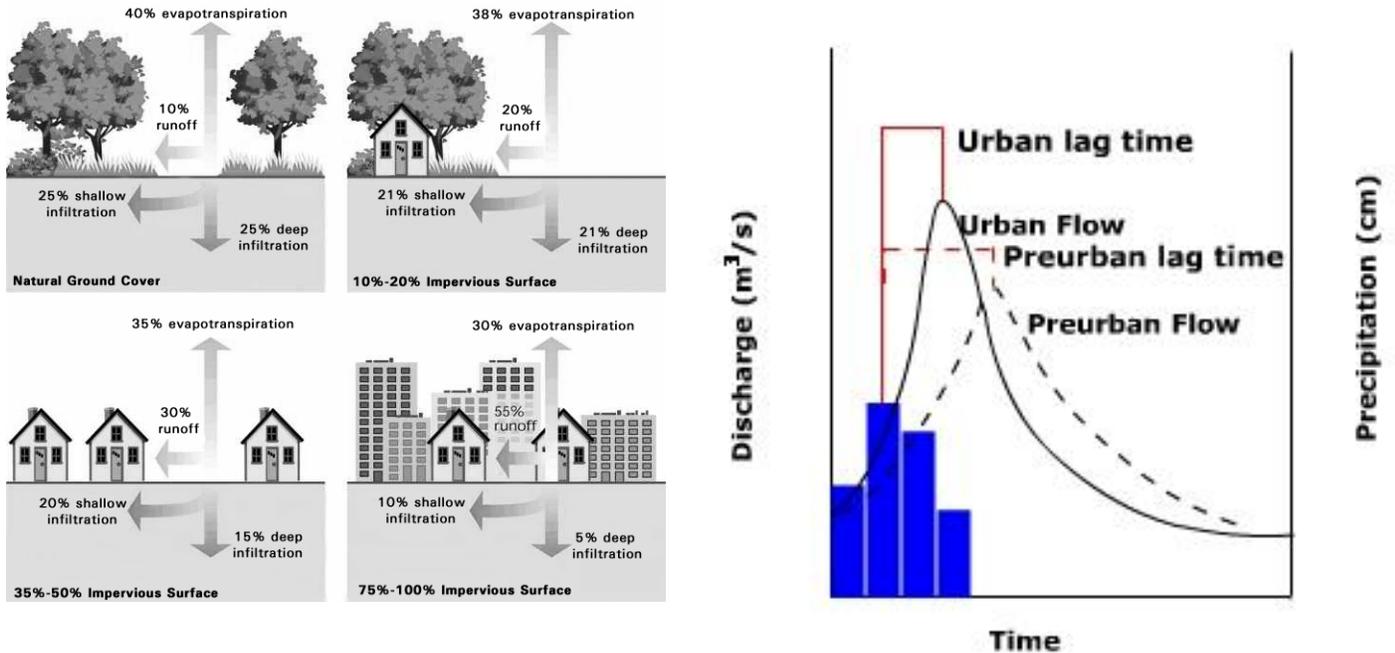
Figure 51: Effect of Urbanization on Hydrologic Processes

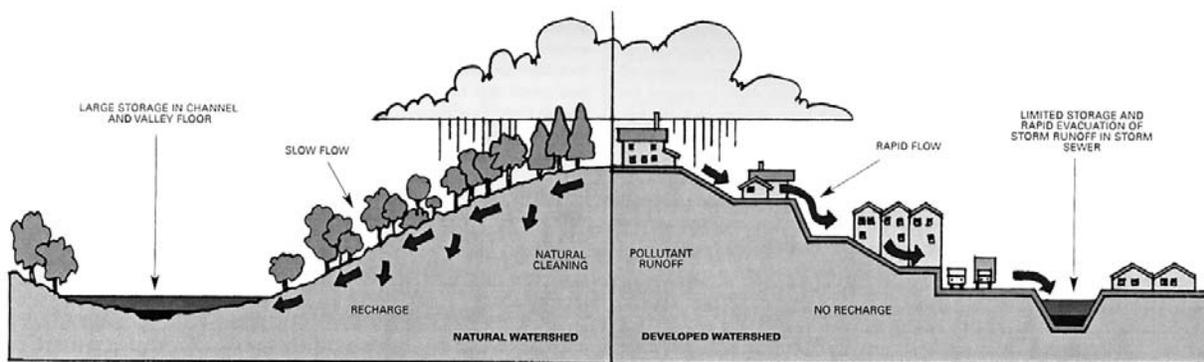
Figure 52: Effect of Urbanization on Groundwater Recharge and Water Quality

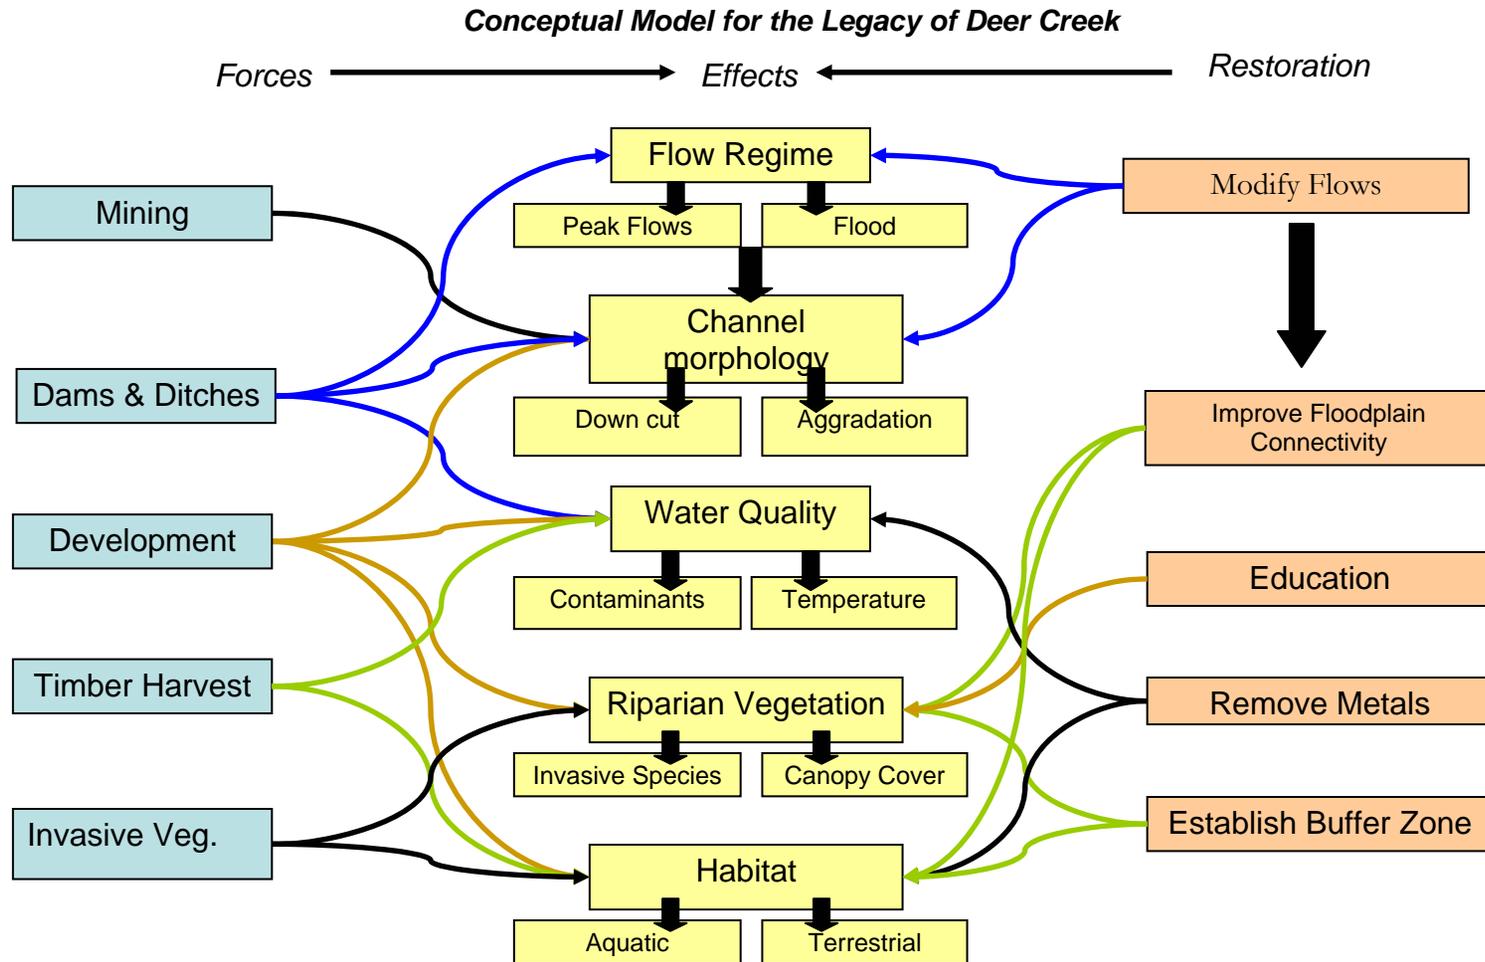
Figure 53: Conceptual model for Deer Creek restoration efforts.
