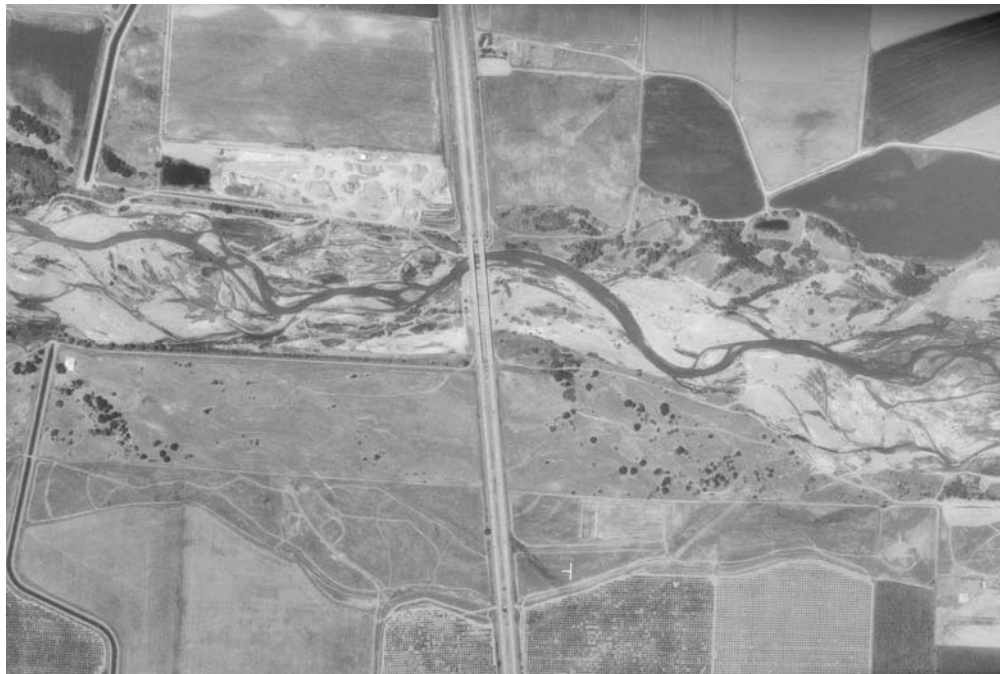
- Thomes Creek is wide and has a highly braided character through the entire assessment area. Total stream channel width was often in excess of 1,000 feet, while at both the Hall Creek low-water crossing (see Image Comparison 4b) and Interstate 5 crossing site (see Image Comparison 4c) total stream width was about 3,000 feet.

Image Comparison 4c. Thomes Creek at the Interstate 5 crossing site in 1952 (above) and 1994 (bottom). Note the braided stream condition in both images. The Interstate 5 Bridge locations and lengths are shown as a blue bar. The extent of overflow patterns in 1952 are shown by the black lines and the 1994 extent of stream constriction is shown by the yellow line. Comparing these images show the extent of channel constriction. (The feature to the west of Interstate 5 is the Corning Canal crossing.)

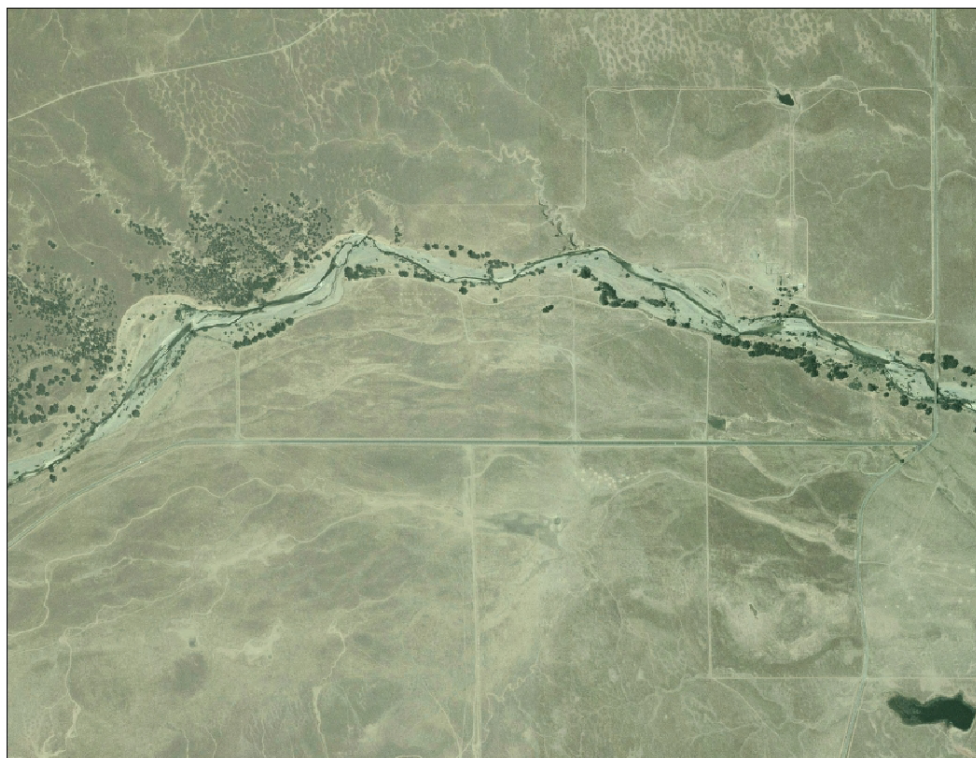
**Figure 9a (top, 1947) and 9b (bottom, 2004). This is Site 6, along Elder Creek and approximately 1 mile west of the Paskenta Road. Note significant erosion features shown by the arrows. An old stream erosion feature is shown with the wavy line.**

Along the northern bank of Elder Creek there are a number of significant erosion features, similar to what was seen in Sites 1-3. Sharp cut banks exist in the 1947 photograph, along with dendritic gully erosion patterns (as shown on Figure 9a). Riparian growth is very scant along Elder Creek and not present in side gullies.

In 2004 the erosion features appear less noticeable than in 1947, with the possible exception of the gully shown by the furthest east arrow on Figure 9a. Riparian growth - all of which exists directly along Elder Creek - appears mostly unchanged between 1947 and 2004. Finally, agricultural efforts appear to have been curtailed south of Elder Creek between 1947 and 2004, with only grasslands/rangelands south of Elder Creek during more recent years.
